## ARBORIST REPORT

Tree Inventory, Tree Descriptions and Recommendations Relative to Proposed Construction

### Winchester Boulevard Office

**FEBRUARY 12, 2016**

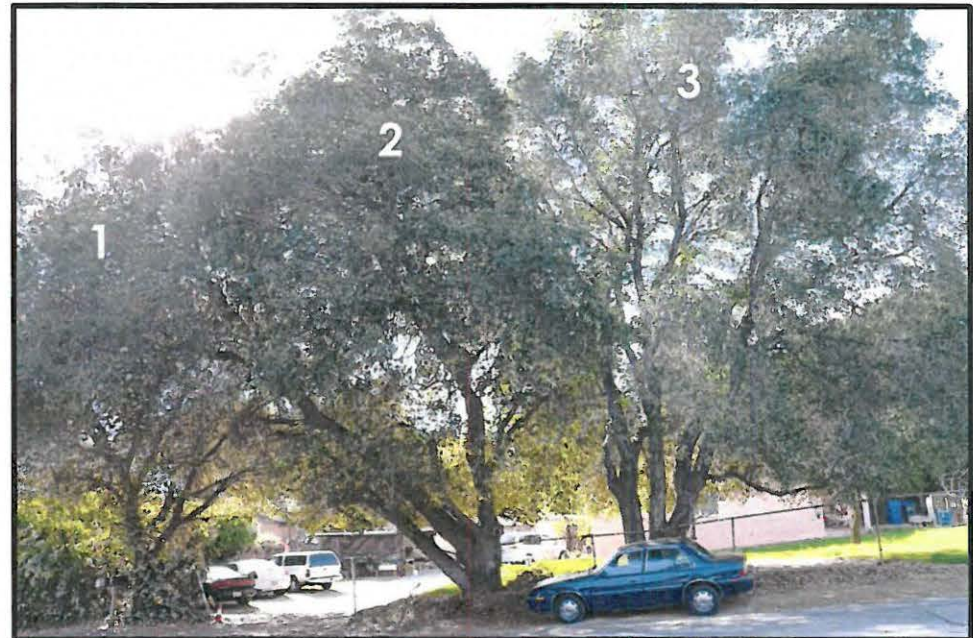
Cover photo: coast live oaks #1, 2 and 3. As per the current plans, tree #1 will be removed and #2 and 3 will remain, but construction is really too close to trees #2 and 3 for them to remain. All photos in this report were taken by D. Ellis on February 9, 2016 unless otherwise noted.

- 3) **The proposed building is simply too close to many of the large oak trees,** even though these trees are shown to be saved. Examples are **coast live oaks #2, 3, 9, 16 and 17**. The building should be moved to 10 feet beyond the actual dripline of the trees unless it can be shown (e.g. with story posts) that the building itself as well as construction of the building, will not cause excessive pruning of the canopies of these trees.

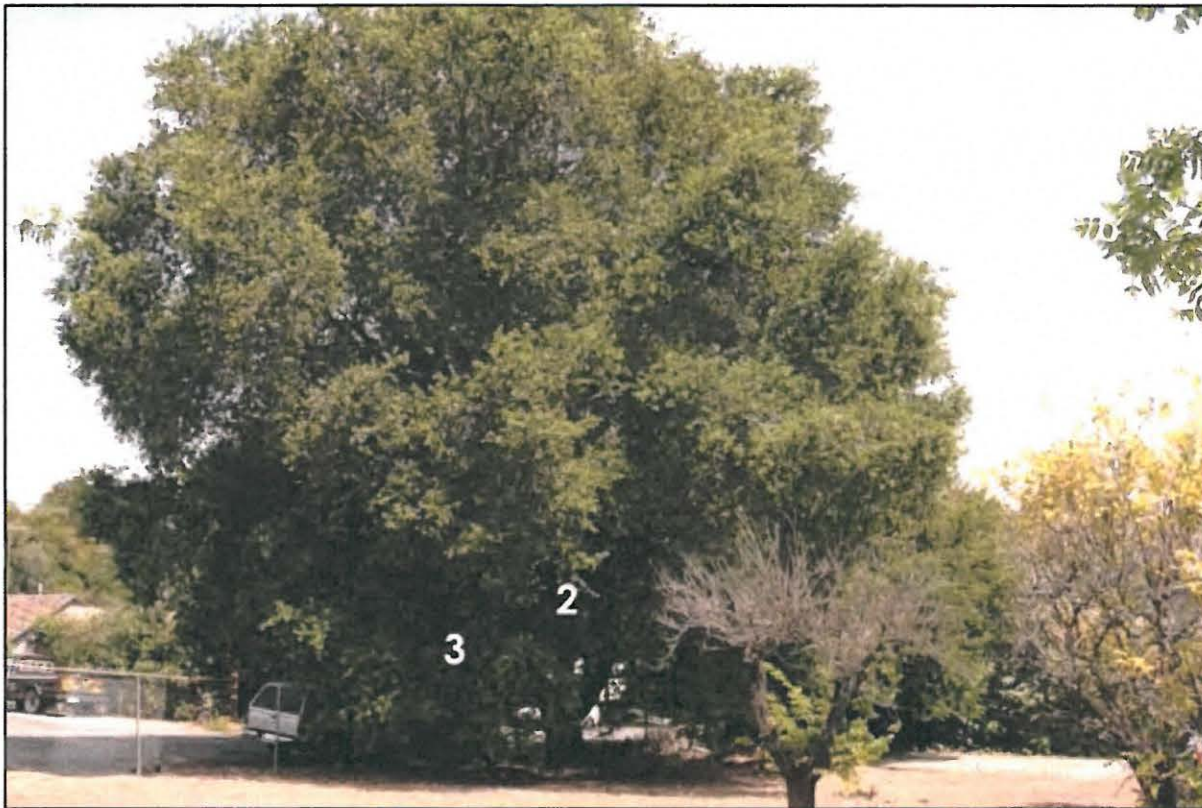
This is a partial side-view of **coast live oaks #2 and 3** from the southwest. Imagine a 2-story building 12 feet from the trunks of these trees, which tucked well inside the canopy. Now imagine trying to construct the 2-story building without having to cut off all the branches on the building side of the trunk. Such pruning will be necessary if the building is constructed as shown on the plan I reviewed. This photo was taken April 9, 2012 so the trees have probably grown a bit larger since then.

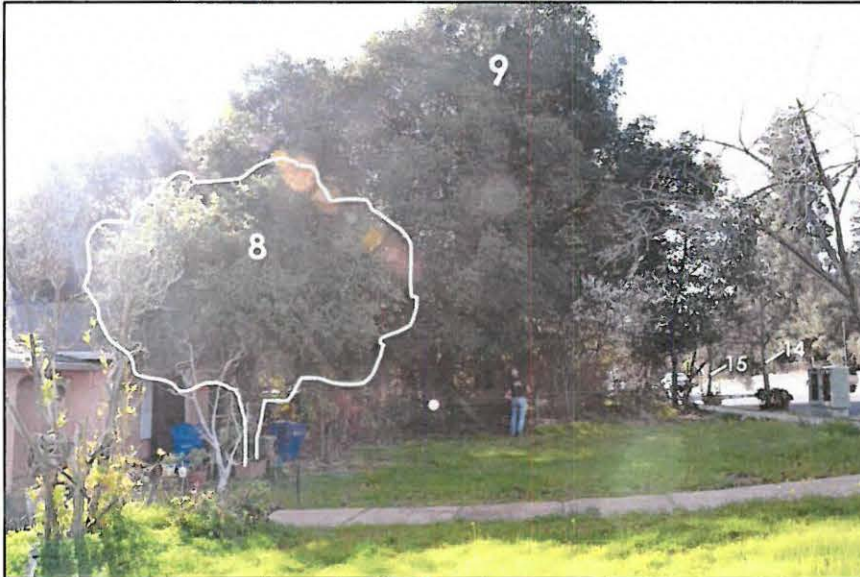
Upper Left: **coast live oak #8** (foreground) with large coast live oak #9 in the background. Winchester Blvd. to the right.

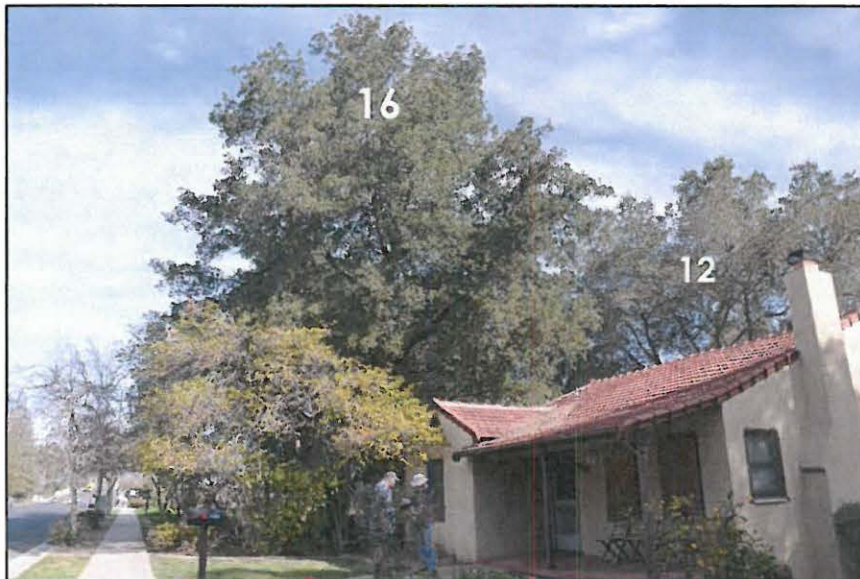
Lower Left: **coast live oaks #12 and 16**. Winchester Blvd. to the left.

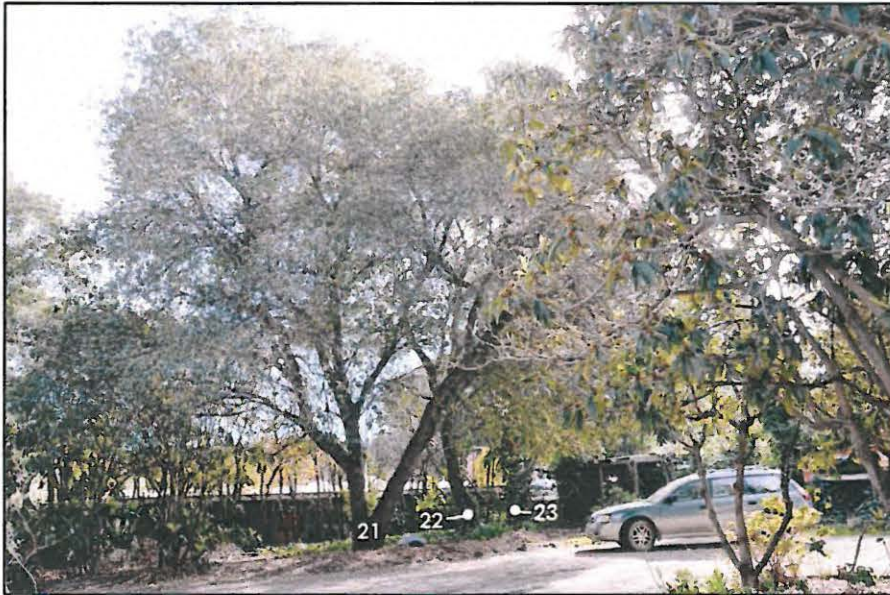
Upper Left: **coast live oaks #21-23.**

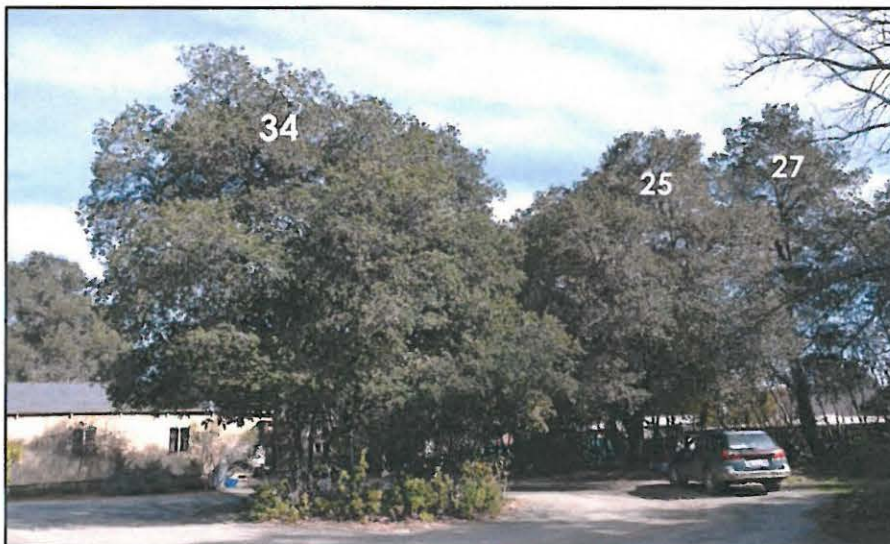
Lower Left: **coast live oaks #25, 27 and 34.**

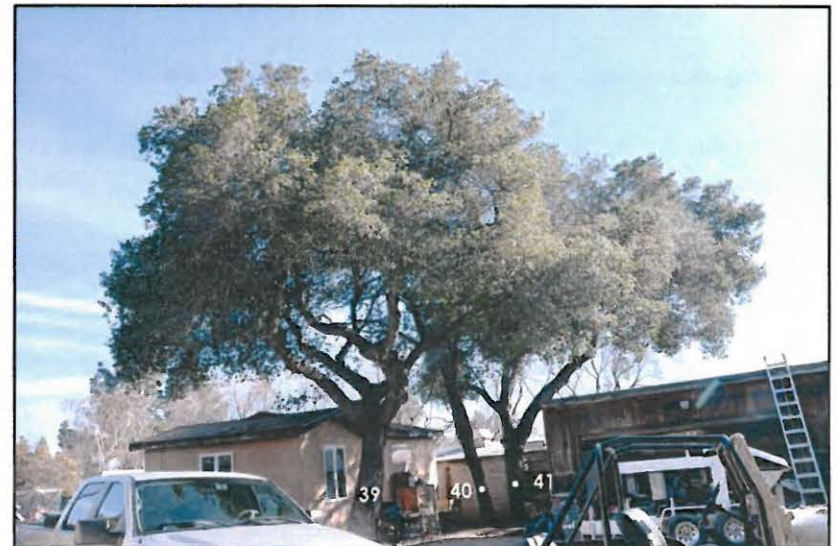
Right: **coast live oaks #29 and 41, with valley oak #40 in the background.**

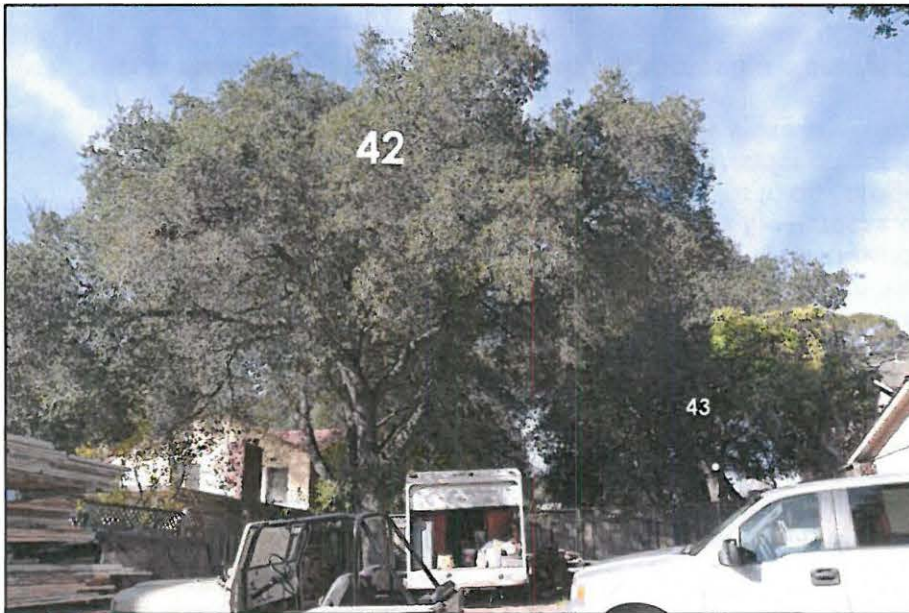
Upper photo: **coast live oak #42**, with smaller **coast live oak #43** in the background.

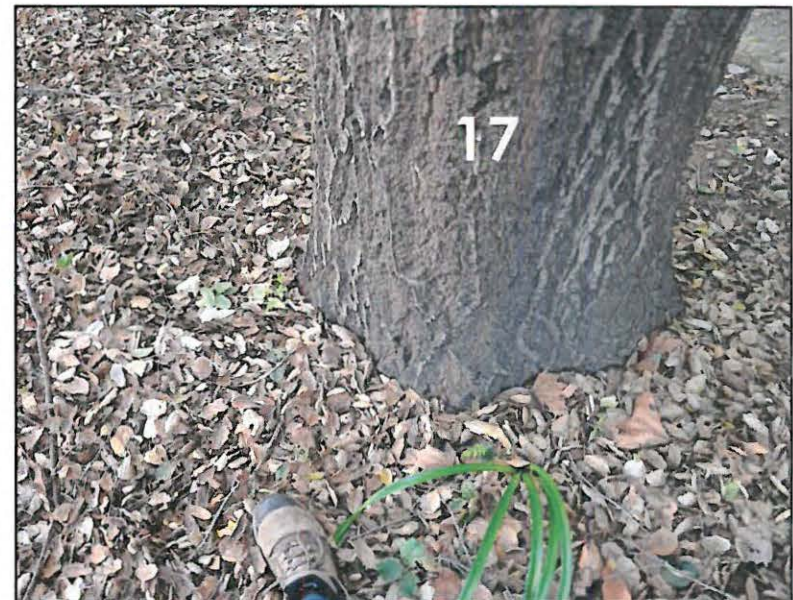
Lower photo: ground surface around **coast live oak #17**, which is typical for many of the trees on site - natural leaf and twig litter mulch. This is the best ground covering for most trees, although I would pull it away from the root collars. The soil is very loose and friable, and this probably has a lot to do with the high vigor ratings for many of these oaks.
