TOWN OF LOS GATOS
PLANNING COMMISSION STAFF REPORT
Meeting Date: March 25, 2015

APPLICATION NO.: Tree Removal Permit Application T14-004

LOCATION: **10 Jackson Street** (corner of East Main Street and Jackson Street)

10 Jackson Street, Los Gatos – Tree Removal Permit Pictures

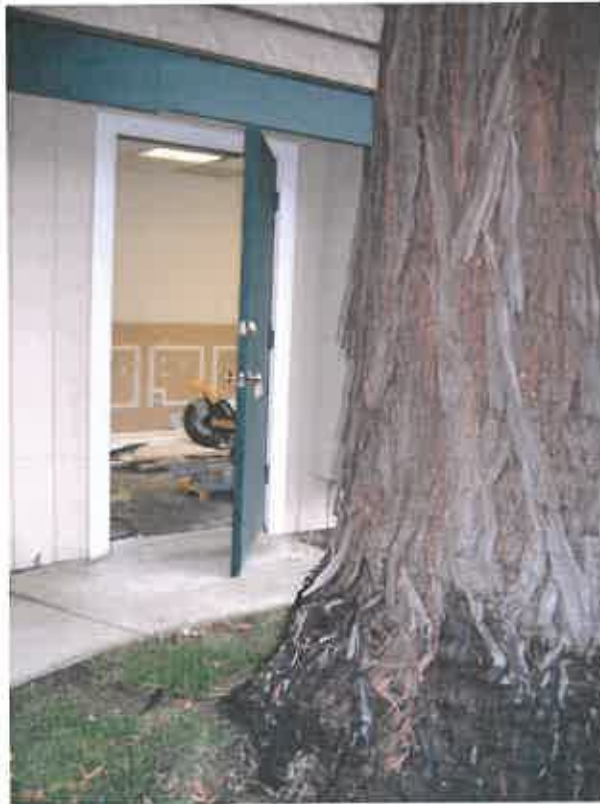
2007 Picture of Tree at Suite 105 obstructing the door opening because of raised concrete walkway.

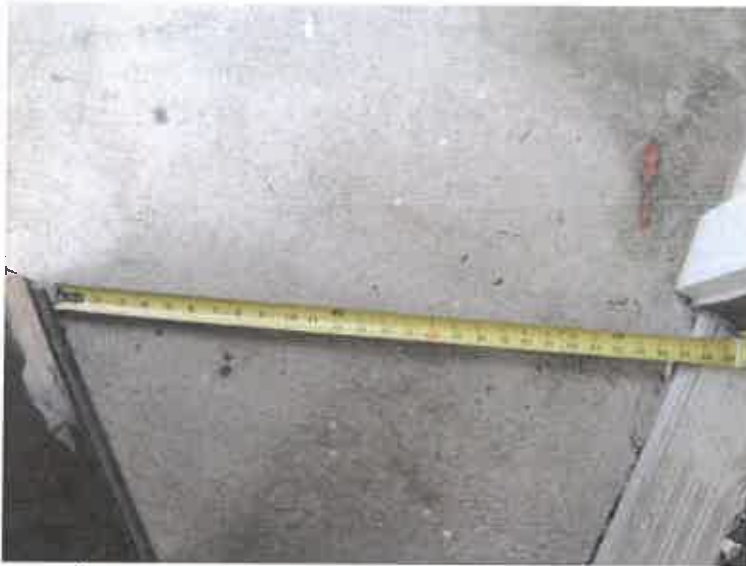
2007 - walkway at Suite 105 showing door opening to a maximum of 28 inches because of raised concrete caused by tree. To avoid this in the future, door was re-hung opening inward.

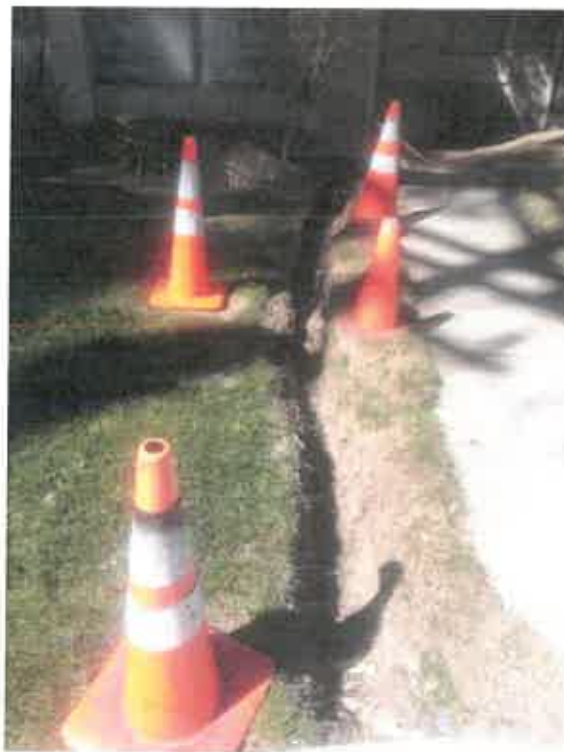
2015 - trench dug to remove drainage pipe clogged with tree roots causing rain water to accumulate on building roof.

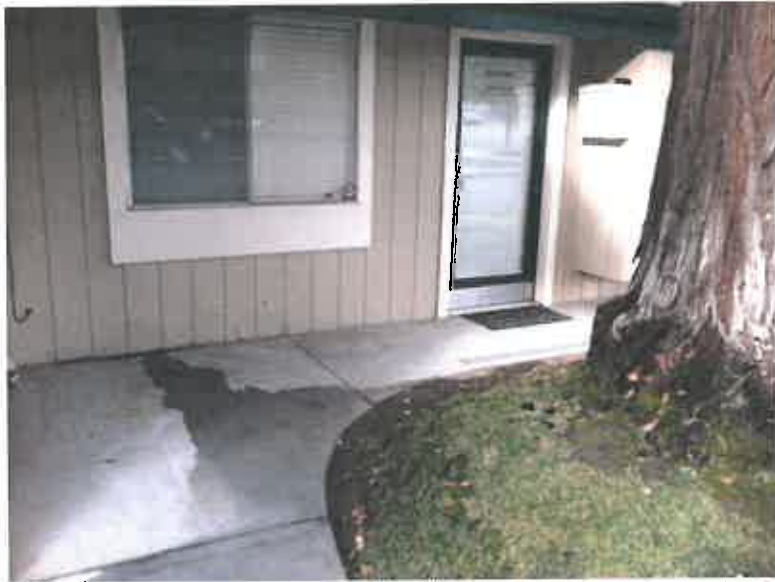
2014 – sloping concrete caused by tree forces water toward suite 105 and not away from the building resulting in water damage

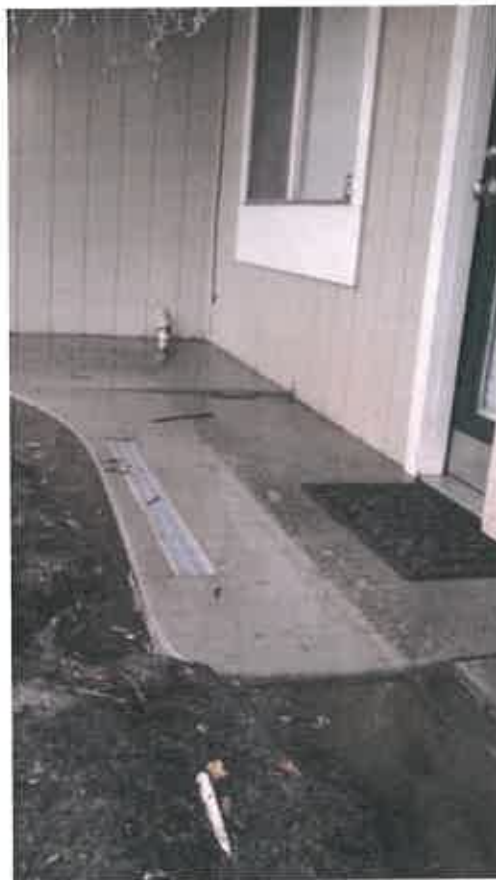
2014 – with more rain the drainage problem gets worse driving more water toward the building causing severe water damage

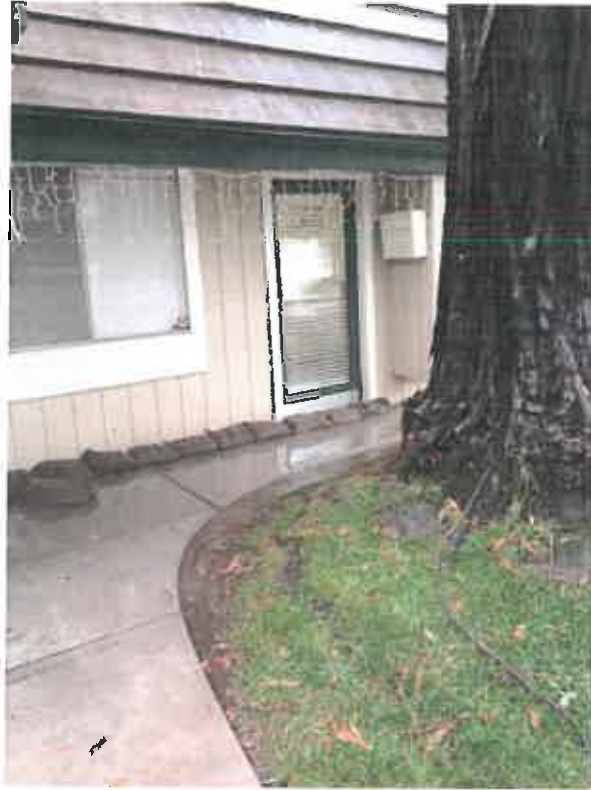
2014 – sandbags are used in order to keep the water from causing damage to the building

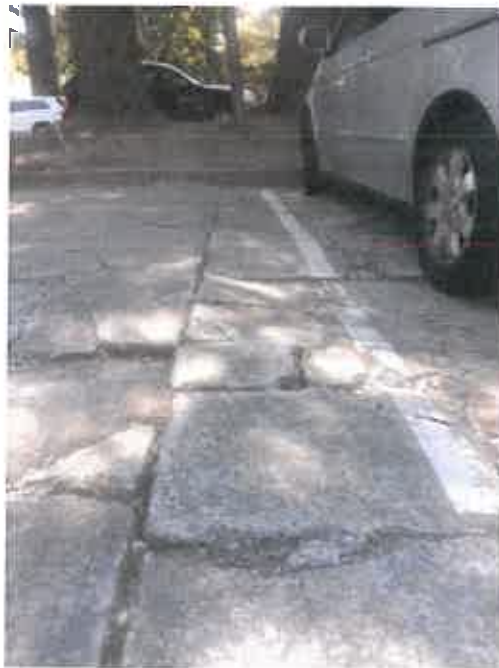
2015 – Picture of rear parking lot area and resulting damage caused by coastal redwood. This picture demonstrates that tree roots will break concrete. Fortunately the roots can be trimmed and concrete re-poured.

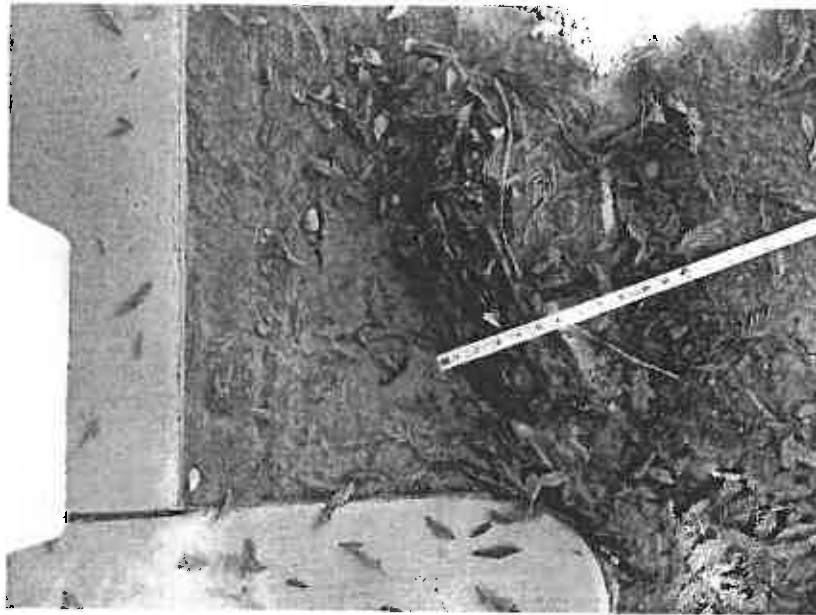
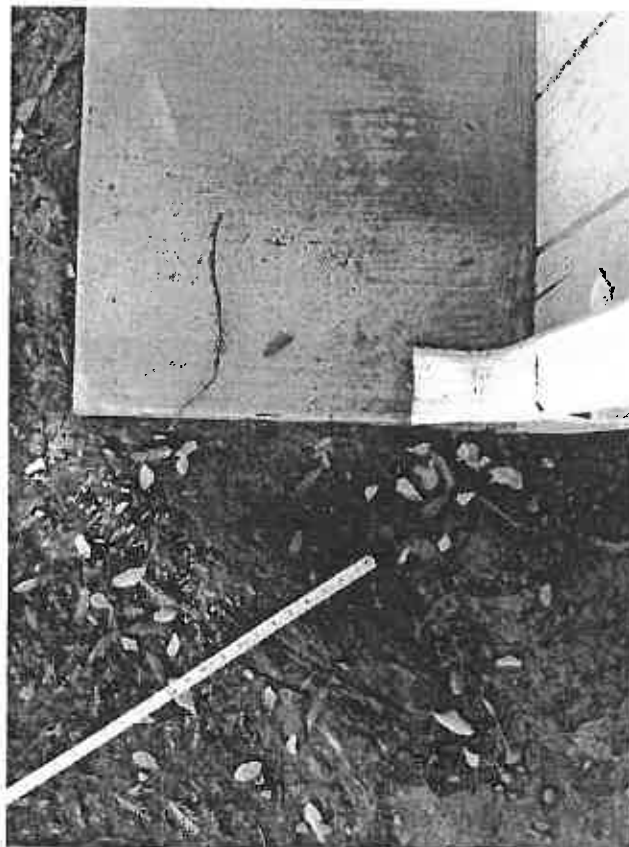
The building is eight feet to south and seven feet to west of the tree. The concrete walkway to the suite has recently been replaced. There are two visible surface roots along the recently replaced walkway that are approximately seven inches in diameter (Appendix B). The large surface roots are within 15 and 36 inches to the building foundation. The new walkway slab is already heaving in one location.

Large surface roots near the building foundation and walkway

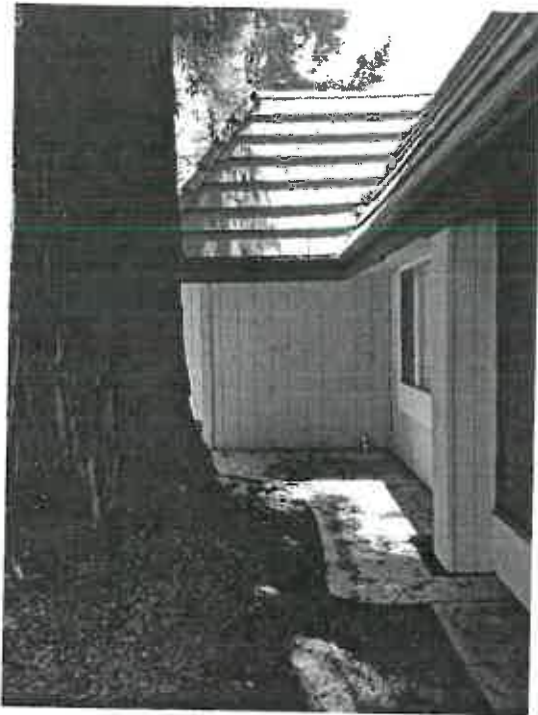
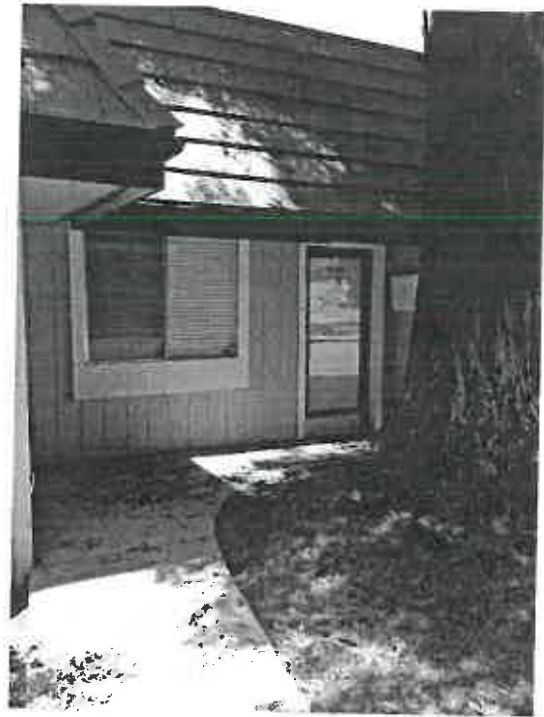
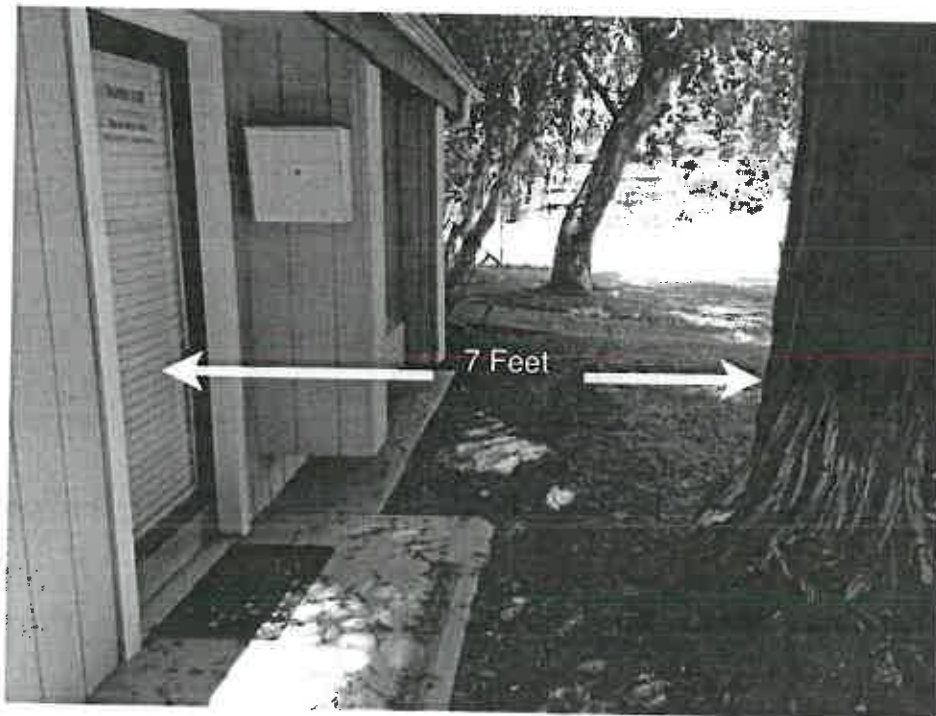
The coast redwood is located within seven feet of the foundation. This is a large coast redwood in close proximity to building. Although determining the soil conditions regarding subsidence can be difficult, it is clear that the redwood tree is growing near the foundation and large roots are present. All three factors are present and there is high potential for the tree to damage the building or heave the foundation.

Tree's proximity to the building

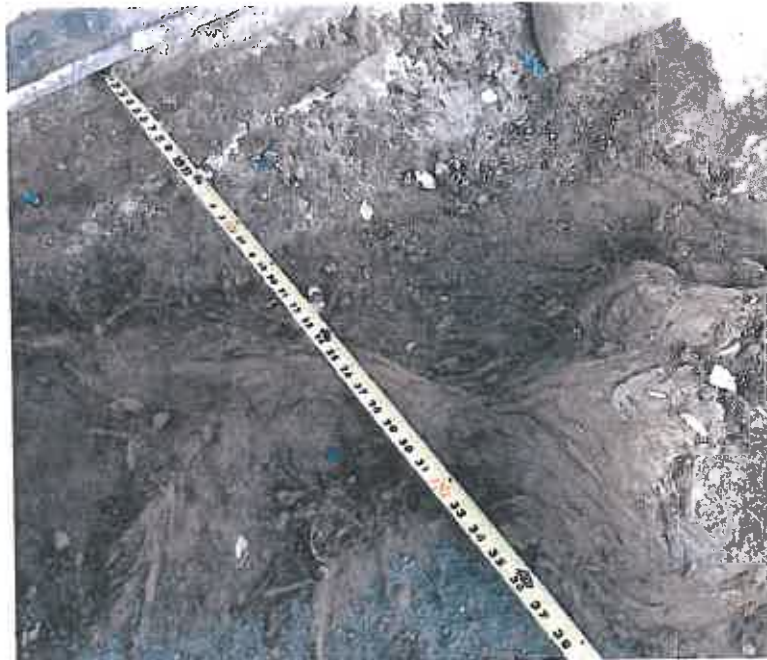
As noted previously, the sidewalk has been removed and the soil excavated to roughly 12 inches below top of slab exposing some of the tree roots. We observed several root clusters in close proximity to the building foundation (see attached photos). The size of the roots varies with the larger roots measuring approximately 8 to 10 inches in diameter. Some of these larger roots are directly against the foundation. The path of the roots below the excavation is unknown.

We did not observe damage to the foundation of the building, however only the top few inches of the footing were visible.

Based on our site visit, it remains our opinion that tree's root system if not removed, has the potential to damage the building foundation. The foundation may become cracked, settle, or heave which could compromise its load-bearing capacity and result in damage to the structural framing and architectural finishes above.

Photo 2: Root Cluster Adj. to Foundation

If the tree is to be removed, we recommend care be taken to prevent damage to the foundation.

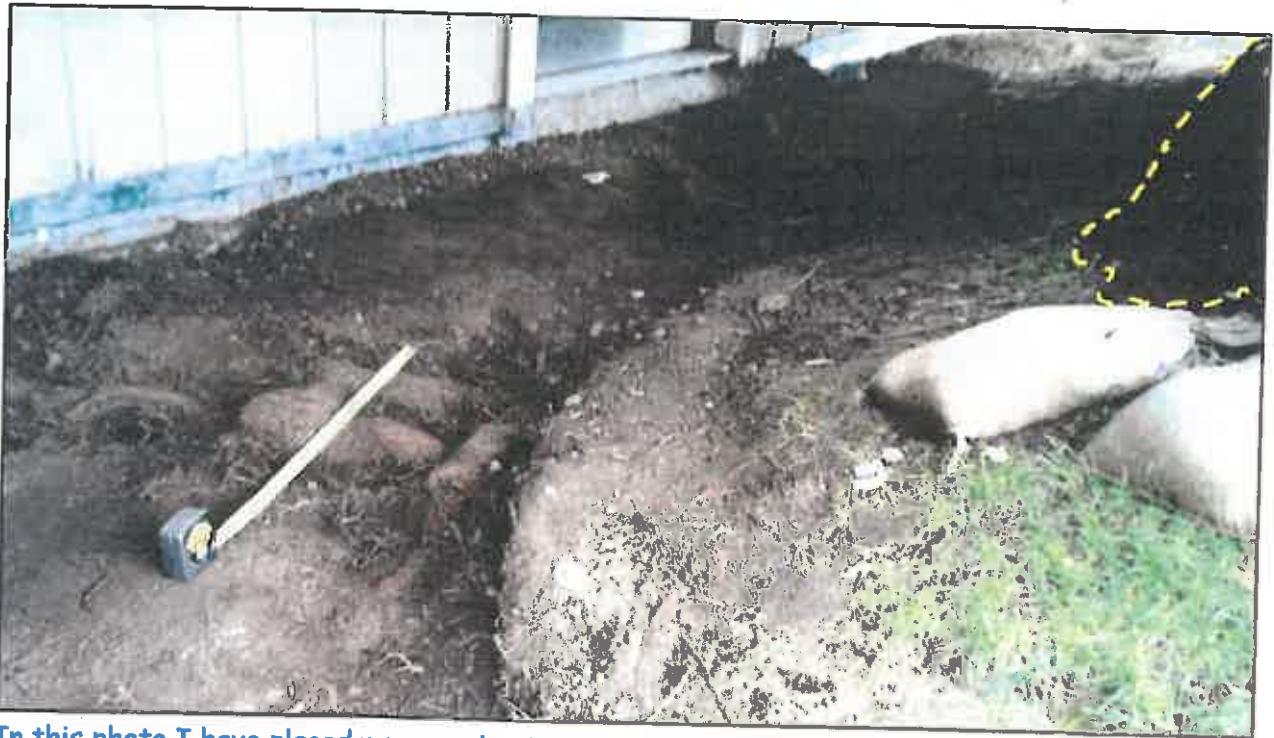
In this photo I have placed a measuring tape across a mat of roots that is 15 inches wide, with individual roots up to 8 inches in diameter. The corner of the base of the trunk is highlighted at right with a yellow dotted line. There are many other large exposed roots within the area of the photo that are not visible, due to poor lighting.

It appears that the existing pavement (walkways) have been removed along the building, but there has been no excavation to further investigate where roots are going and what (if any) foundation damage these roots are causing. Since the soil along the foundation had not been excavated down to the bottom of the footing I was not able to see roots in this area. I did observe exposed roots up to 4 inches in diameter within 12 inches of the footing, and smaller roots closer to, and growing toward the footing. I did not see any roots actually contacting the footing. It is possible that there may be roots below the soil surface that are contacting the footing.
