Deborah Ellis, MS

15735 Camino Del Cerro – Peer Review #1 of the arborist report and recommendations for trees in the vicinity of the proposed development

- Arborist Report (*Tree Inventory, Assessment & Protection. Camino Del Cerro Los Gatos*). Monarch Consulting Arborists, August 4, 2015

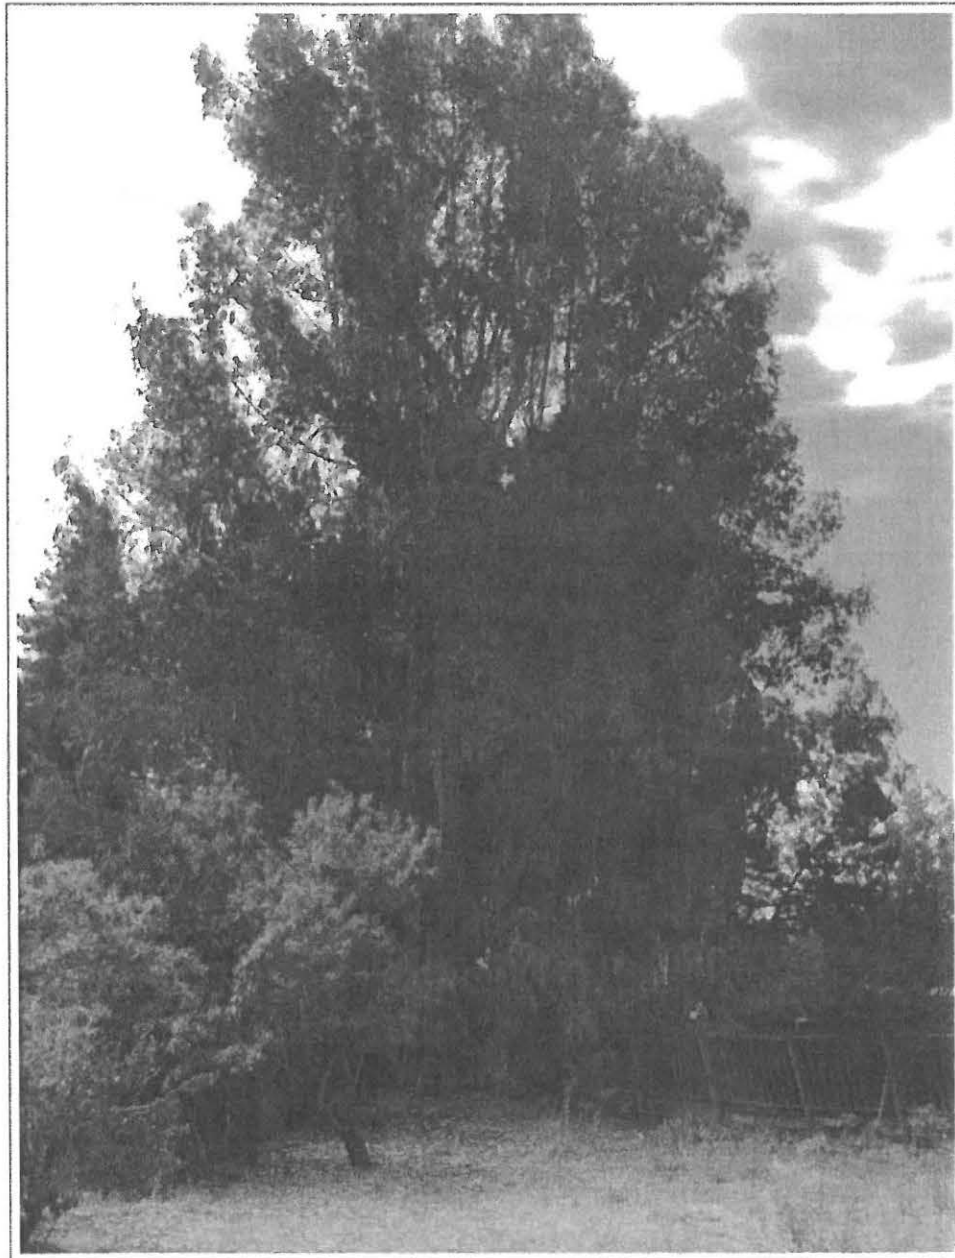
C2: Blue gum eucalyptus 887

#887, 84" blue gum Eucalyptus: I can now see that grading will occur within the vicinity of this tree; hence the "High" level of <construction> influence. I would recommend the removal of this tree even if there were no construction impact.

- 8) **I agree with the recommendation to remove blue gum Eucalyptus #887.** I don't see how the construction impact to this tree is "High", but in any case now is a good time to remove this large and problematic tree.

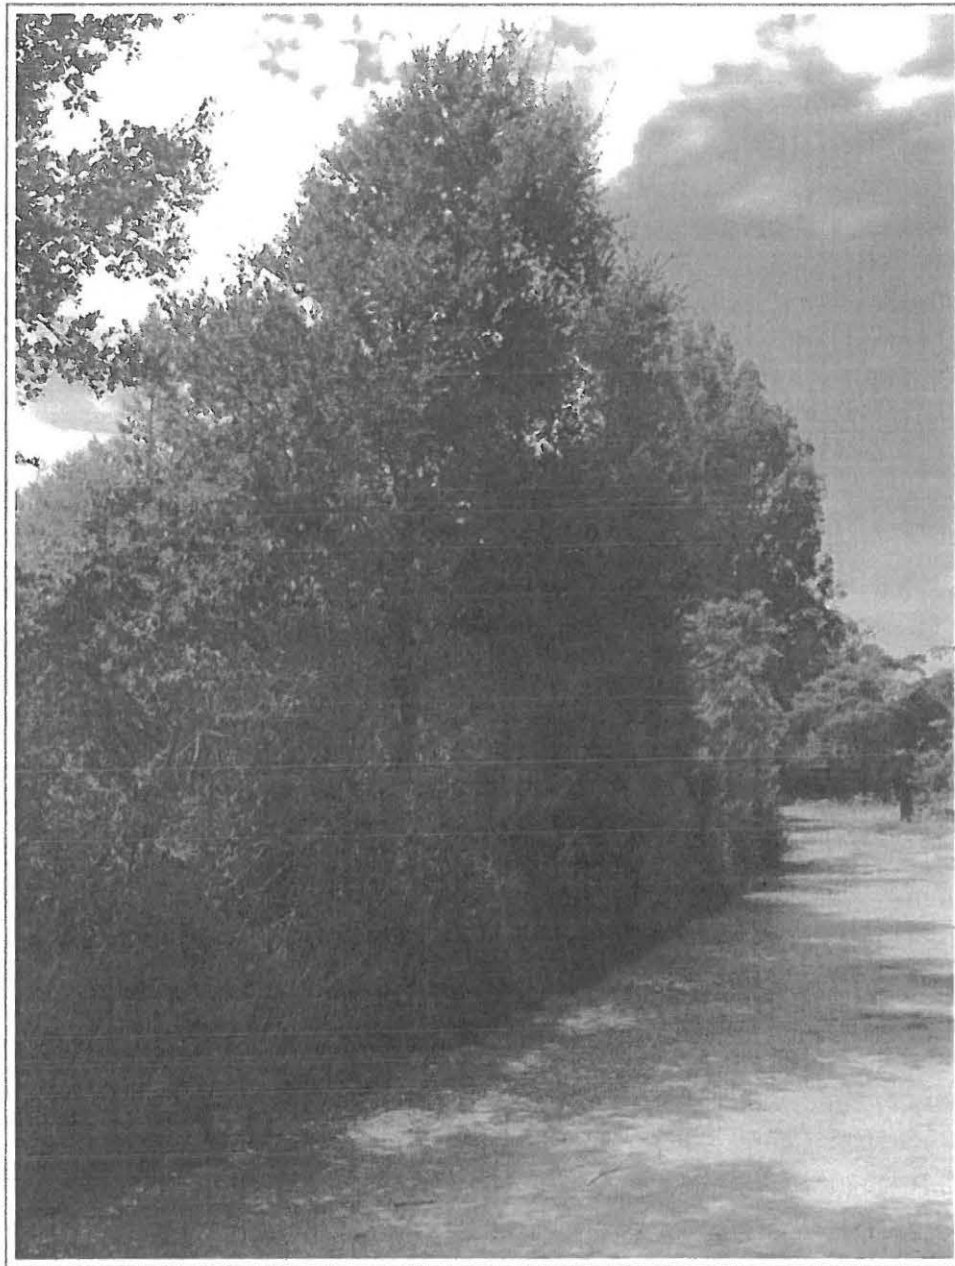
C7: Driveway

My main tree protection concern at this time is for several of the trees along the existing and proposed driveway. The following trees may be too close too and could sustain significant root damage due to driveway construction (assuming typical subgrade preparation):

I think that root damage can be reduced to an acceptable level by moving the driveway and associated grading farther from the trees, so that at least the 3xDBH¹ and preferably the 6xDBH root protection distance or farther is provided for these trees. That means that the actual driveway needs to be farther than the calculated distances from these trees, to take into account any necessary over-excavation distances beyond the driveway. Based upon the site plan it seems that this should be relatively easy to accomplish, and it should not significantly alter the plan design or the functional use of the site.

- 9) **Protected trees to remain along the driveway:** I do not think that the recommendation #4 on page 9 of the arborist report (construct the driveway out of porous materials and do not cut into soil surface for sub-base treatment) is going to work. If this is really possible, then great. But usually the subsurface area is going to be ripped and compacted, with some soil removed, in order to ensure the most stable base possible. So the impacts to some of the trees, e.g. coast live oaks #879 and 880 may be greater than "Low". It may be a good idea to investigate this further and perhaps move the driveway farther from the trees, or reduce the width of the driveway.

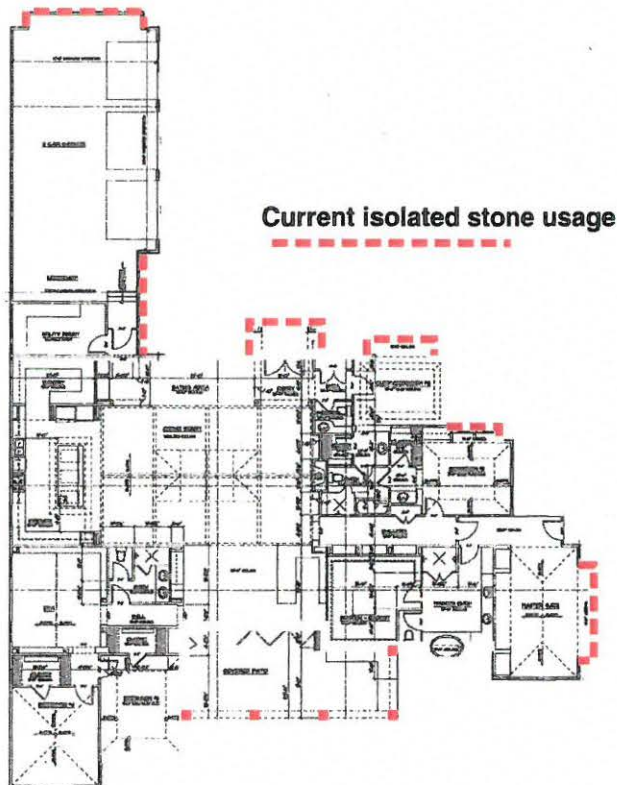
1. The architectural style is a bit eclectic, but seems to be drawing inspiration from the Tuscan and Mediterranean Styles. Stone veneer is employed in areas on three sides of the house (see diagram below), but it appears rather fragmented and used purely decoratively whereas the architectural style would usually include more stone relative to the stucco, and the stone would be used to define significant volumetric areas of the structure.

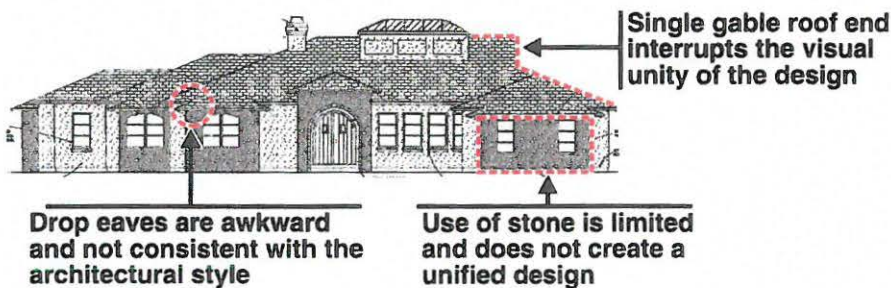
2. While hip roof forms are used extensively, there is one awkward area where a gable end is used to accommodate a large skylight over the Great Room.
3. The detail proposed for the drop eaves at bay pop outs is awkward, and not typical of the architectural style.

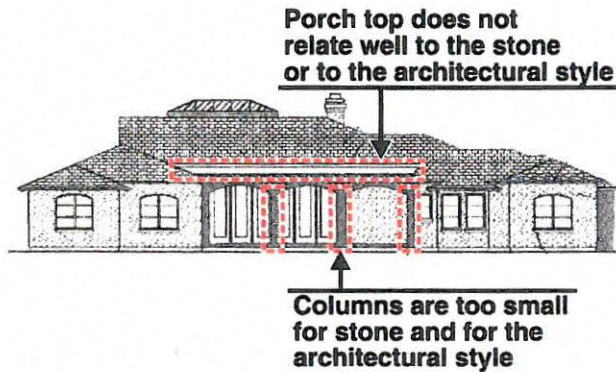
4. The columns at the rear covered patio are too small for the architectural style and for the scale of stone.
5. The parapet at the rear covered patio does not seem to work very well with the stone at the rear patio.

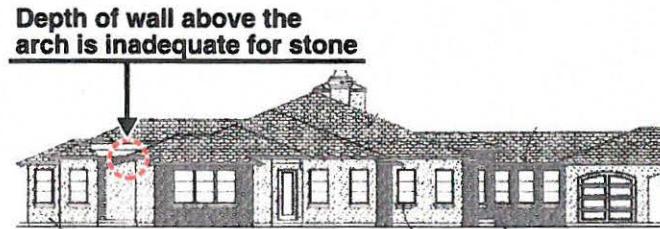
6. The depth of the wall area above the stone arch at the side of the rear patio is too small for a stone wall.
