Town of Los Gatos, California

## Existing Conditions Analysis

Last Updated December 23, 2002

ANDERSON BRULÉ ARCHITECTS

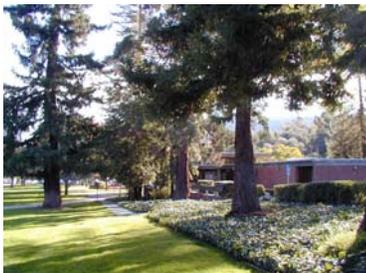
The front lawn area is very inviting, creating a park like setting. The exposed aggregate sidewalk is in good shape. Algerian ivy is used as a ground cover on planting beds along the redwood walk. The ivy can harbor rodents and is very aggressive towards other plants. The parking area is screened from East Main Street with a 4' hedgerow that is well trimmed and very effective in screening cars from Main Street views. The parking islands are typically planted with Star Jasmine, which seems to work. Some areas are thinned by either pedestrian traffic or shade from mature trees. The Villa Avenue/Fiesta Way planting corner at the parking lot is bare, probably due to the Eucalyptus trees.

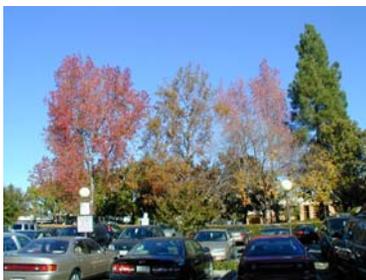
The entrance to the Civic Center from the parking lot is awkward with the planting strip/tree wells between the parking and the sidewalk. Pavers have been installed between trees but have settled or were installed below top of curb. The current situation may pose a tripping hazard.

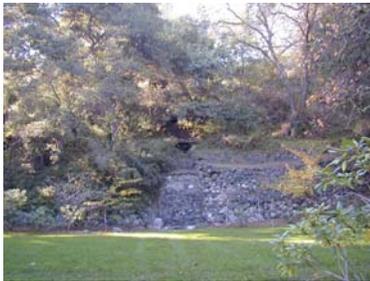
Pageant Park is located immediately to the South of the civic center, across the police vehicular drive. Currently, its location and entrance is difficult to distinguish, the access is steep and it appears to be under utilized. A screened enclosure for mechanical equipment is located adjacent to the entrance. The park is surrounded by mature trees and includes a large terraced rock wall and waterfall constructed by Town residents. There are informal trails traversing the slope above the park.

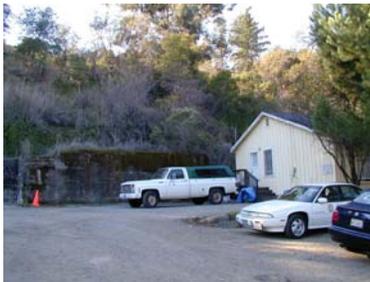
The slope behind the Villa house lots and Pageant Park has been left in a natural (wild) state. This makes the most sense due to the steep areas and difficulty in any kind of maintenance approach. Remnant walls from an old winery are built into the steep slope located behind the western residential structure and adjacent parking area on Villa. The residential structures on Fiesta Way have a cottage type landscape and are quite nicely kept.
