**RE: 339-341 Bella Vista Avenue**

## ARBORIST REPORT

**341 Bella Vista Avenue  
Los Gatos, California**

**OCTOBER 28, 2013**

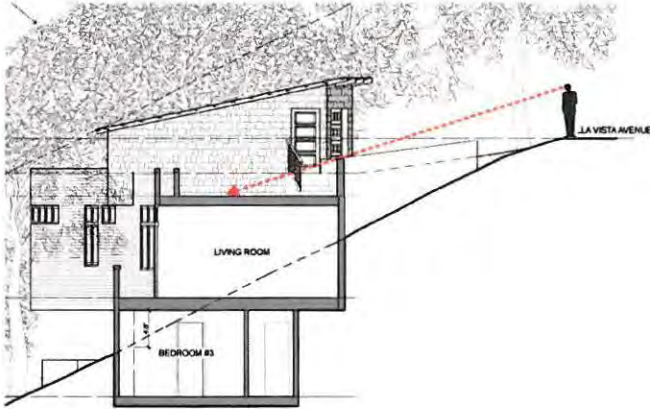
I have only one minor concern. The upper living level roofs will be visible from Bella Vista Avenue (see section diagram below). I saw many people walking along the west edge of the pavement during my site visit since there are no sidewalks in this area. The roof on the southern portion of the house is proposed to be covered with stone paving, the roof over the northern portion is proposed to have a gravel roof. The plans and other drawings show planters at the edge intended to contain landscaping to shield views to the roof. However, it is generally unwise to rely on future owners to provide or maintain adequate landscape buffers as the sole mitigation measure. My recommendation would be to provide more visually suitable paving on this portion of the roof.

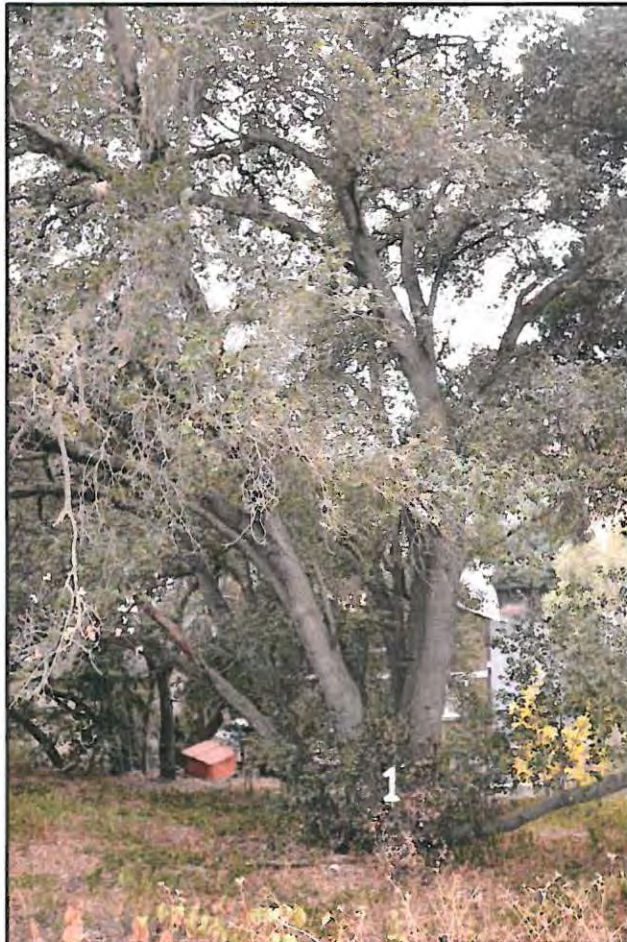
**The key trees for this site are:** **Coast live oaks #1, 2 and 3** which are the largest trees on the site but will be removed because they are within the proposed house. Oak #3 is shown to remain, but it is not in good condition. Other trees on the site that are worth saving are the following coast live oaks in Fair/Good condition: **#10** (16-inch trunk diameter), **#17** (19-inch), and **#22** (8-inch).

Left Photo: **coast live oak #1**, viewed from Bella Vista Avenue upslope and to the east.

Right photo: **coast live oak #2** from the same viewpoint. Both trees will be removed because they are within the proposed house.

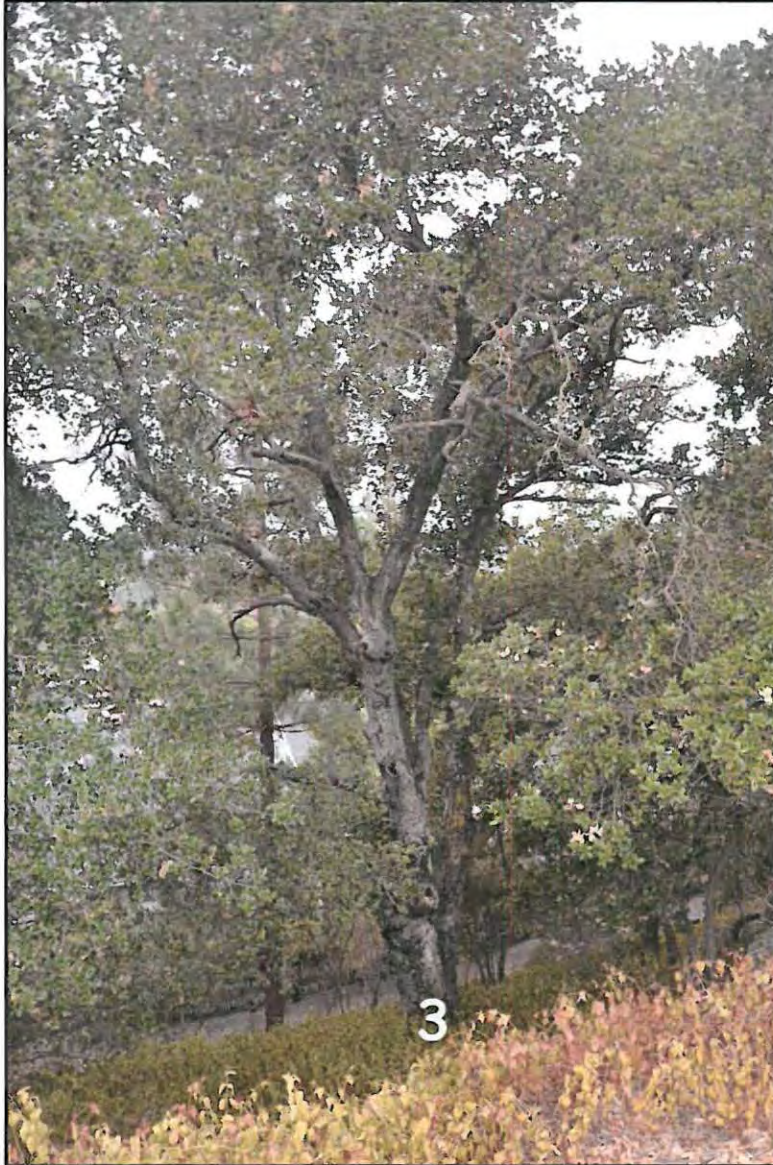
Left photo: **coast oak #3**, in "Fair/Poor" condition but scheduled to remain. Viewed from Bella Vista Avenue upslope and to the east.

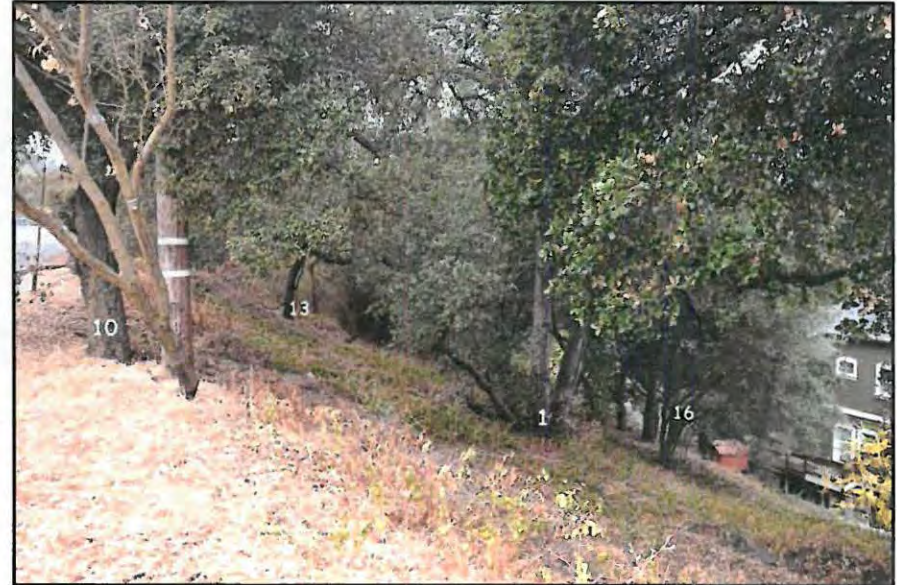
Right photo: looking across and down the slope from Bella Vista Avenue to the Northeast. **Coast live oaks #1 and 10**, **valley oak #13** and **olive #16** are numbered.

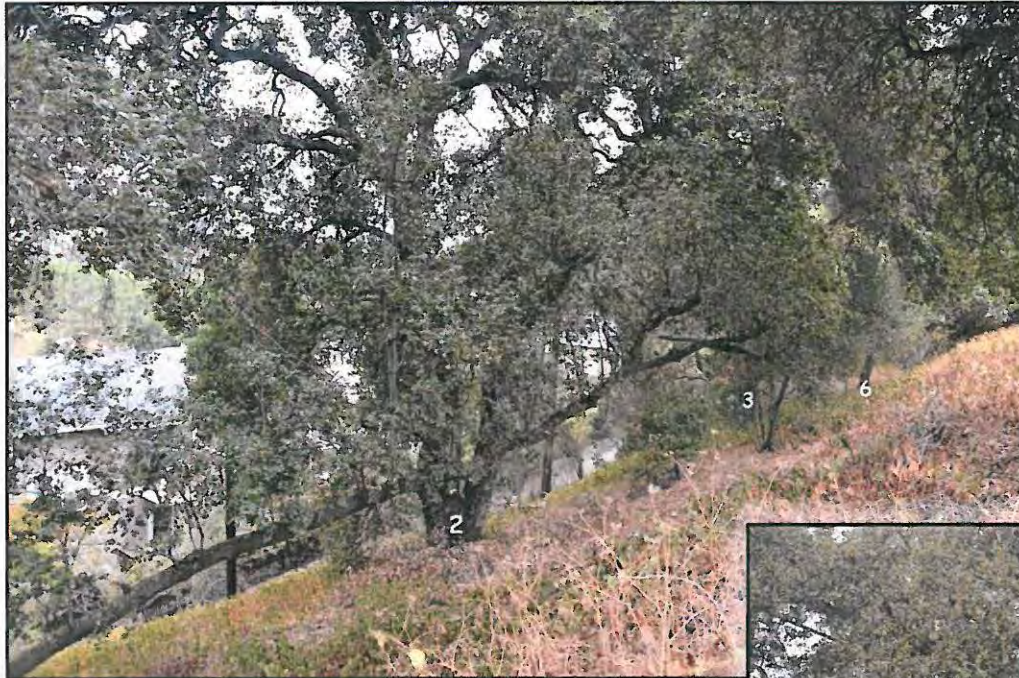
Upper photo: **coast live oak #2** in foreground, with **coast live oaks #3 and #6** labeled in the background. Looking across and down the slope from southeast to northwest.

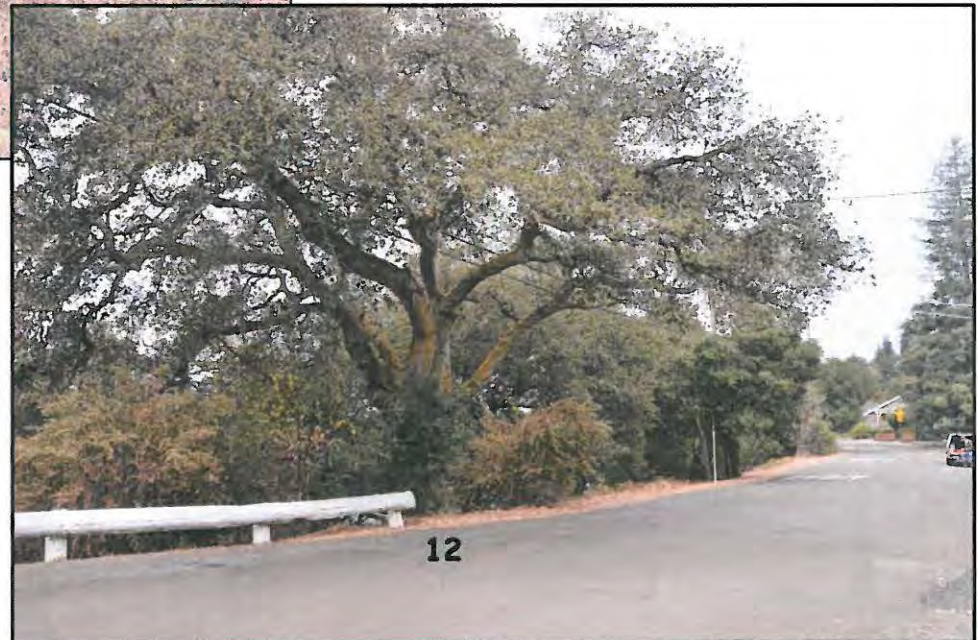
Lower photo: **Coast live oak #12** along Bella Vista Avenue, from the south.

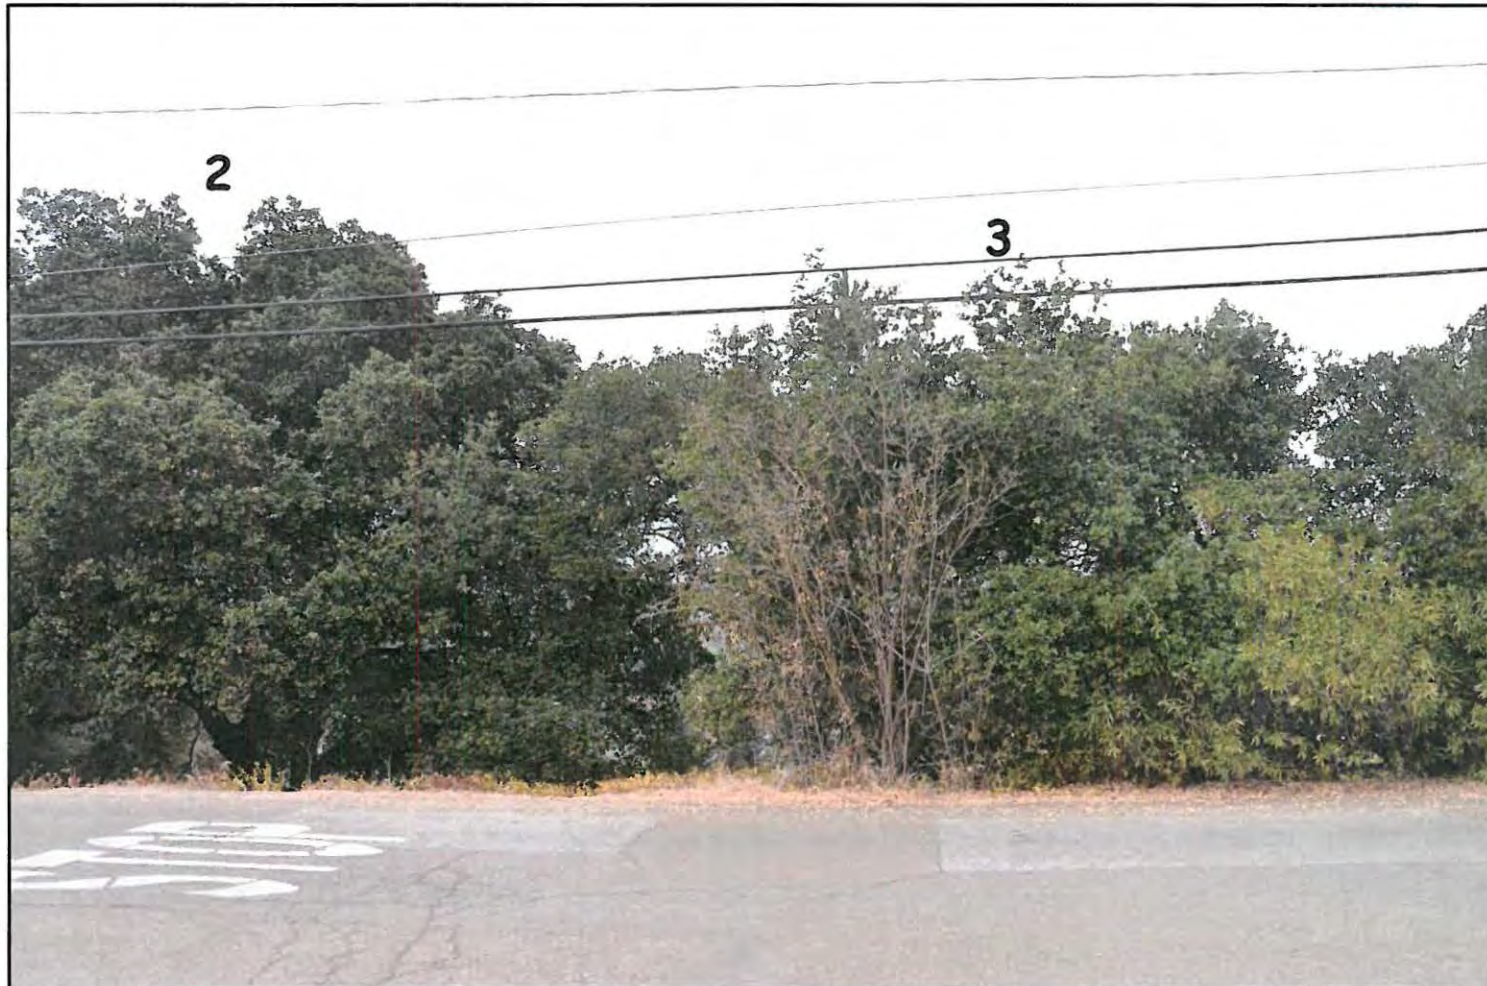
Coast live oaks #2 and 3 from the across Bella Vista Avenue to the east.
