**17061 WILD WAY - PROJECT DATA**

**New Construction at 17061 Wild Way.**

A New Home  
17061 Wild Way, Los Gatos.

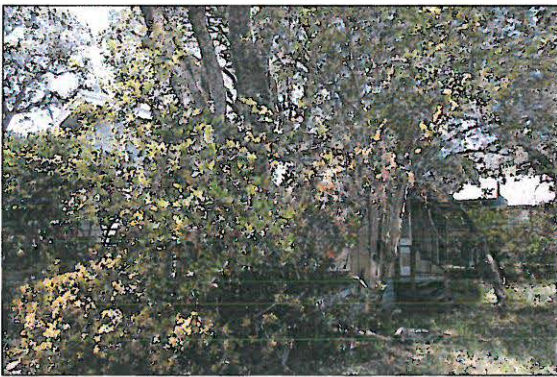
Both the existing house and garage are in poor condition and will be demolished. A Structural Report has been provided. The house was removed from the historic register.

*Existing house on the site*

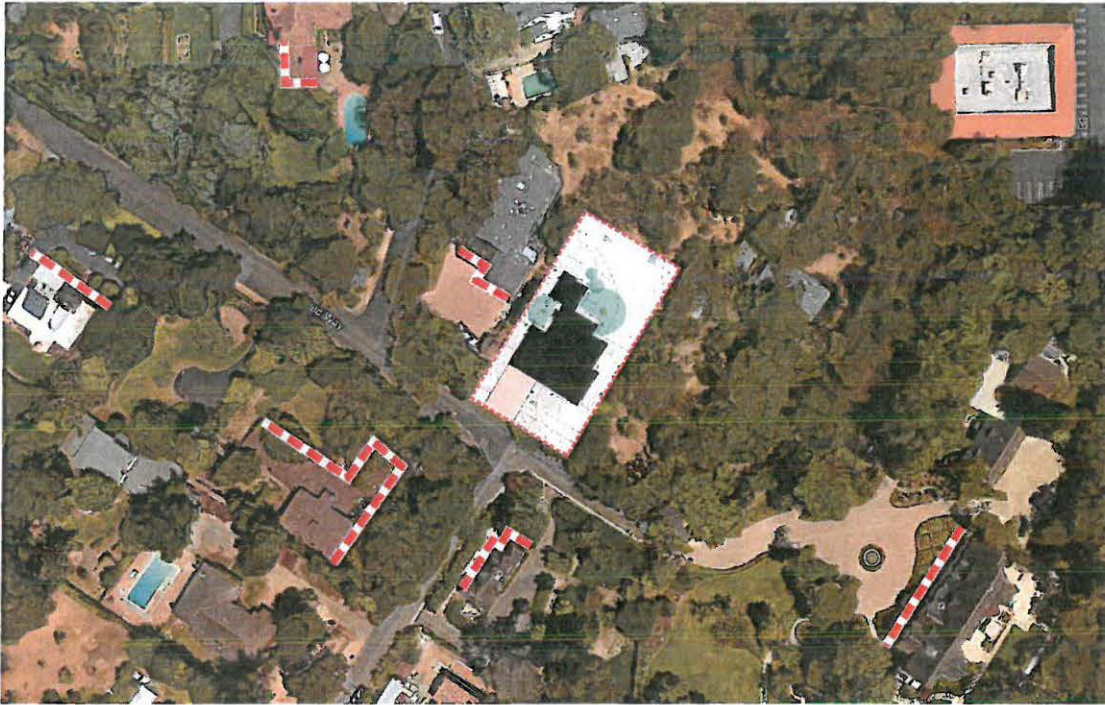
1. The front setback , at 25 feet, is 5 feet short of the required setback, and much smaller than others in the immediate neighborhood (see illustration below). While the side setback at the nearby house located across Wild Way at the southeast corner of the Wild Way/Oak Ridge Way intersection is relative small, street views to the facade are buffered with heavy landscaping. The frontage landscaping for the proposed house will be limited because of the primary 2-car garage access from Wild Way. Justification for the reduced setback has been stated as a desire on the part of the applicant and neighbors with whom the applicant has spoken to save as many of the large trees on the site as possible. The applicant is also providing some visual mitigation by recessing the garage and dividing it with two doors.

Recommendation: This is an issue that staff and the Planning Commission will need to make in balancing the benefits of a greater setback versus the retention of at least one of the large existing trees on the site. The only observation that I have is that a additional 5-foot of setback would probably not materially change the visual impact of the house. However, the applicant could reduce the footprint to meet the front setback requirement. Consideration could also be given to the planting of trees within the driveway, as shown in the two photos below, to add some buffer landscaping .

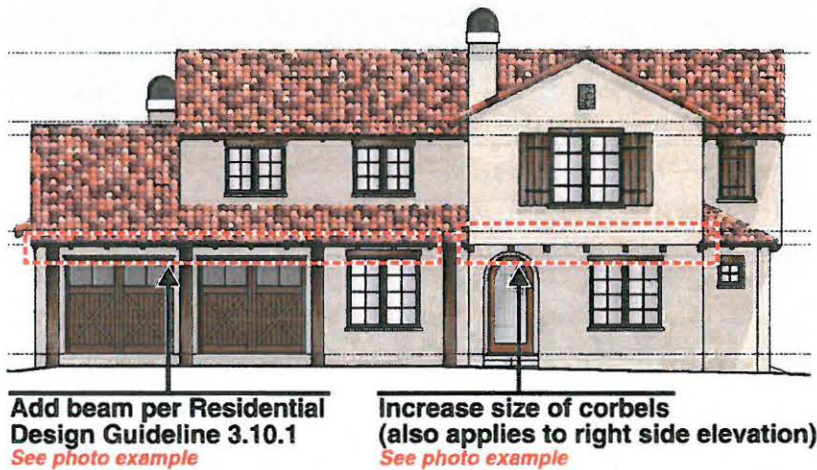
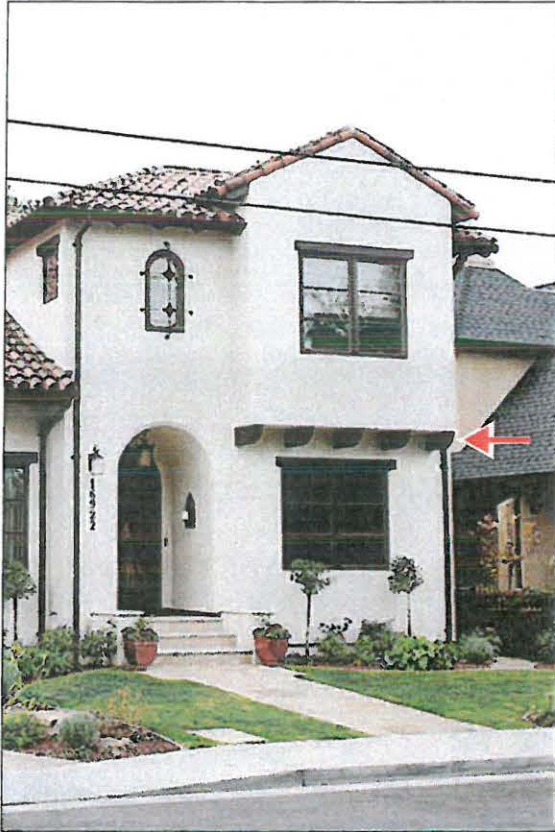
2. The corbels supporting the popouts on the front and right side elevation seem a bit small.

Recommendation: Increase the size of the corbels (see example photo on the following page).

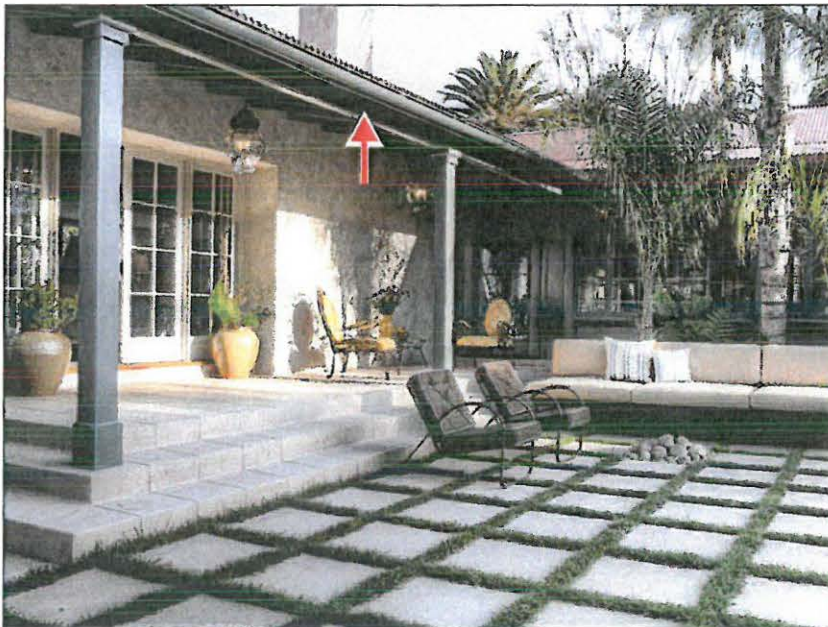
3. The columns in front of the garage are lacking a traditional beam.

Recommendation: Add a beam per Residential Design Guideline 3.10.1 (see example photo below).

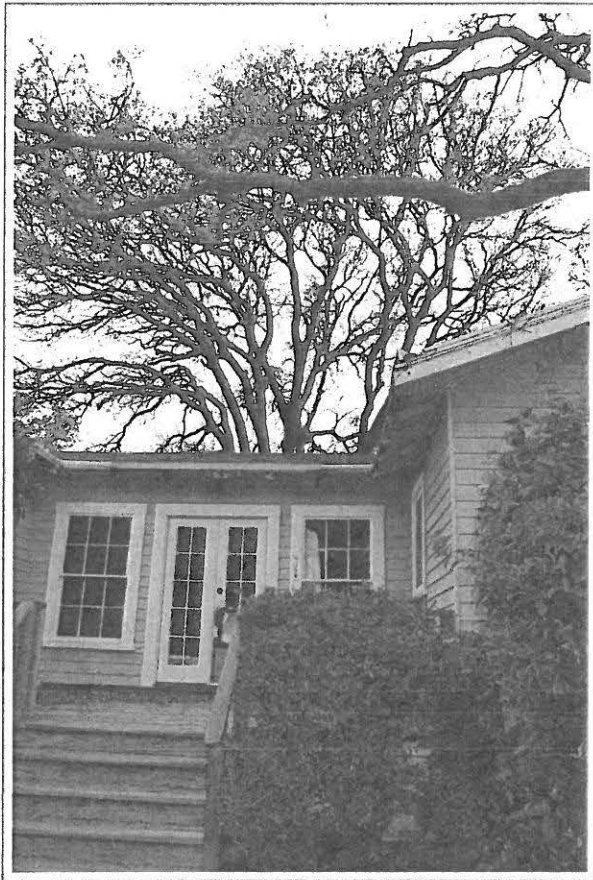
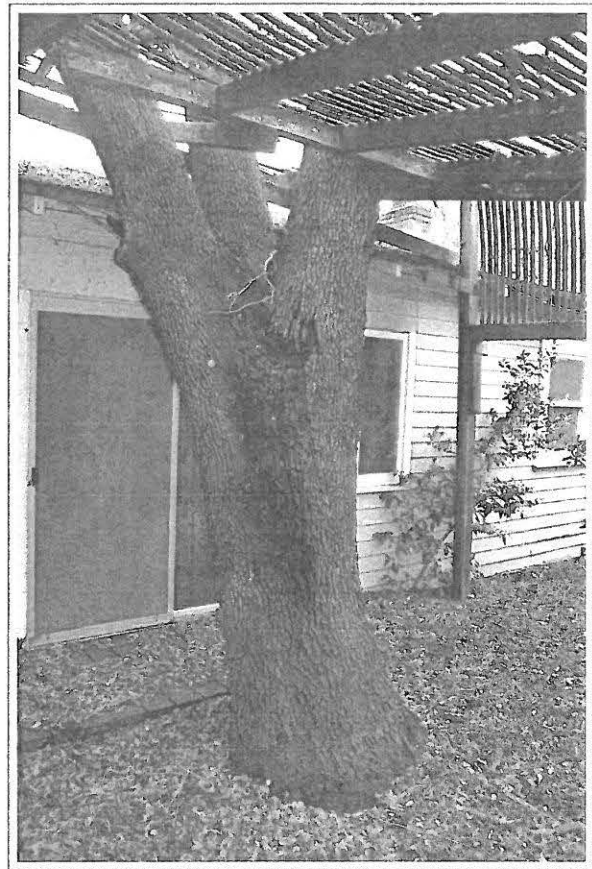
## C2: Blue Oak 635

Regarding impacts to the two large oaks adjacent to the home, **#635 and 643**, it is my opinion that impacts will be tolerable, provided all recommendations regarding the protection and care presented herein and the applicant's report are closely followed, and the project arborist is frequently retained to assess and address impacts. Impacts to **#635** will seemingly be the least due to its existing rooting structure appearing directed away from the proposed home. Impacts to **#643** appear slightly greater, but careful hand-digging of the foundation perimeter, performed in conjunction with the project arborist's involvement, can limit impacts and promote success of survival and maintaining anchoring capacity.

1. Obtain all necessary permits from the Town of Los Gatos prior to removing or significantly altering any tree.
2. Refer to Appendix D of this document for general protection guidelines and specifications.
3. Protect blue oaks 635 and 643 at their CRZ distance of five times the trunk diameter, bridge over the root zones, and wrap the trunks with wattle during demolition and construction.
4. Protect the remaining trees to be preserved at their drip line distances and protect trees as groups where possible.
5. Replant with new trees to replace any loss in screening and refer to Section 29.10.0985 Determination and Conditions of Permit: Tree Canopy Replacement Standard.

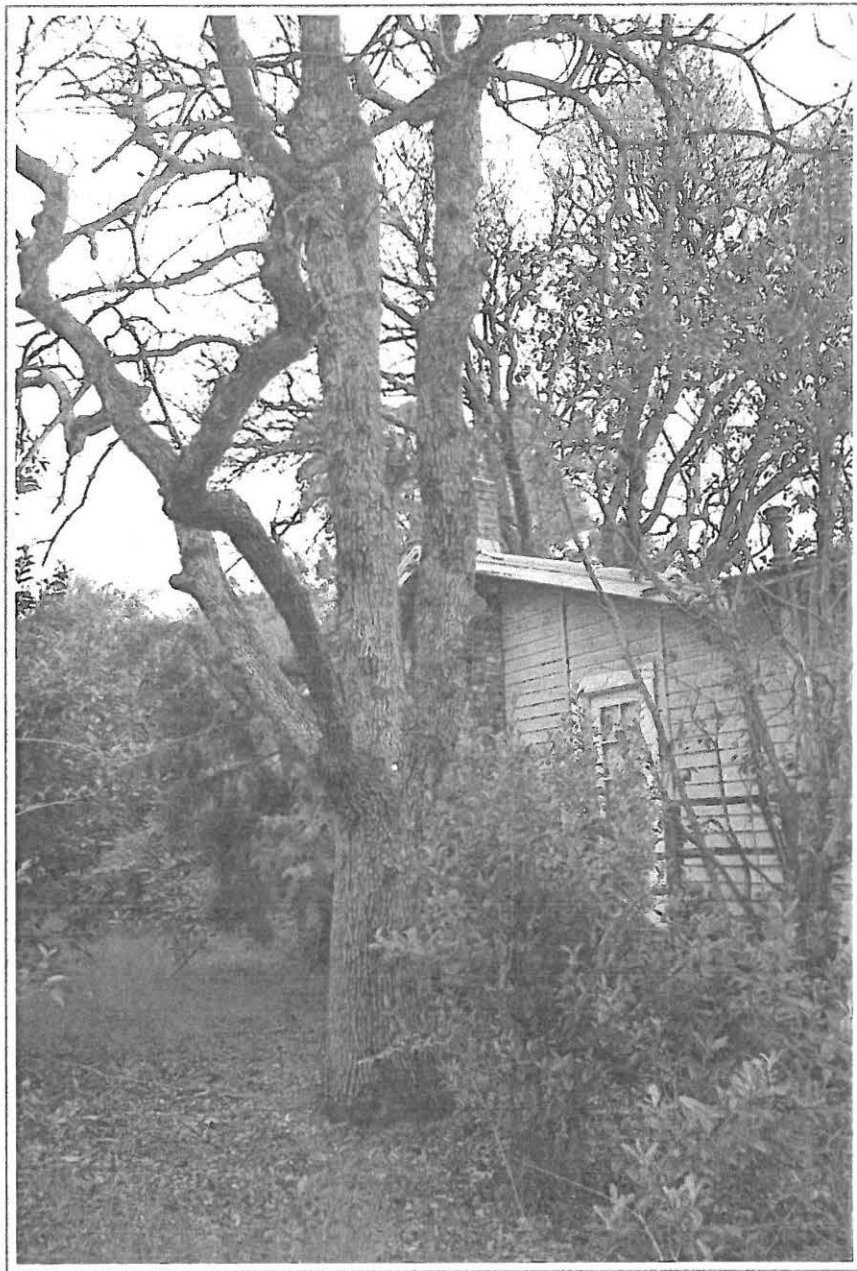
**C4: Blue Oak 644**

Tree Species	Number	Trunk Diameter	~ Height	~ Crown Diameter	Condition	Suitability	Influence Level	Notes	Disposition	Replacements
Blue oak ( <i>Quercus douglasii</i> )	644	18	30	30	Fair	Poor	High	May have armillaria, signs of old fungal fruiting bodies near base.	Remove	4 x 15 gal Trees
Peruvian pepper ( <i>Schinus molle</i> )	645	4	20	20	Fair	Poor	High		Remove	3 x 15 gal Trees
Coast live oak ( <i>Quercus agrifolia</i> )	646	8	20	20	Fair	Poor	High	Leans	Remove	3 x 15 gal Trees
Coast live oak ( <i>Quercus agrifolia</i> )	647	12	15	0	Dead	Dead	High		Remove	None
Blue oak ( <i>Quercus douglasii</i> )	648	10	30	8	Poor	Fair	Low	Adjacent property	Retain	
Coast live oak ( <i>Quercus agrifolia</i> )	649	17	30	15	Fair	Fair	Low	Adjacent property	Retain

Regarding **#644**, it is a blue oak with a trunk diameter of 19 inches, and the fourth largest tree on site. In my opinion, its removal for a new residence conforms to Town Code due to being in only fair condition; its location within a large section of the proposed home, thus possibly reduce the otherwise-permissible building envelope by more than 25-percent; and the high number of other oaks, both large and small, being retained throughout the site.
