## ARBORIST REPORT

485 Monterey Avenue  
Los Gatos, California

MARCH 31, 2015

Arborist Report for 485 Monterey Ave., March 31, 2015.

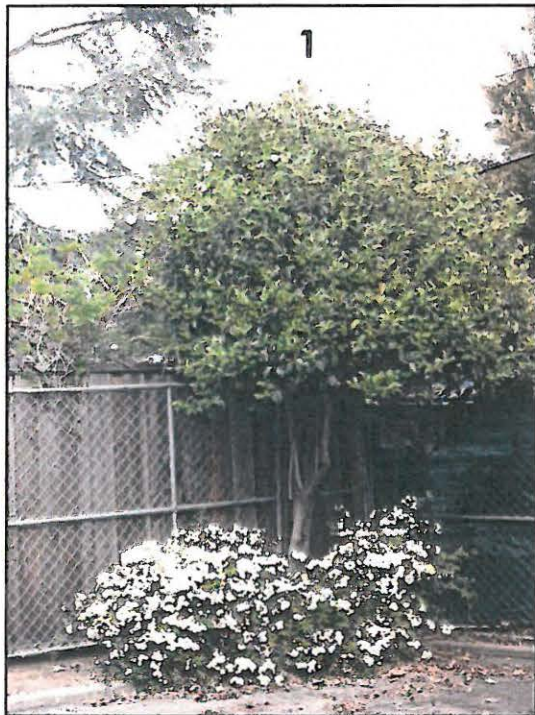
**Glossy privet #1** at the northwest corner of the site. This small tree may be able to remain.

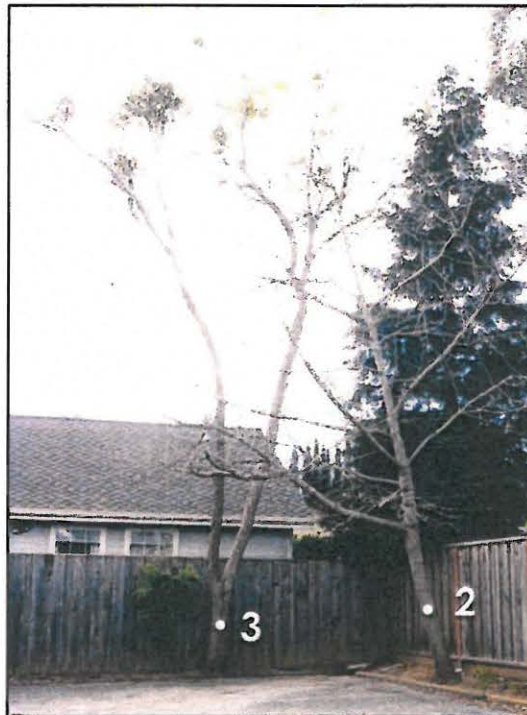
**#2 red maple**, leaning toward the proposed garage and also into adjacent **ash tree #3**.

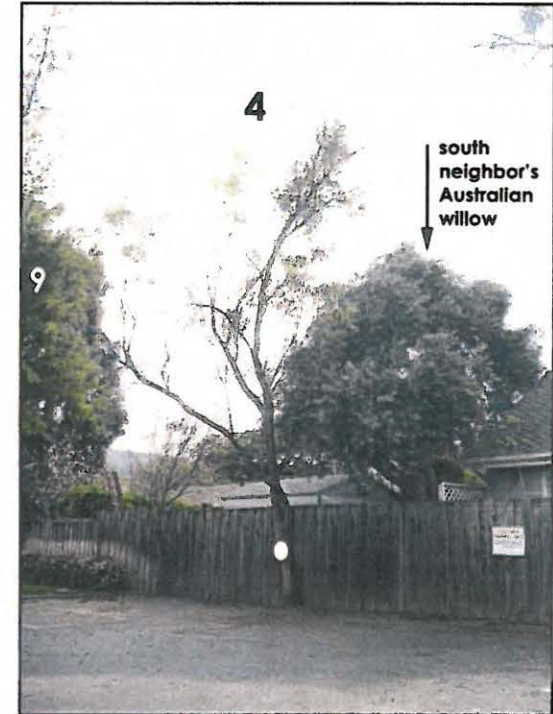
**#4 ash**. In the background: (right) **south neighbor's Australian willow** overhangs the site by 10 feet. The partial canopy of large **evergreen ash #9** is at left.

4. **Neighboring trees:** whose canopies overhang the project site must receive tree protection in the same manner as existing trees to remain on the project site; for example tree protection fencing and signage. The general contractor shall fence off the **dripline** of this tree as much as possible in order to avoid damaging branches and compacting the soil beneath the canopy. If pruning is necessary in order to avoid branch breakage, the general contractor shall hire a **qualified tree service** to perform the minimum necessary construction clearance pruning. Neighboring trees that require protection are: one **Australian willow tree** on the south perimeter of the site. The canopy of this tree overhangs the project site by about 10 feet.

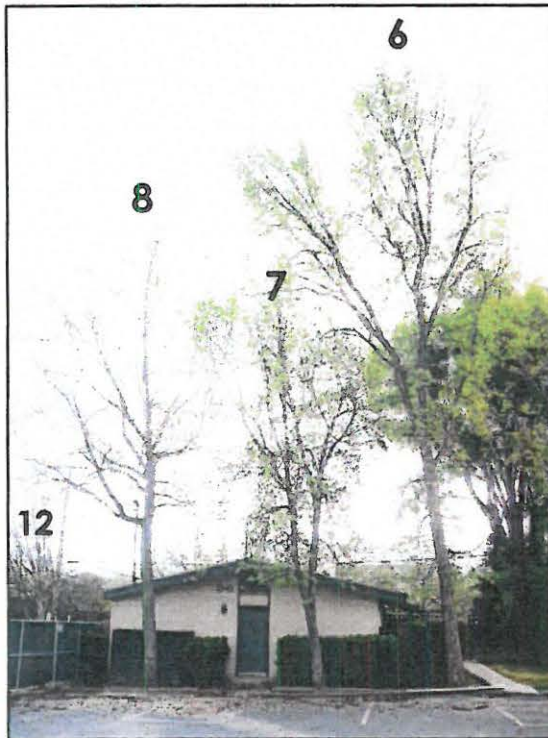
7	sweet gum	12	50*35	70	60	Fair	Severe	Remove	Construction	Construction: within proposed house. Condition: roots are causing pavement damage. Lower trunk has car impact mechanical wound and bleeding canker.	3	5	9
8	sweet gum	15	60*40	75	70	Fair	Severe	Remove	Construction	Construction: within proposed house. Condition: roots are causing pavement damage.	4	6	11
9	evergreen ash	30	60*45	85	60	Fair/Good	Severe	Remove	Construction	Construction: 2-story house is 2 to 3.5 feet from trunk. This will not work for obvious reasons. Condition: topped at 30 feet but some crown restoration pruning has been	7	12	22

Sweet gums #6, 7 and 8 with crape myrtle #12 in the background at left, outside the perimeter construction fence.

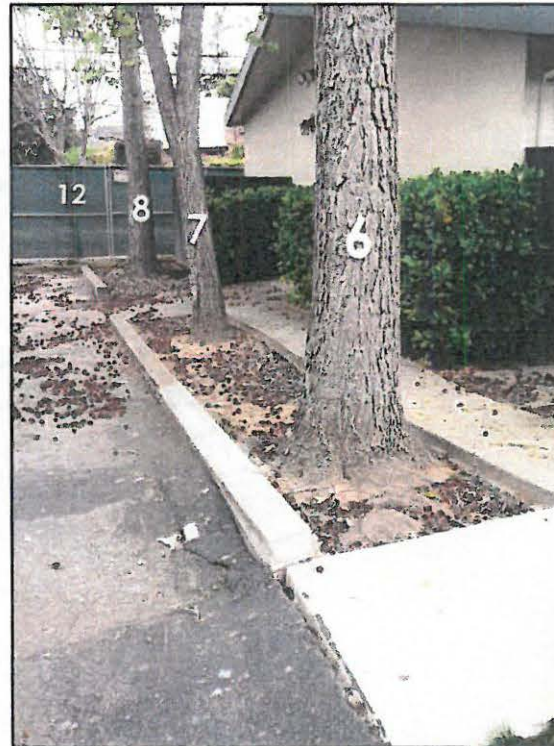
Close-up of pavement damage caused by the roots of sweet gums #6, 7 and 8.

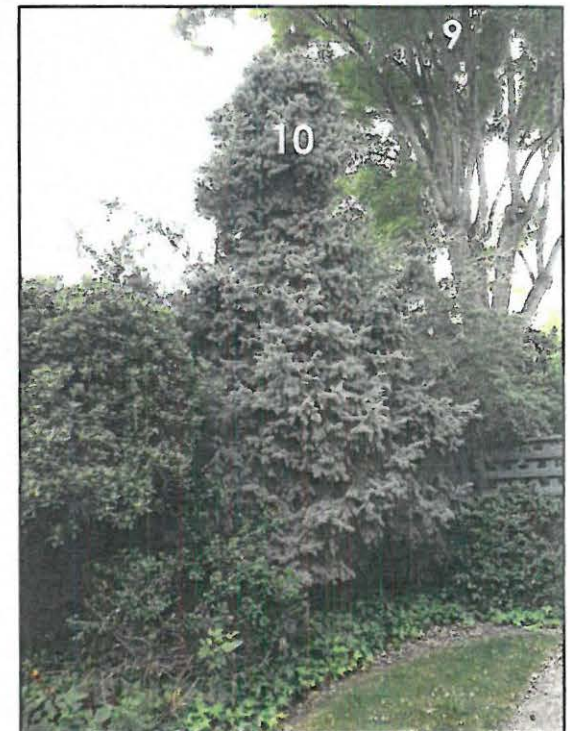
Colorado blue spruce #10 with evergreen ash #9 in the background.

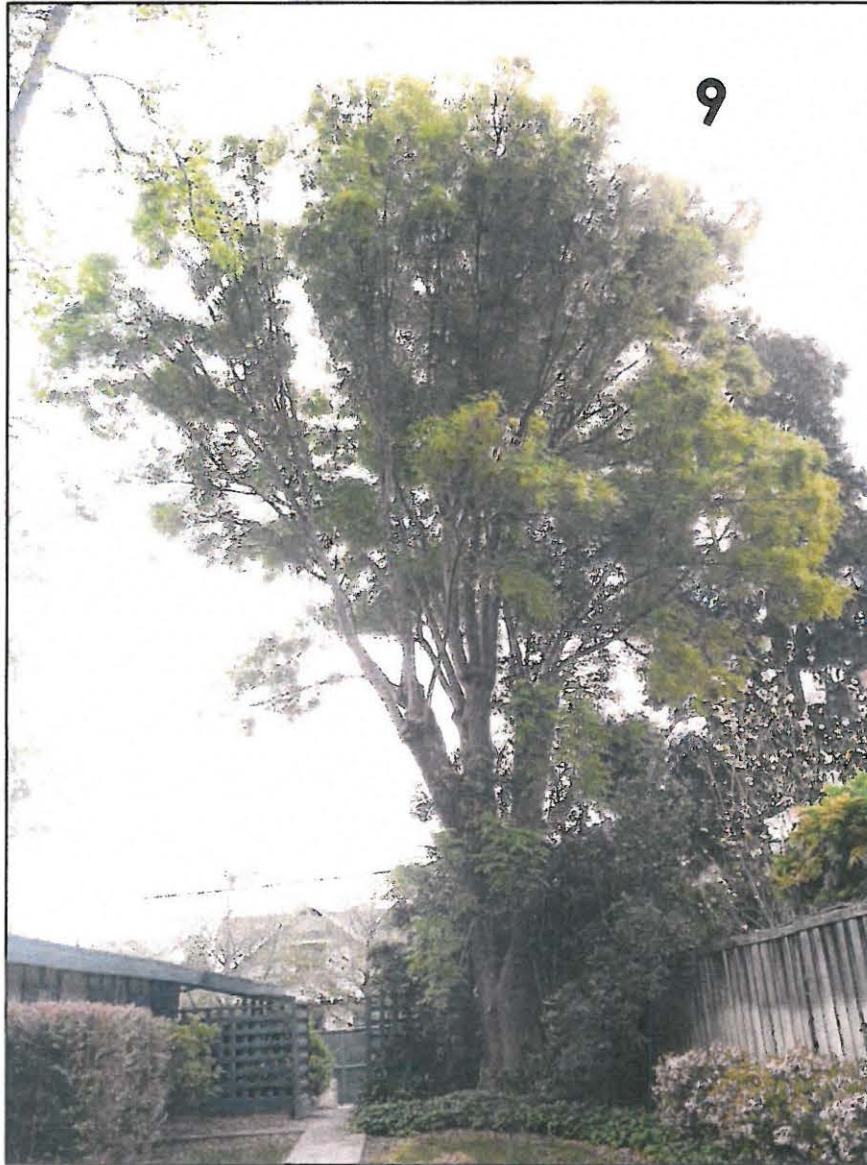
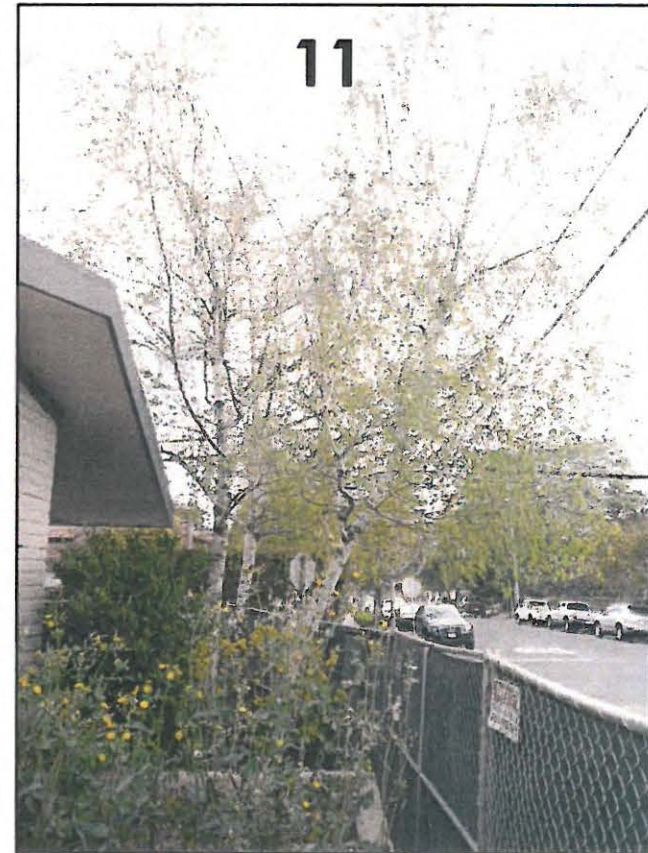
Left: large **evergreen ash #9**, along the south perimeter near Monterey Avenue. Right: **European white birch #11**, northeast corner of the site at the corner of Monterey Avenue (right) and Andrews Street.
