Los Gatos Luxury Cars
Development Review Application
620 Blossom Hill Road, Los Gatos CA

ARBORIST REPORT

Los Gatos Luxury Cars
620 Blossom Hill Road
Los Gatos, California

FEBRUARY 20, 2014

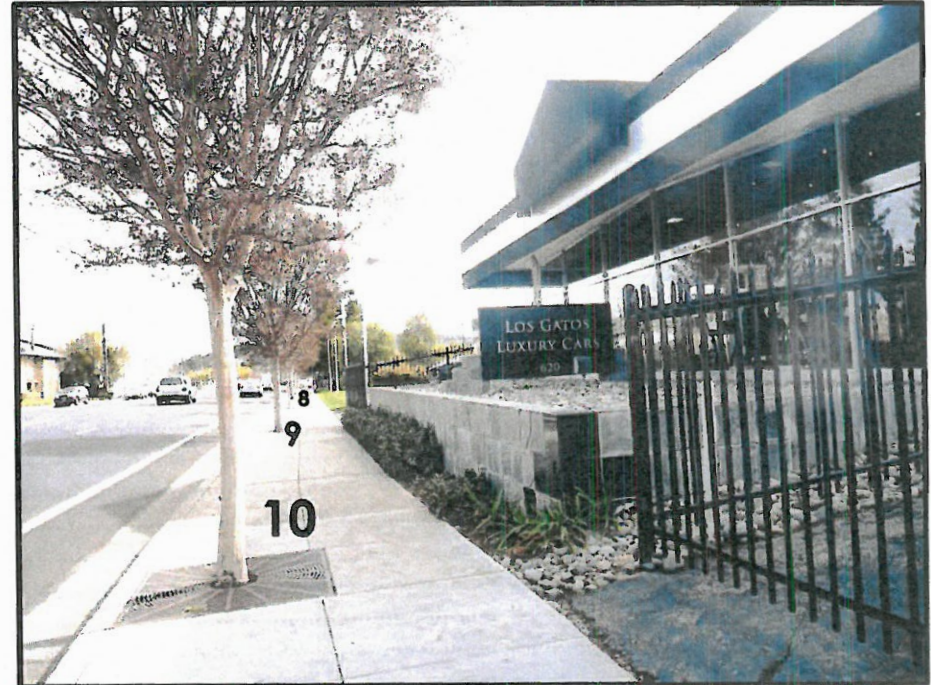
Cover photo: The showroom of Los Gatos Luxury Cars along Blossom Hill Road, looking to the Northwest. City street trees **crape myrtles #10 and #9** are visible and labeled. All photos in this report were taken by D. Ellis on February 18, 2014.

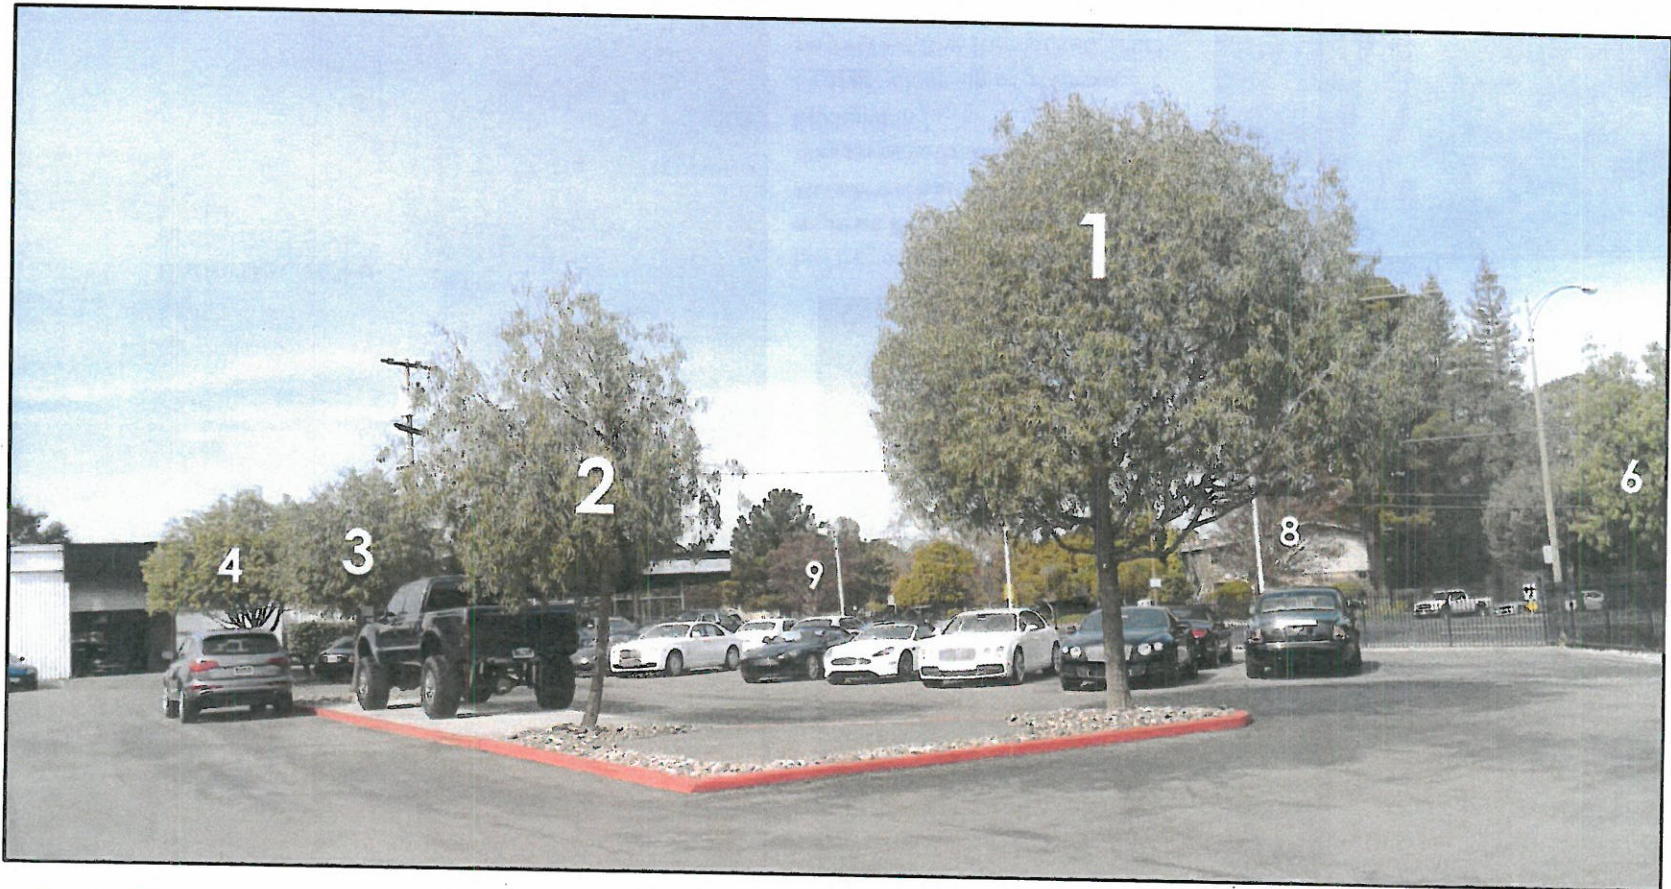
Australian willows #1, 2, 3, 4 and 6, with City street tree crape myrtles #8 and 9 visible in the background.

1. **Remove the following 6 trees: #1-4 Australian willows, #8 crape myrtle and #12 Brisbane box.**
2. **Save and protect the following 9 trees: #5, 7, 9-11 and 14-17.**

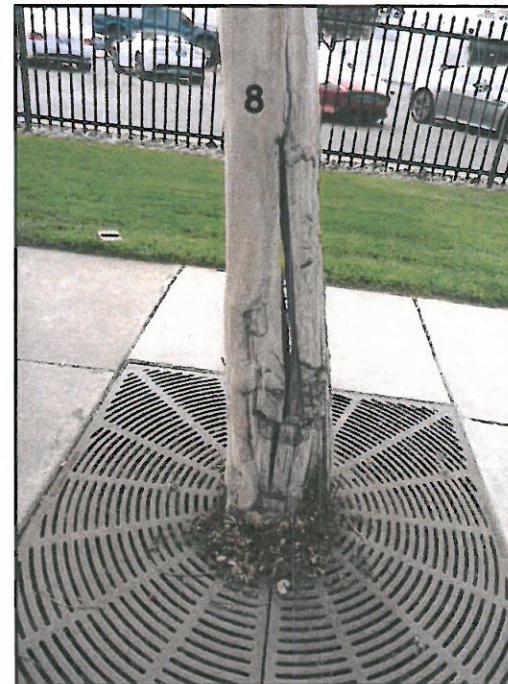
*08	Crape myrtle	8	20*15	80	20	Poor	Low/ Moderate	Remove	Structure	<u>Condition:</u> car hit has cracked trunk all the way through from ground to 4.5 feet above the ground; can see daylight through crack – also much internal decay visible. As a part of new landscaping replace this tree a new tree of same species.	2	3	4
*09	Crape myrtle	8	20*16	80	75	Good	Low/ Moderate	Save		<u>Condition:</u> root collar is close to edge of tree grate. Cut grate to create a gap of several inches between trunk and grate.	2	3	4
*10	Crape myrtle	6	18*10	75	70	Good	Low/ Moderate	Save		<u>Condition:</u> minor car hit wound to lower trunk.	1	2	3

*14	Crape myrtle	9	25*18	90	50	Fair	Low/Moderate	Save		Condition: root collar recently starting to overgrow tree grate. Cut grate to create a gap of several inches between trunk and grate. Large scaffold branch failure wound and cavity on trunk.	2	4	5

Left photo: crape myrtle street trees #7 and 8, with Australian willow #6 and Brisbane box #5 in the background.

Center: close-up of crape myrtle #8 with cracked trunk; this tree should be removed and replaced.

Left: close-up of crape myrtle #14 overgrowing tree grate.

4. **Replace crape myrtle #8** (due to poor condition) with a new crape myrtle tree, as part of new landscaping.
5. **Tree Disposition Plan:** re-label the trees with the tree numbers used in this report. These are the actual numbers on the tree tags that were placed on these trees in the field. Also revise the Legend so that the tree tag numbers are used.

11. **The metal tree grates around crape myrtle City street trees #7, 9-11, 14, 15 and 17 have trunk openings that are too small or will soon be too small due to trunk diameter growth.** The root collars of several of these trees are starting to grow over the grate, which can eventually girdle and kill the tree or cause it to fall over. Cut the grates to make the tree trunk hole larger so that there is a gap of at least 2 inches between the grate and the tree's root collar or trunk.

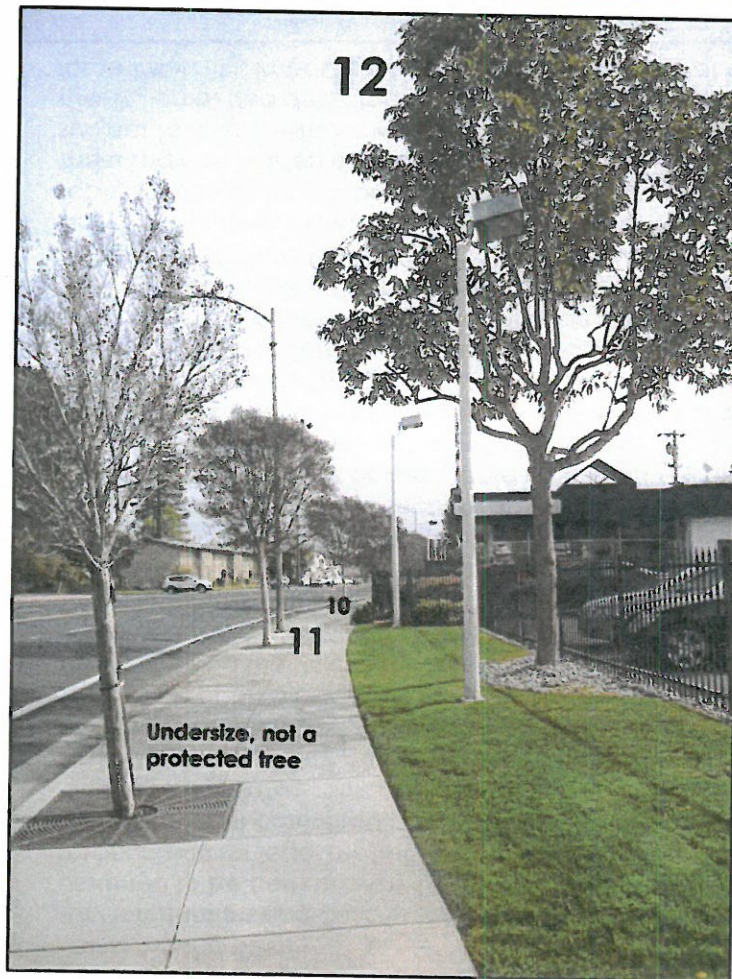
Brisbane box #12 on the right, with **crape myrtle street trees #10 and 11** at left.

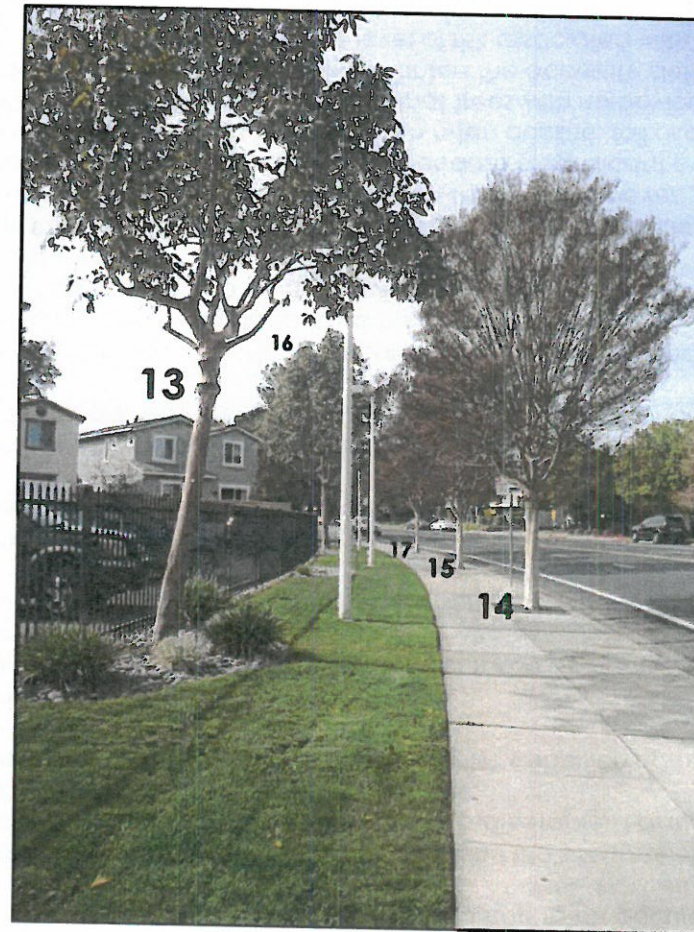
Brisbane box trees #13 and 16 on the left, with **crape myrtle street trees #14, 15 and 17** on the right.
