RESOLUTION 2014-040

**RESOLUTION OF THE TOWN COUNCIL OF THE TOWN OF LOS GATOS
GOVERNING THE DESIGN REVIEW PROCESS AND CLARIFYING
THE ROLES AND RESPONSIBILITIES OF THE ARCHITECTURAL CONSULTANT
AND RESCINDING RESOLUTION 2002-25**

RE: 550 Hubbel Way

550 Hubbell Way,
Los Gatos, California

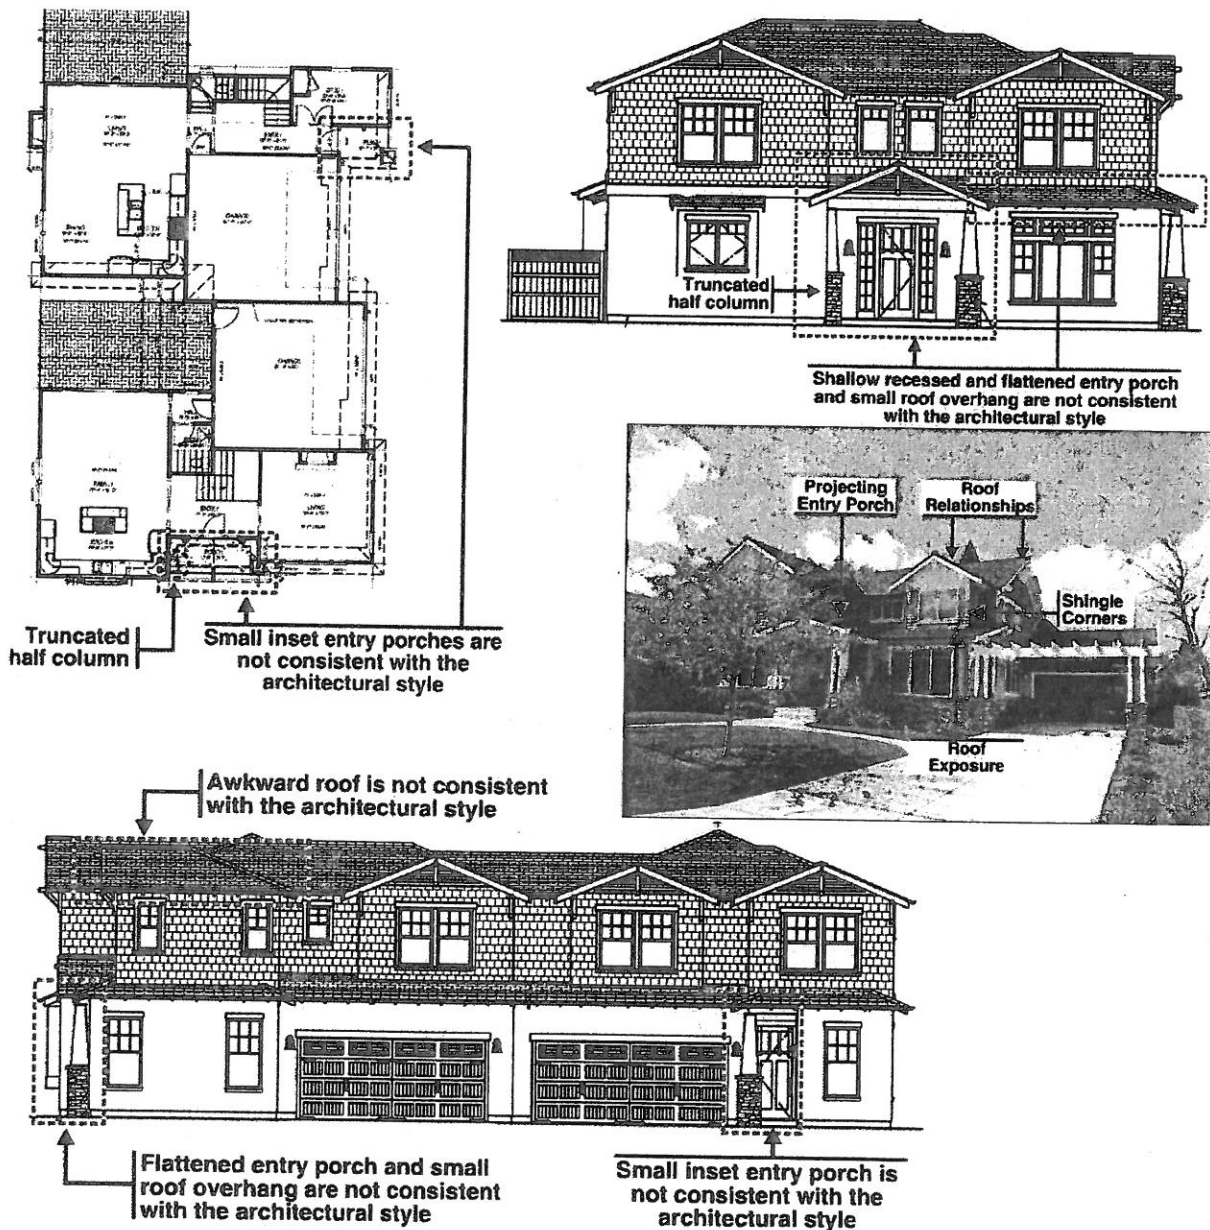
1. The porches facing the street were very small, and recessed into the building form very much unlike the typical Craftsman Style entry.
2. The entries to the rear two units also were small, recessed entry porches which is not consistent with the architectural style.
3. The roof exposure at the second floor line on the street elevations at the auto court entry seemed too small.
4. The top roof adjacent to the auto court entry was very awkward, and not consistent with the architectural style.

The proposed design had a gable end facing the street and a very close hip end to the north.

Those concerns were summarized in the illustrations and photo example of one approach example shown below.

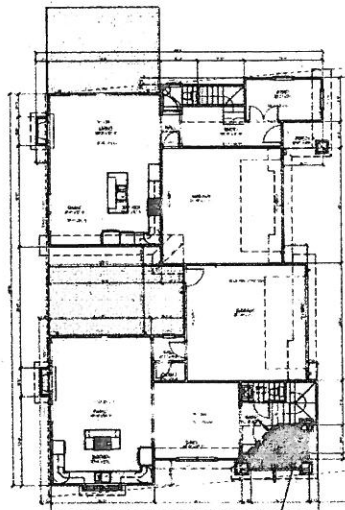
PORCH: Current Submittal

My feeling is that the project has been substantially improved from that submitted in March. I am comfortable with the rear porches being smaller in size than the street-facing porches given the limitations in space necessitated by the attached townhouse product type and the dimensions of the site. However, I am still not convinced that the porches on the front units are meeting the word and spirit of the Town's Residential Design Guidelines 3.10.1 which calls for usable porches. The porch depth, while larger than first proposed, would seem to preclude porch furniture in a comfortable arrangement. And, I am rather uncomfortable with the angled wall at the entry door which encroaches on the available porch space. This arrangement is much less satisfactory than the similar project example in San Mateo shown the applicant at our meeting (see photo below).

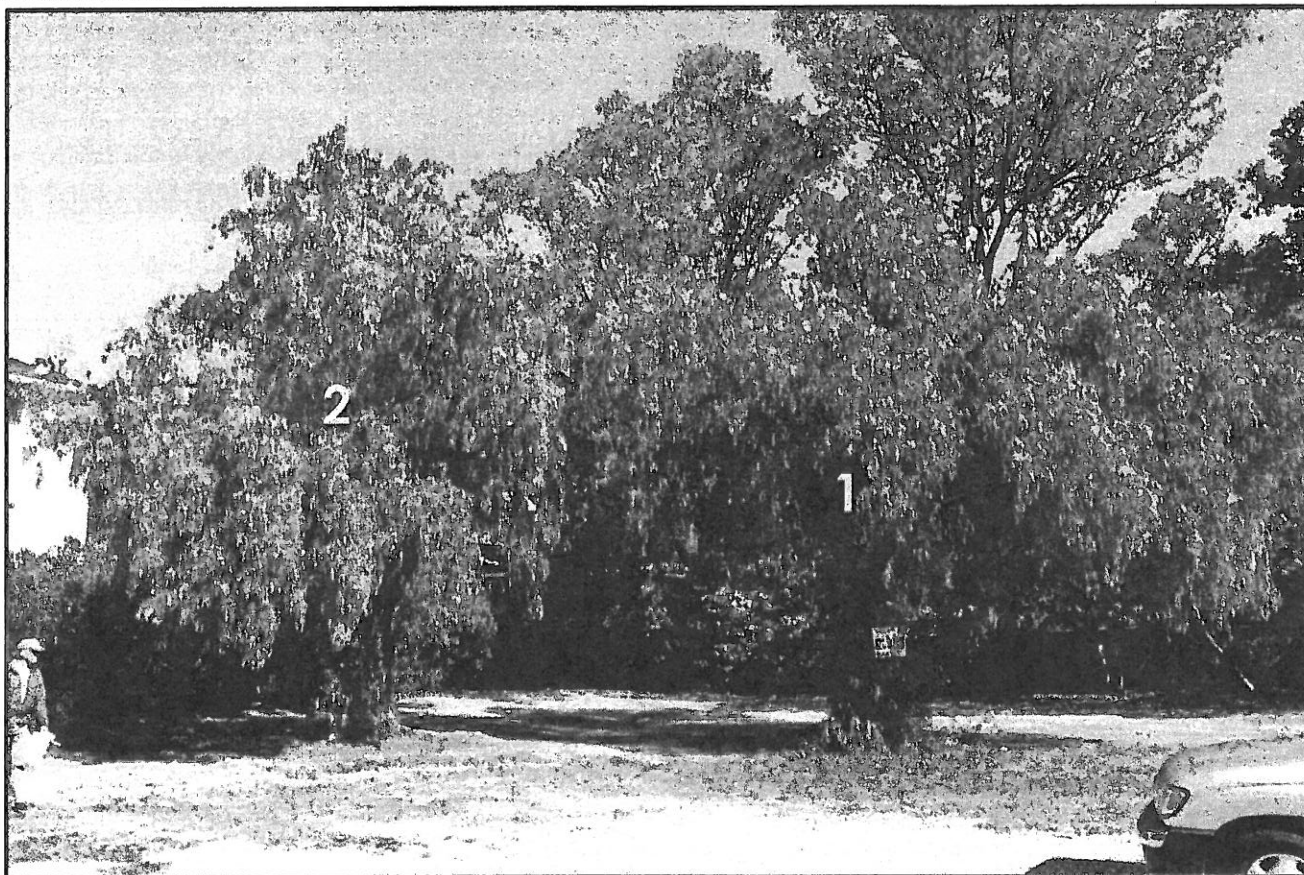
Tree #	Common Name	Trunk Diam. @ 3 ft.	Preservation Suitability	Expected Construction Impact	Action	Reason
1	Calif. pepper tree	37	Fair/Poor	Severe	Remove	Construction, Structure
2	Calif. pepper tree	36	Fair/Poor	Severe	Remove	Construction, Structure
3	Red River gum	14	Fair/Poor	Low/Moderate	Debatable	Overall Condition, Nuisance (mess from insect dripping)
4	coast live oak	7	Fair	Moderate/Severe	Debatable	Construction
5	silver wattle	7	Fair/Poor	Moderate/Severe	Remove	Construction
6	silver wattle	3,2,4,5,2,7	Fair/Poor	Severe	Remove	Construction
7	silver wattle	7,6	Poor	Severe	Remove	Construction Structure, Risk,
8	silver wattle	13	Poor	Severe	Remove	Construction, Structure, Risk,

California pepper trees #1 and 2, right to left. Note the two large Red River gum Eucalyptus trees in the background, growing on the neighboring property to the west.

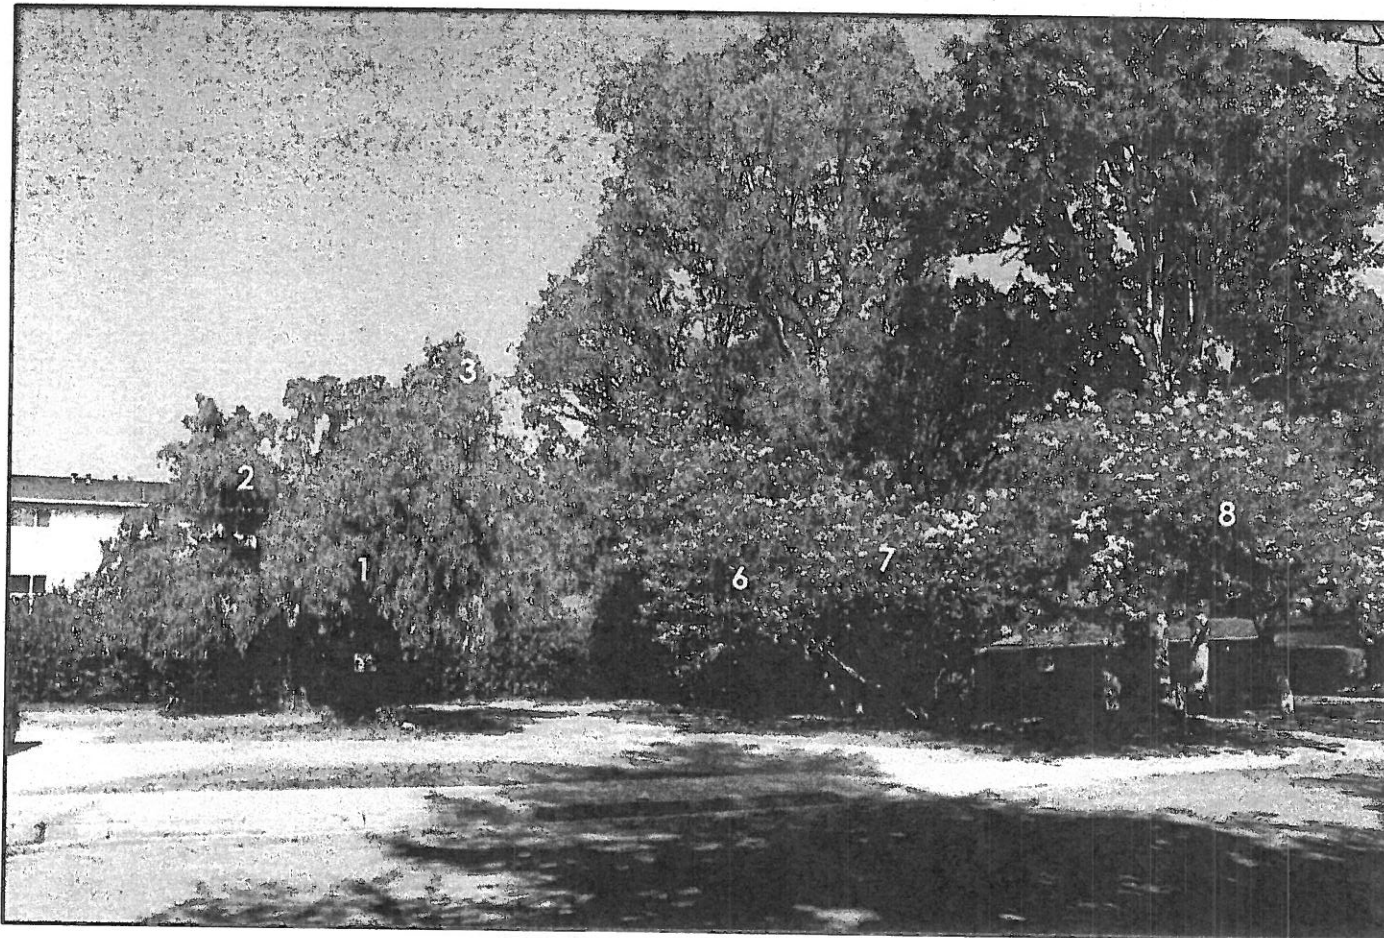
Most of the subject trees are visible in this photo. From left to right, **California pepper trees #2 and #1**, **Red River gum #3** in the background, and **silver wattle acacias #6, 7 and 8**.

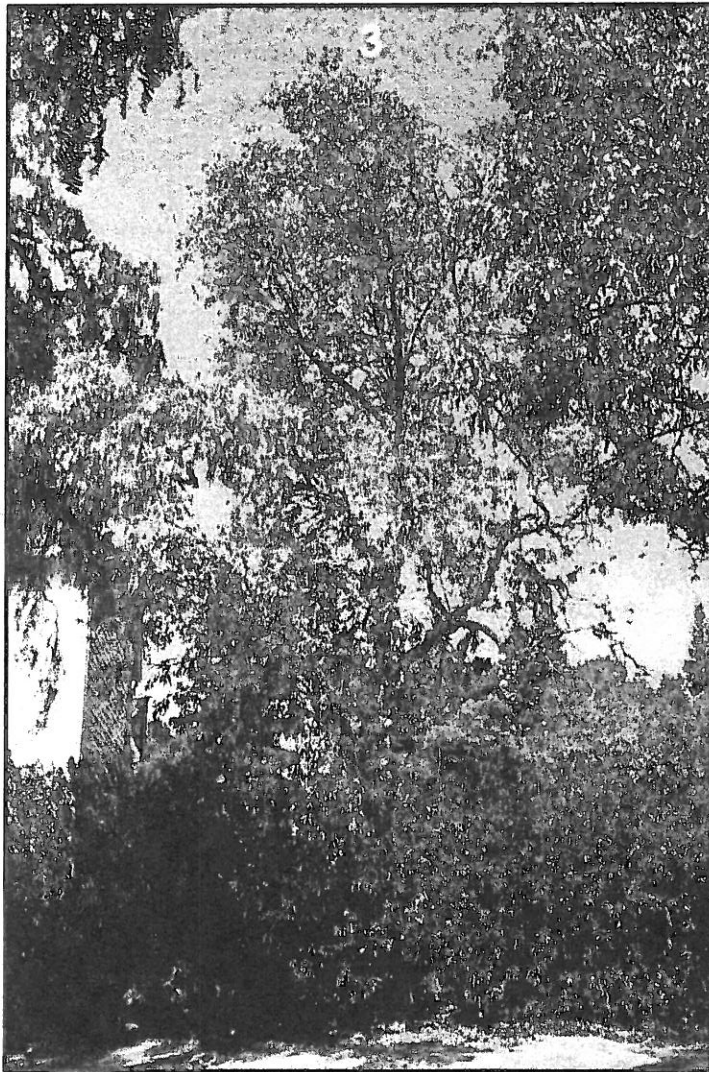
Left photo: Red River gum #3 along the North property line, near the Northwest corner.

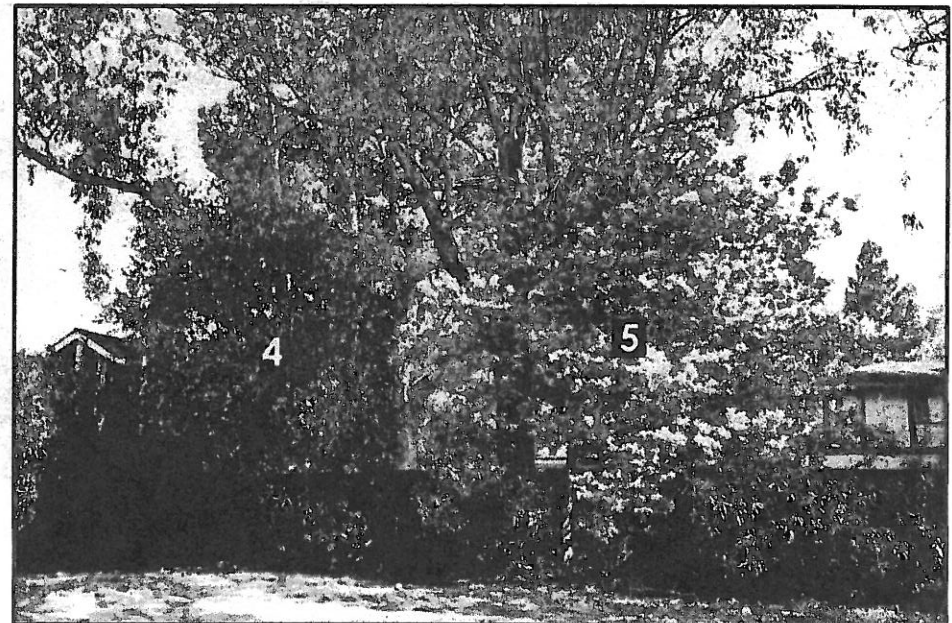
5	Acacia dealbata, silver wattle	7	30*20	80	60	Fair/Poor	\$1,260	Moderate/Severe	Remove	Construction	Construction: trunk is within a few feet of proposed driveway; shown as Remove on the Site Plan. I agree. Not a good tree for this location.	2	3	5
6	silver wattle	3,2,4,5,2,7	45*25	80	50	Fair/Poor	\$240	Severe	Remove	Construction	Construction: within proposed driveway. Condition: stump sprout.	4	6	11

Right photo: small coast live oak #4 and silver wattle acacia #5. The larger tree in the background between these two trees is on neighboring property to the east.

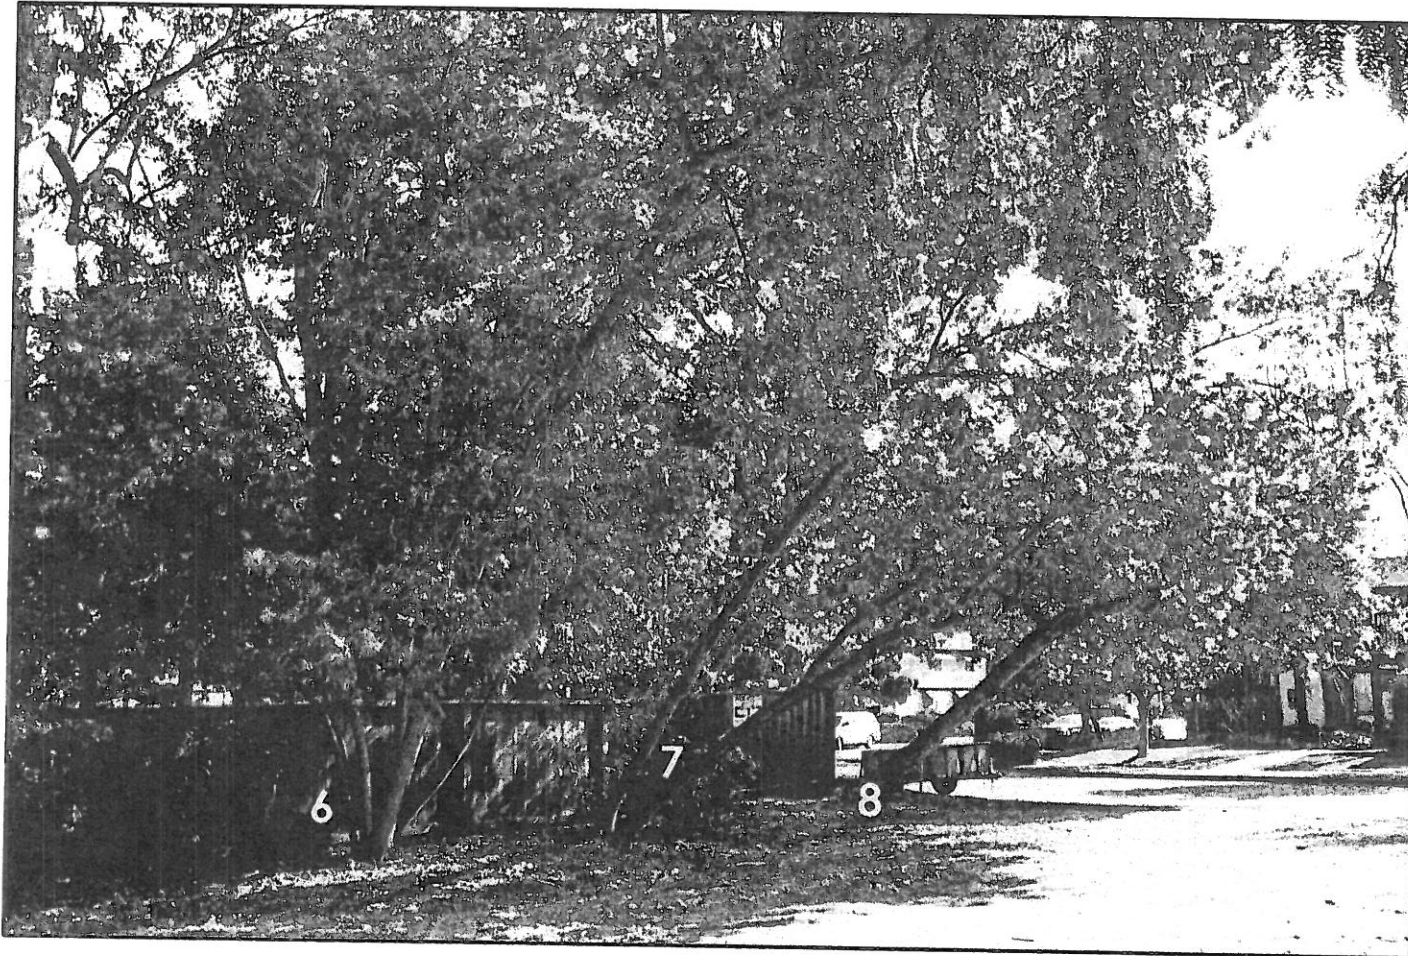
Tree #	Species & Common Name	Trunk Diam. @ 3 ft.	Size	CONDITION		Preservation Suitability	Val	Expected Construction Impact	Action	Reason	Notes	ROOT PROTECTION DISTANCES		
				vigor	structure							3xDBH	5xDBH	OTZ
7	silver wattle	7.6	40*35	80	40	Poor	\$100	Severe	Remove	Structure, Risk, Construction	Construction: within proposed driveway. Condition: leans 45 degrees toward site. Cracks in both trunks opposite lean.	2	4	7
8	silver wattle	13	25*30	70	40	Poor	\$160	Severe	Remove	Structure, Risk, Construction	Construction: less than 2 feet from edge of driveway. Condition: leans 45 degrees toward street and project site driveway. Soil is heaving opposite lean -- tree may be in the process of failing.	3	5	13

Silver wattle acacia #6 through 8, left to right, along the east property perimeter near Hubbell Way. These trees lean toward the site and away from adjacent trees on the neighboring property.
