**TOWN OF LOS GATOS**  
**PLANNING COMMISSION STAFF REPORT**  
**Meeting Date: August 27, 2014**

APPLICATION NO.: Tree Removal Permit Application T14-070

LOCATION: **16570 Garden Lane** (southeast side of Garden Lane, approximately 600 feet southwest of Los Gatos Boulevard)

### 16570 Garden Lane, Arborist Peer Review Report

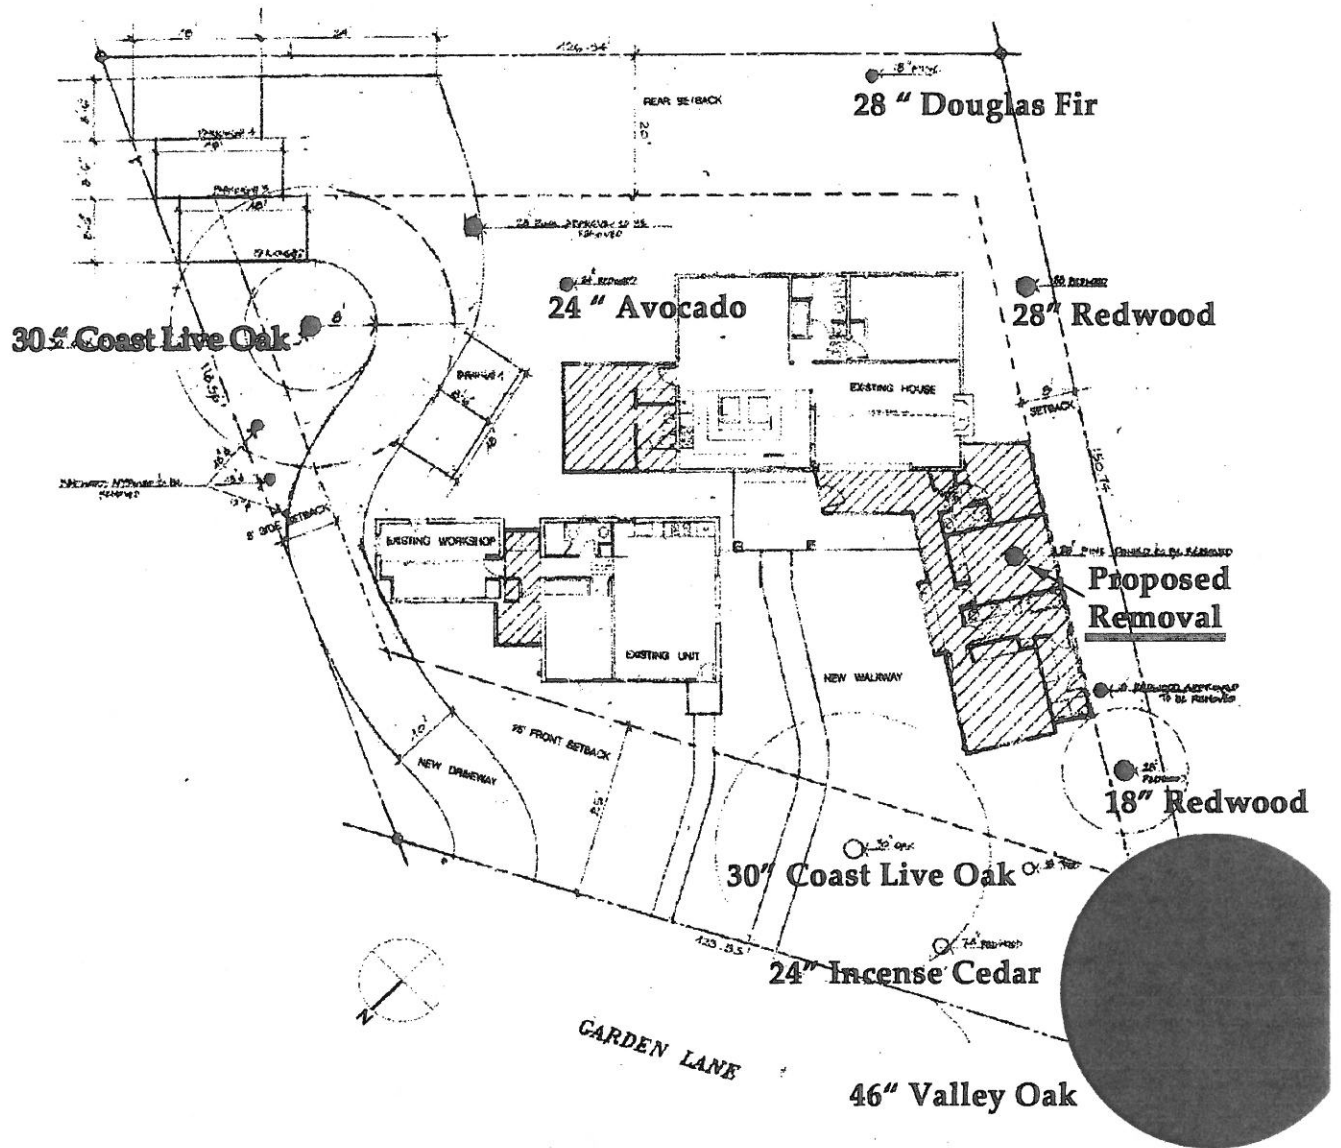
# Site Plan

Just the (8) largest trees to remain are noted on this map. There are (5) more significant trees to be left after the *Cedrus, deodara*, Deodar Cedar is removed. Please note the canopy renderings are not accurately to scale. The canopies of the three Oaks are much larger than depicted.

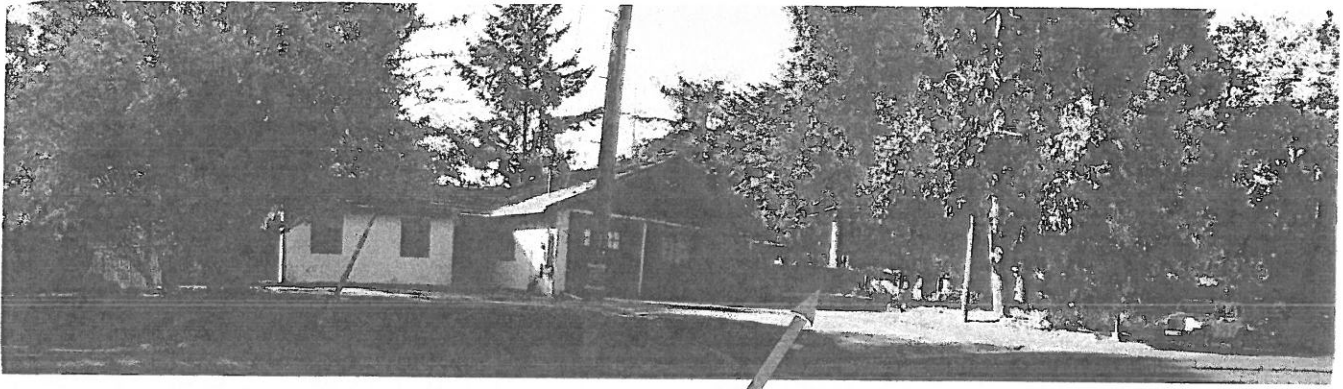
Bottom view of proposed Cedar removal

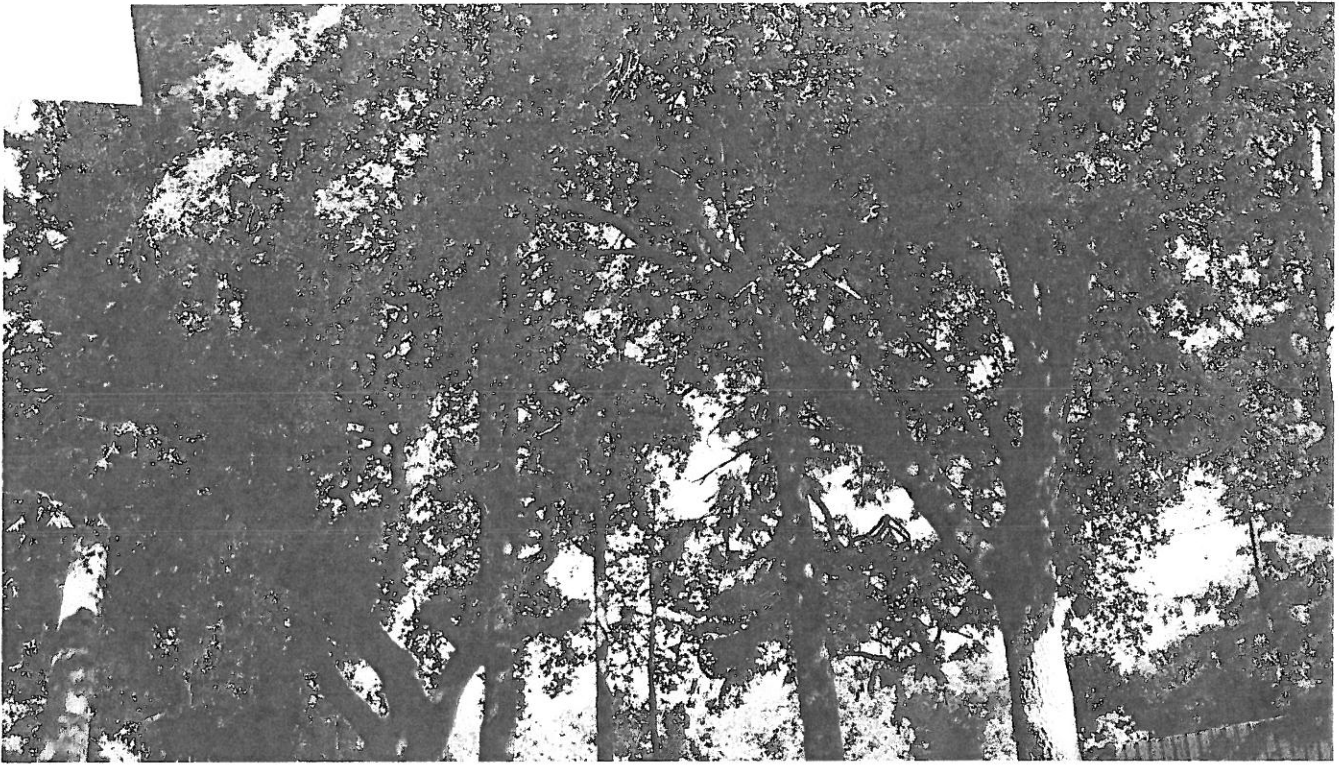
This *Quercus agrifolia*, Coast Live Oak is in the back yard. The canopy is so large it won't fit in a photograph.

This is a partial view of some of the canopy from the front porch of the house. This is a beautifully wooded lot.

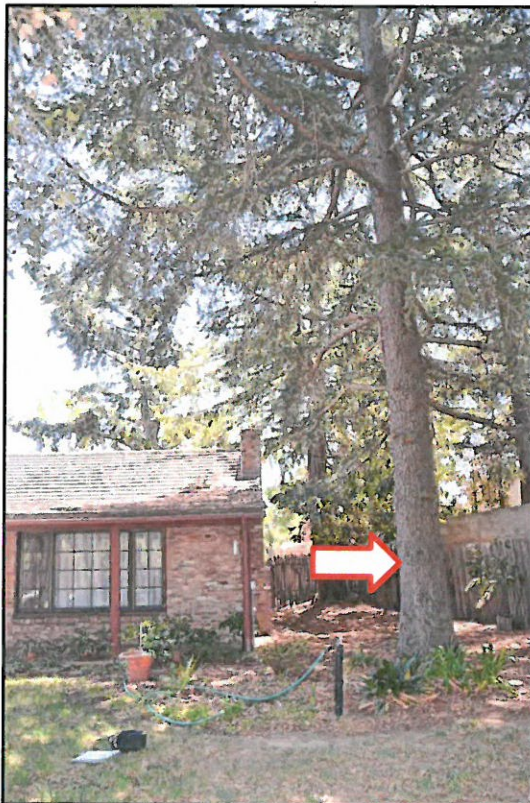
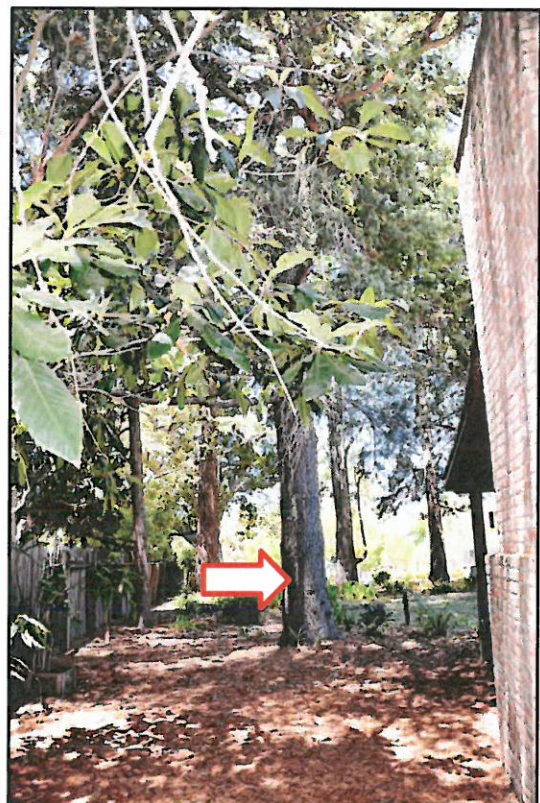
This letter concerns the request to remove a 28-inch diameter deodar cedar in the front yard of the above residence. I have reviewed the Tree Removal Application and Permit dated June 26, 2014, which was denied by the Town of Los Gatos. I also reviewed the applicant's arborist report by Mark Barton of Pruning Specialties, dated July 2, 2014. I evaluated the subject tree on July 25, 2014. The photos above, which I took when I was on site, show the lower portion of the tree from the northwest (left) and the southeast (right).

In my opinion the tree has *Good* vigor and *Fair/Good* structure. Overall its preservation suitability is *Good*. Detailed tree information is presented on page 3. I agree with the applicant's arborist that there are many other larger trees on the property, and if this deodar cedar were removed (and all existing other trees remained), the removal would not have much of an effect on the overall canopy coverage on the subject property, or for the surrounding neighborhood. Below I have included an aerial map of the property and the surrounding neighborhood and have marked the subject deodar cedar on this map.

If the tree remains, I recommend that there be no soil disturbance within a minimum radius of 7 feet from edge of trunk for a disturbance on one side of the trunk, and 12 feet for disturbances on multiple sides of the trunk. These are the **3 and 5xDBH root protection distances**<sup>1</sup> for this tree, respectively. Additional space may be required for the canopy, depending upon the height and location of the proposed addition. Right now the existing house porch corner is 8 feet from the trunk, and the house wall is 13 feet.

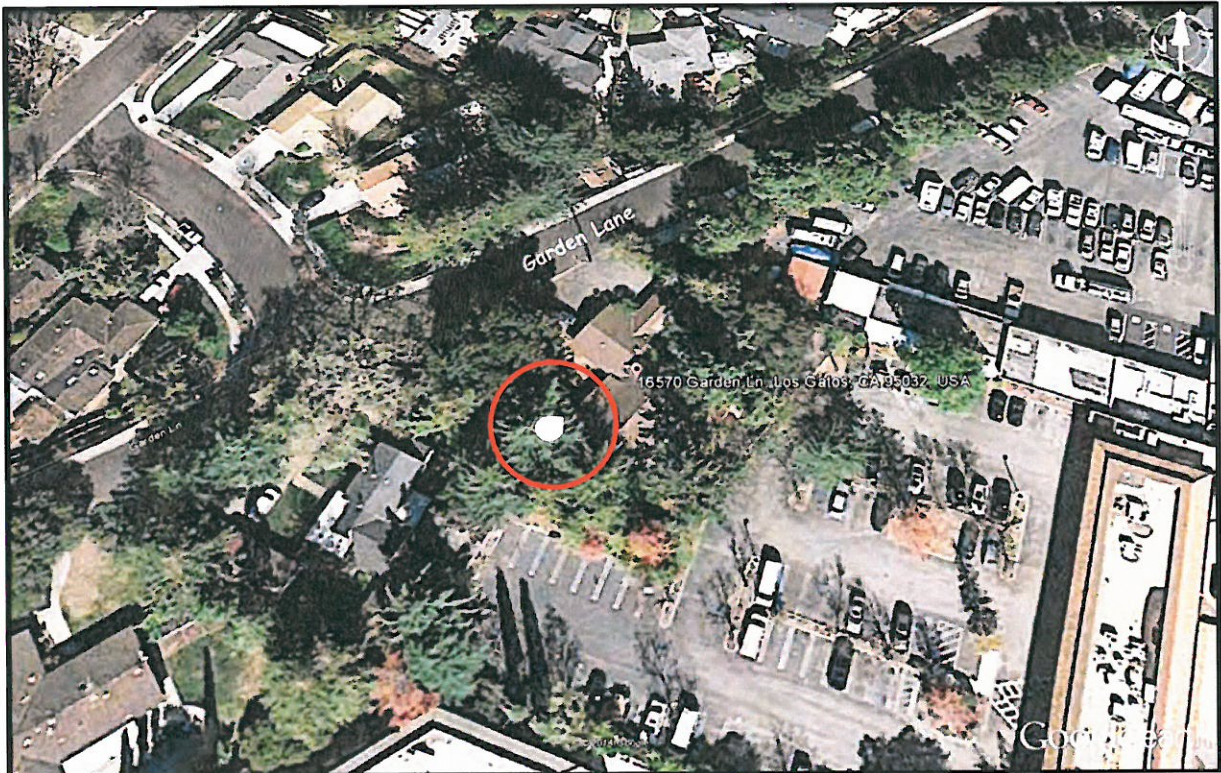
**Aerial Map of 16570 Garden Lane and surrounding neighborhood.** In the above map, I have circled the **dripline** of the subject deodar cedar tree in red and placed a white dot over the approximate top of the tree. The house at 16570 is to the right of the tree and somewhat underneath its canopy.

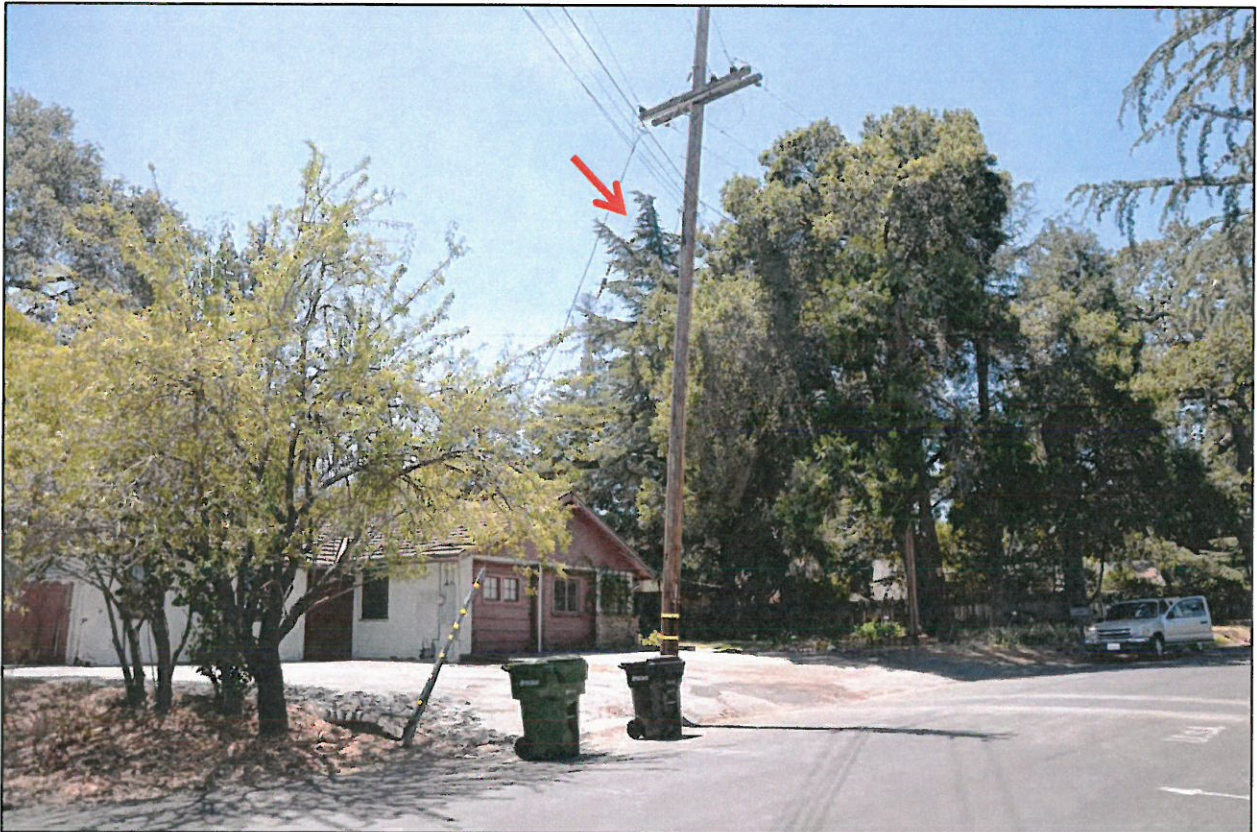
View of the 16570 Garden Lane property from Garden Lane to the northeast. An arrow points to the subject deodar cedar which is barely visible from this viewpoint.

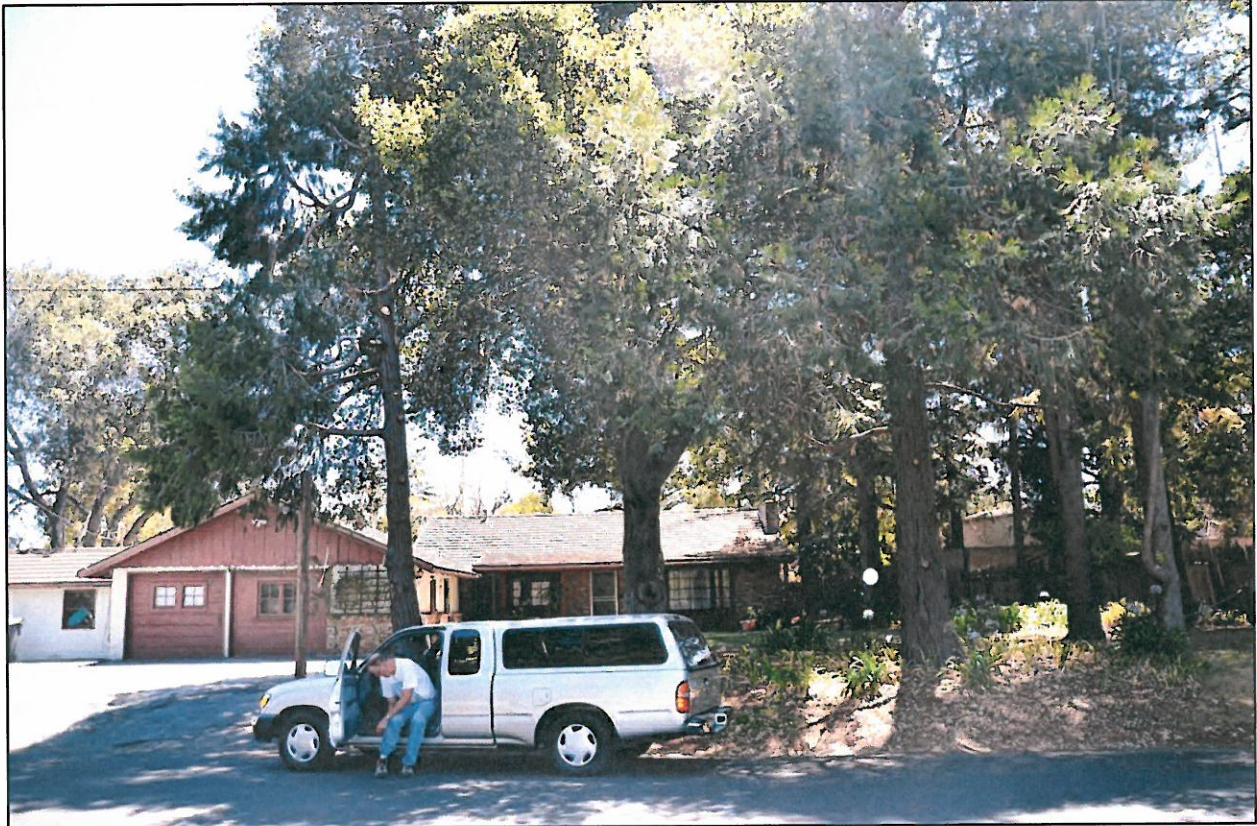
View of the 16570 Garden Lane property from directly across the street on Garden Lane. I have placed a white dot on the lower trunk of the subject deodar cedar tree.

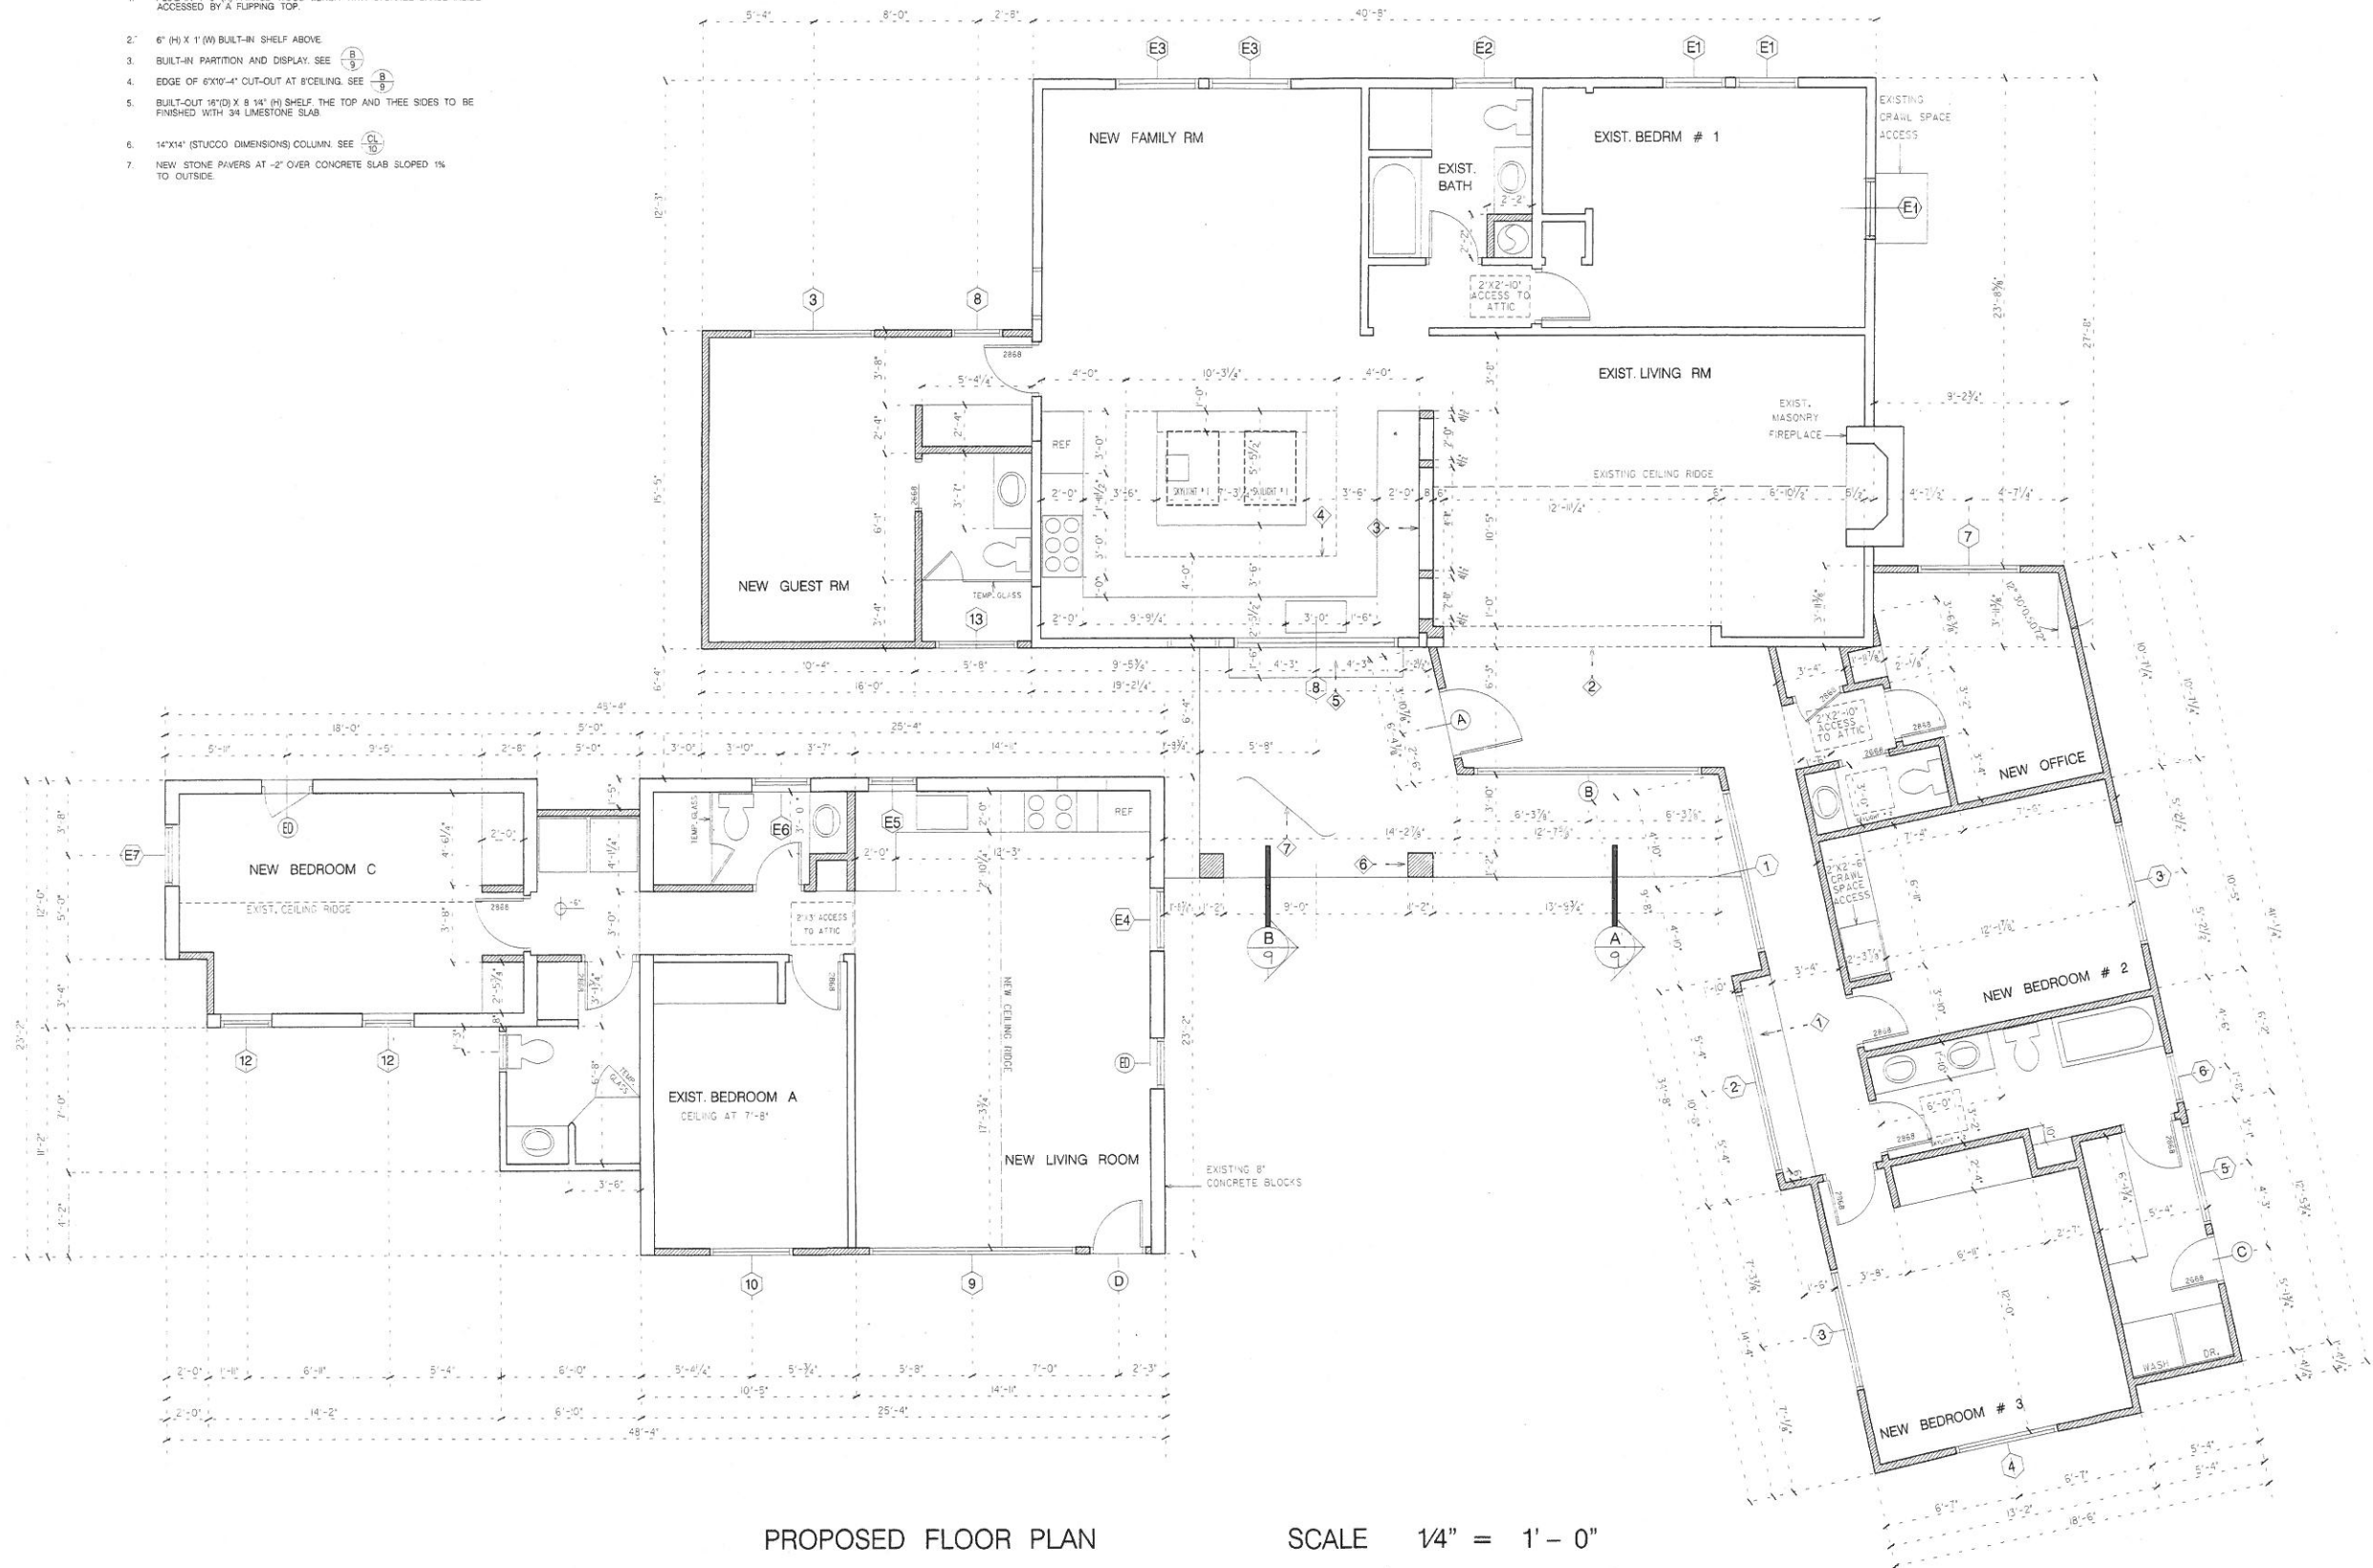
PROPOSED FLOOR PLAN

1. PLUG-IN 1'-6" (H) PAINTED WOOD BENCH WITH STORAGE SPACE INSIDE ACCESSED BY A FLIPPING TOP.
2. 6" (H) X 1" (W) BUILT-IN SHELF ABOVE.
3. BUILT-IN PARTITION AND DISPLAY. SEE (B 9).
4. EDGE OF 6'X10'-4" OUT-OUT AT 8' CEILING. SEE (B 9).
5. BUILT-OUT 16" (D) X 8' 14" (H) SHELF. THE TOP AND THREE SIDES TO BE FINISHED WITH 3/4 Limestone SLAB.
6. 14"X14" (STUCCO DIMENSIONS) COLUMN. SEE (CL 10).
7. NEW STONE PAVERS AT -2" OVER CONCRETE SLAB SLOPED 1% TO OUTSIDE.

The report measured the existing porch corner at eight feet from the trunk, and the house wall at 13 feet from the trunk. Based on these measurements and the future development plans (Exhibit 10), it appears that an addition could be constructed in a manner that would retain the tree with the recommended setbacks.

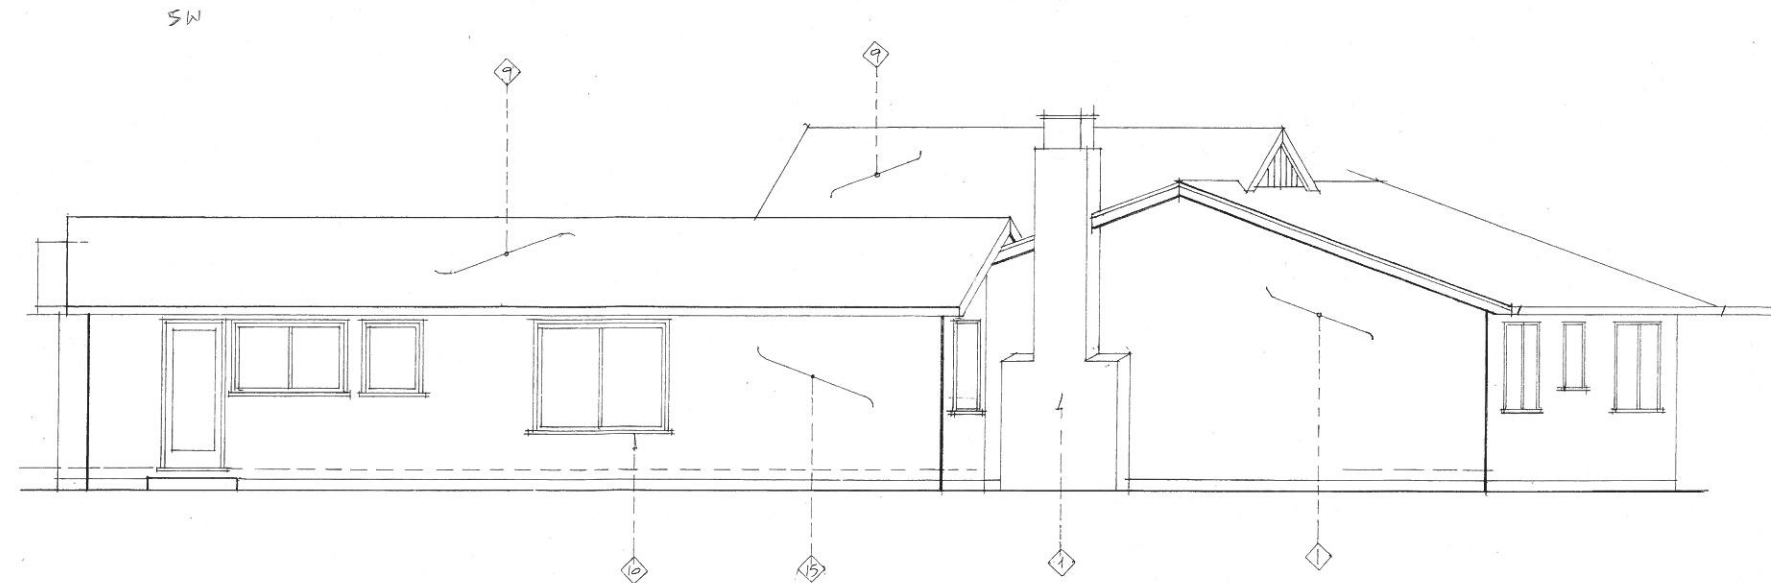
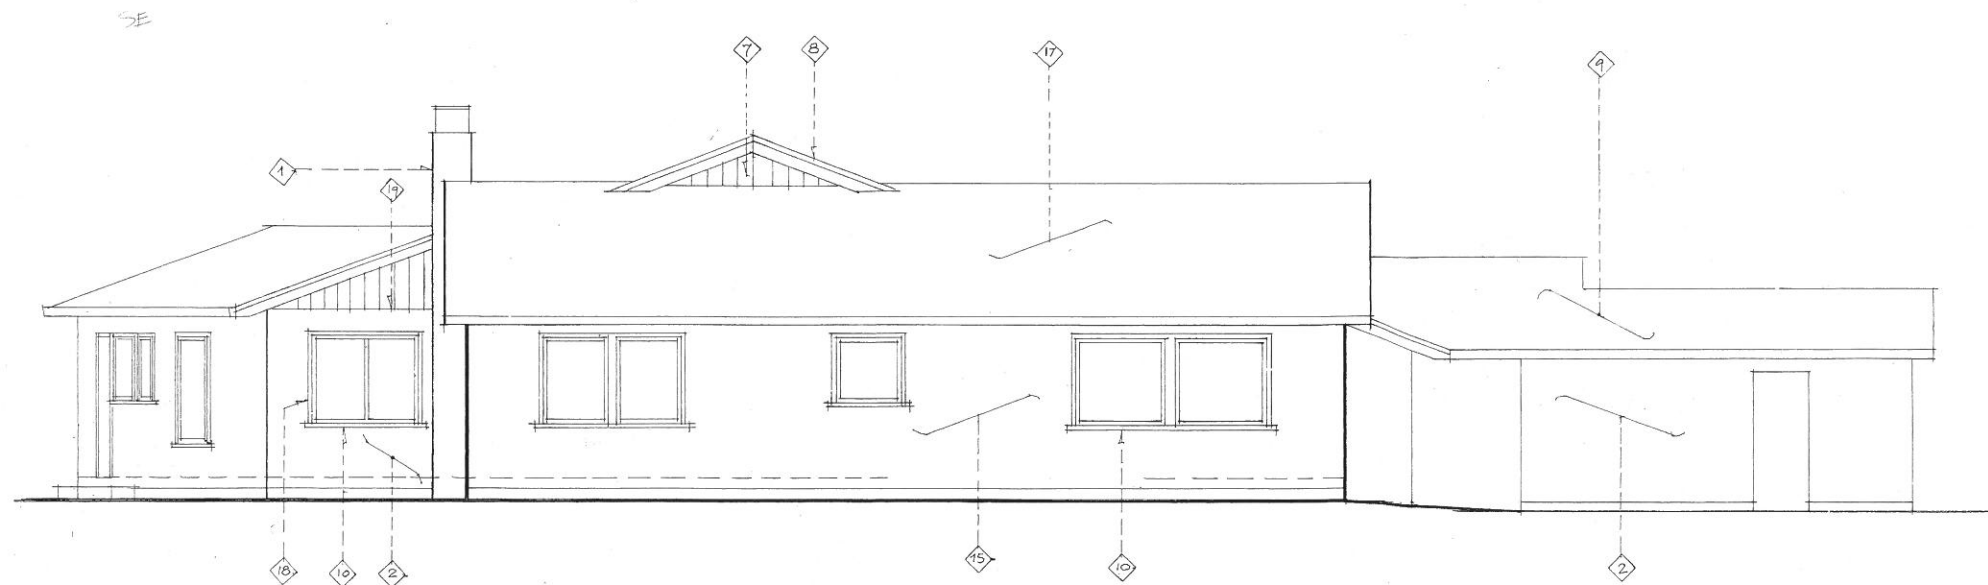
SOUTH WEST ELEVATION SCALE  $\frac{1}{4}" = 1' - 0"$

SOUTH EAST ELEVATION SCALE  $\frac{1}{4}" = 1' - 0"$

1. EXISTING MASONRY CHIMNEY.
2. NEW STUCCO - SEE GENERAL STUCCO NOTES AT SHEET # 2.
3. NEW 6X6 STAINED CEDAR.
4. NEW 6X10 STAINED CEDAR.
5. NEW STAINED AND SHAPED 6X10 CEDAR.
6. NEW STAINED 12" (1) REDWOOD VENT.
7. PAINTED 1X8 SIDING.
8. NEW SMOOTH AND PAINTED 2X8 FASCIA WITH 1X2 1/2" TRIM.
9. NEW ROOF : 50 YEARS PRESIDENTIAL ASPHALT SHINGLES.
10. NEW PAINTED WOOD SILL. SEE (SILL 10)
11. NEW 14"X14" (STUCCO DIMENSIONS) COLUMN. SEE (CL 10)
12. NEW PAINTED 1'-6" X 8" - 1'-6" REDWOOD PLANTER.
13. BUILT-IN SERVING SHELF THE TOP AND THREE SIDES TO BE FINISHED WITH 3/4" LIMESTONE SLAB.
14. TRANSITION BETWEEN SIDING AND STUCCO. SEE (ES 10)
15. EXISTING STUCCO.
16. SOLID CORE HARDWOOD ENTRY DOOR.
17. EXISTING ROOF WITH NEW 50 YEARS PRESIDENTIAL ASPHALT SHINGLES.
18. NEW 1 1/2" PAINTED BRICK MOLDING.

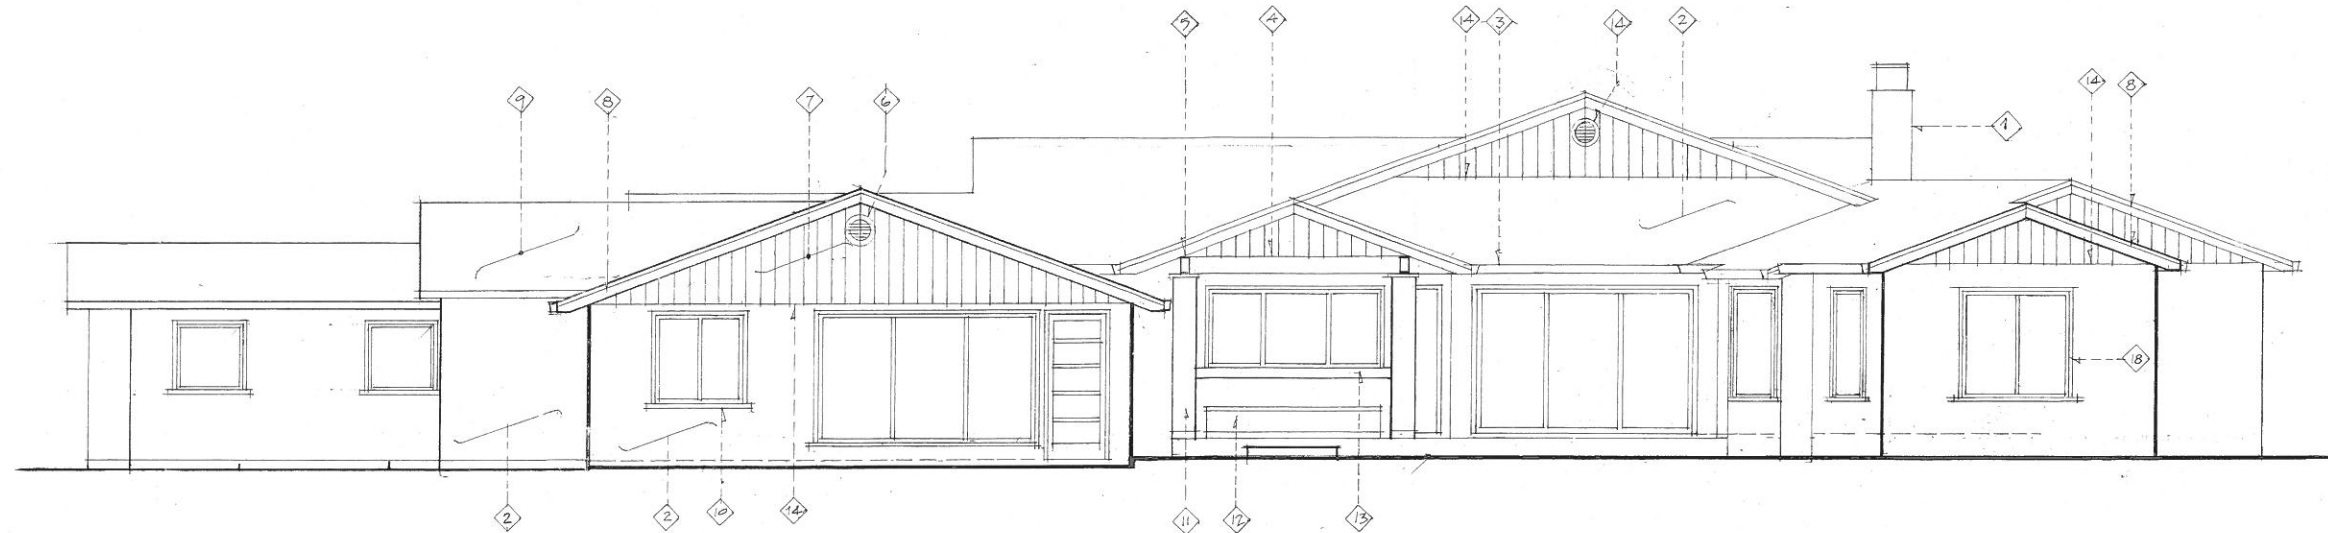
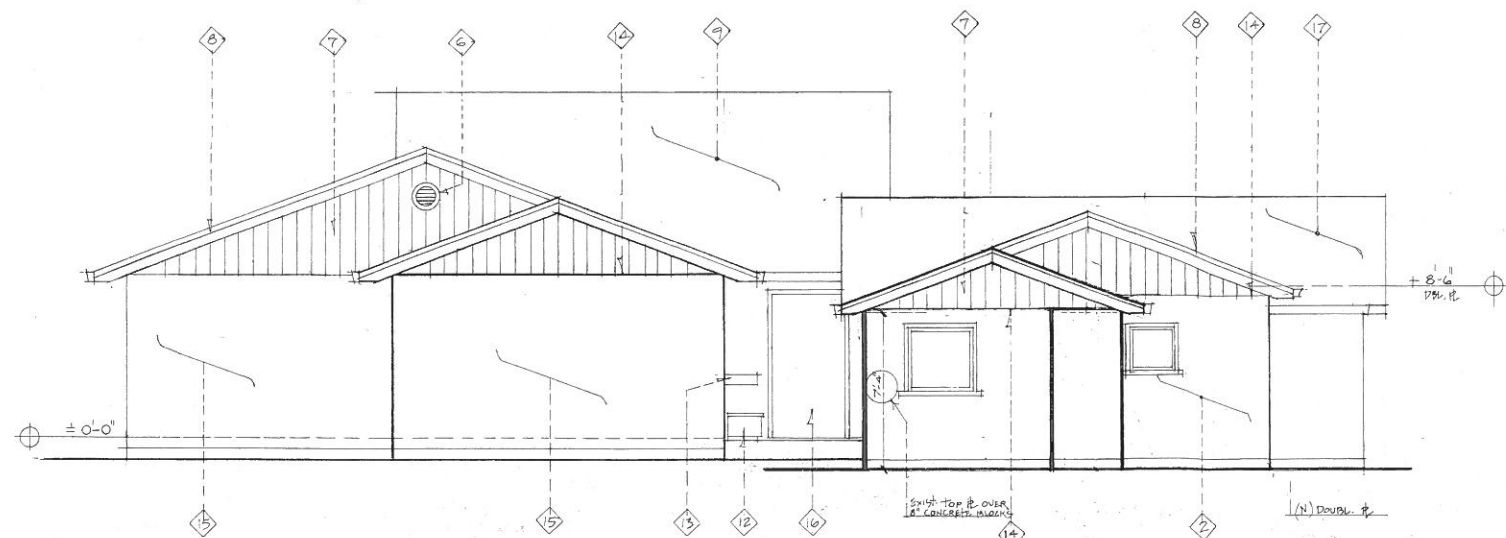
NORTH WEST ELEVATION SCALE 1/4" = 1' - 0"

NORTH EAST ELEVATION SCALE 1/4" = 1' - 0"

1. EXISTING MASONRY CHIMNEY.
2. NEW STUCCO - SEE GENERAL STUCCO NOTES AT SHEET # 2.
3. NEW 6X6 STAINED CEDAR.
4. NEW 6X10 STAINED CEDAR.
5. NEW STAINED AND SHAPED 6X10 CEDAR.
6. NEW STAINED 12" REDWOOD VENT.
7. PAINTED 1X8 SIDING.
8. NEW SMOOTH AND PAINTED 2X8 FASCIA WITH 1X2 1/2" TRIM.
9. NEW ROOF : 50 YEARS PRESIDENTIAL ASPHALT SHINGLES.
10. NEW PAINTED WOOD SILL. SEE (SILL 13)
11. NEW 14'X14' (STUCCO DIMENSIONS) COLUMN. SEE (CL 15)
12. NEW PAINTED 1'-6" X 8' - 1'-6" REDWOOD PLANTER.
13. BUILT-IN SERVING SHELF THE TOP AND THREE SIDES TO BE FINISHED WITH 3/4" Limestone SLAB.
14. TRANSITION BETWEEN SIDING AND STUCCO. SEE (SB 10)
15. EXISTING STUCCO.
16. SOLID CORE HARDWOOD ENTRY DOOR.
17. EXISTING ROOF WITH NEW 50 YEARS PRESIDENTIAL ASPHALT SHINGLES.
18. NEW 1 1/2" PAINTED BRICK MOLDING.
