TOWN OF LOS GATOS
PLANNING COMMISSION STAFF REPORT
Meeting Date: March 25, 2015

APPLICATION NO.: Tree Removal Permit Application T14-004

LOCATION: **10 Jackson Street** (corner of East Main Street and Jackson Street)

10 Jackson Street, Los Gatos – Tree Removal Permit Pictures

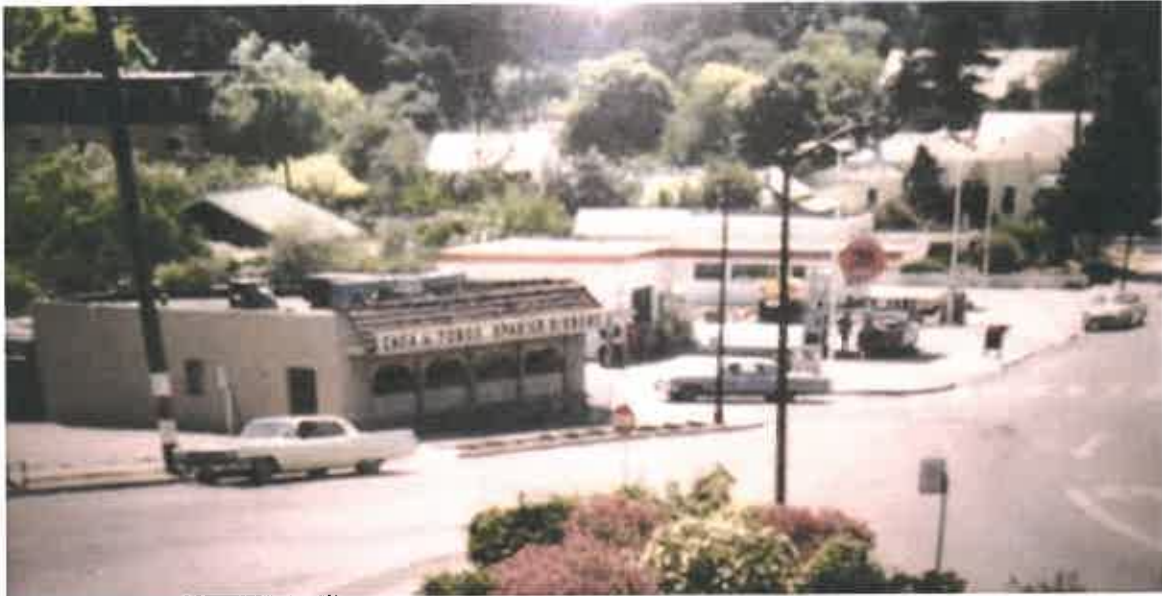
1960's picture of the property showing the 10 Jackson Street property formerly a 76 Gas Station without the subject Coastal Redwood Tree

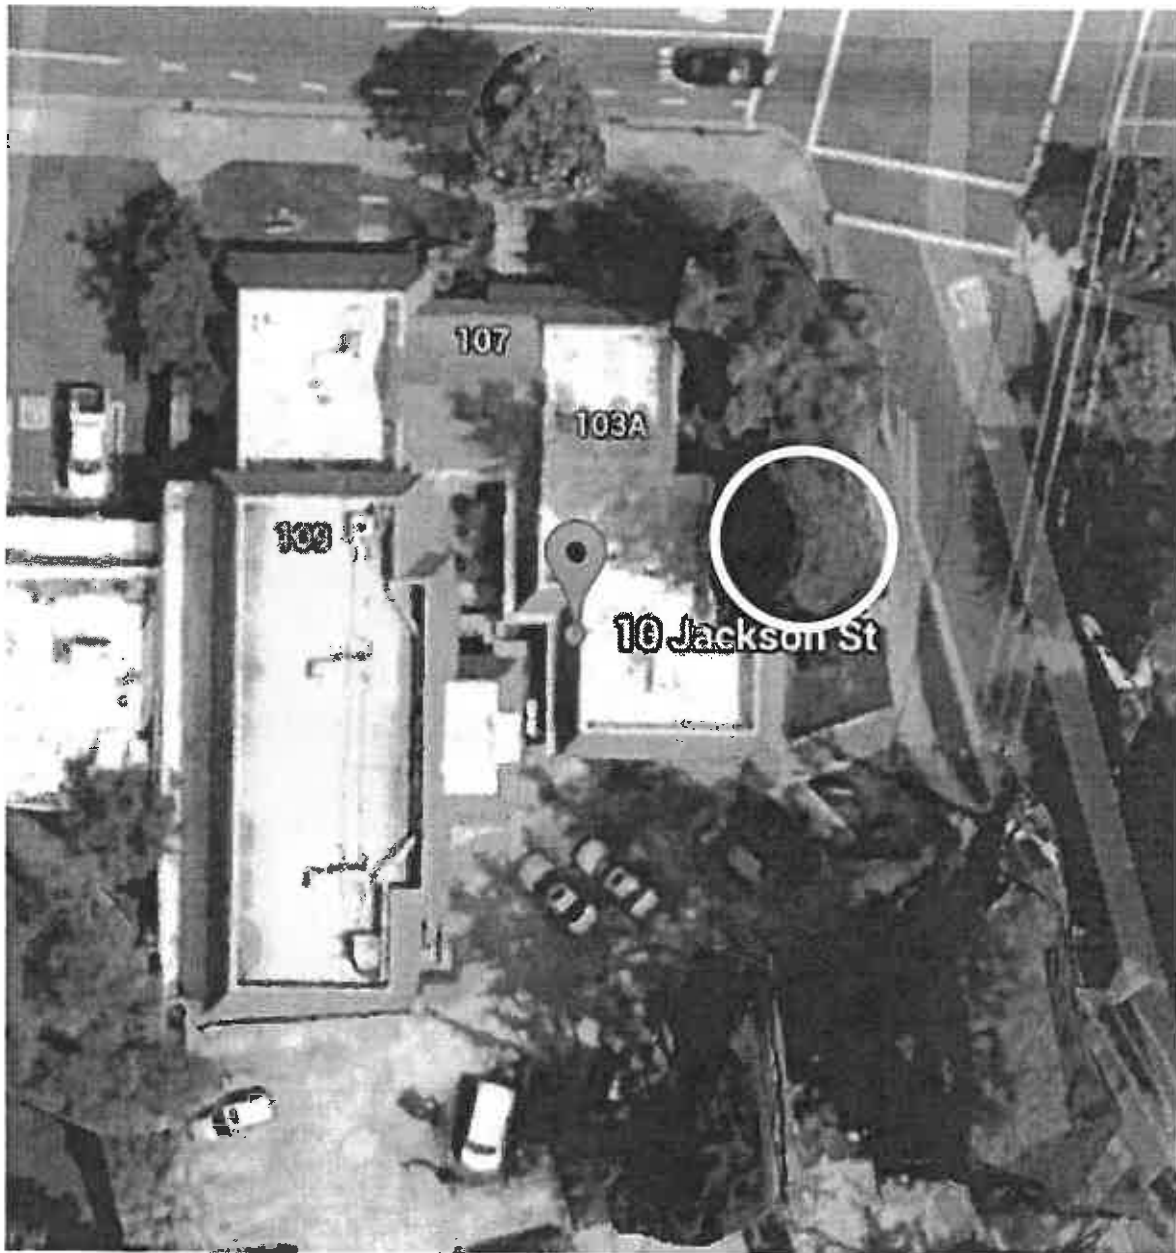
Appendix A: Site Overview

The white circle indicates the location of the coast redwood.

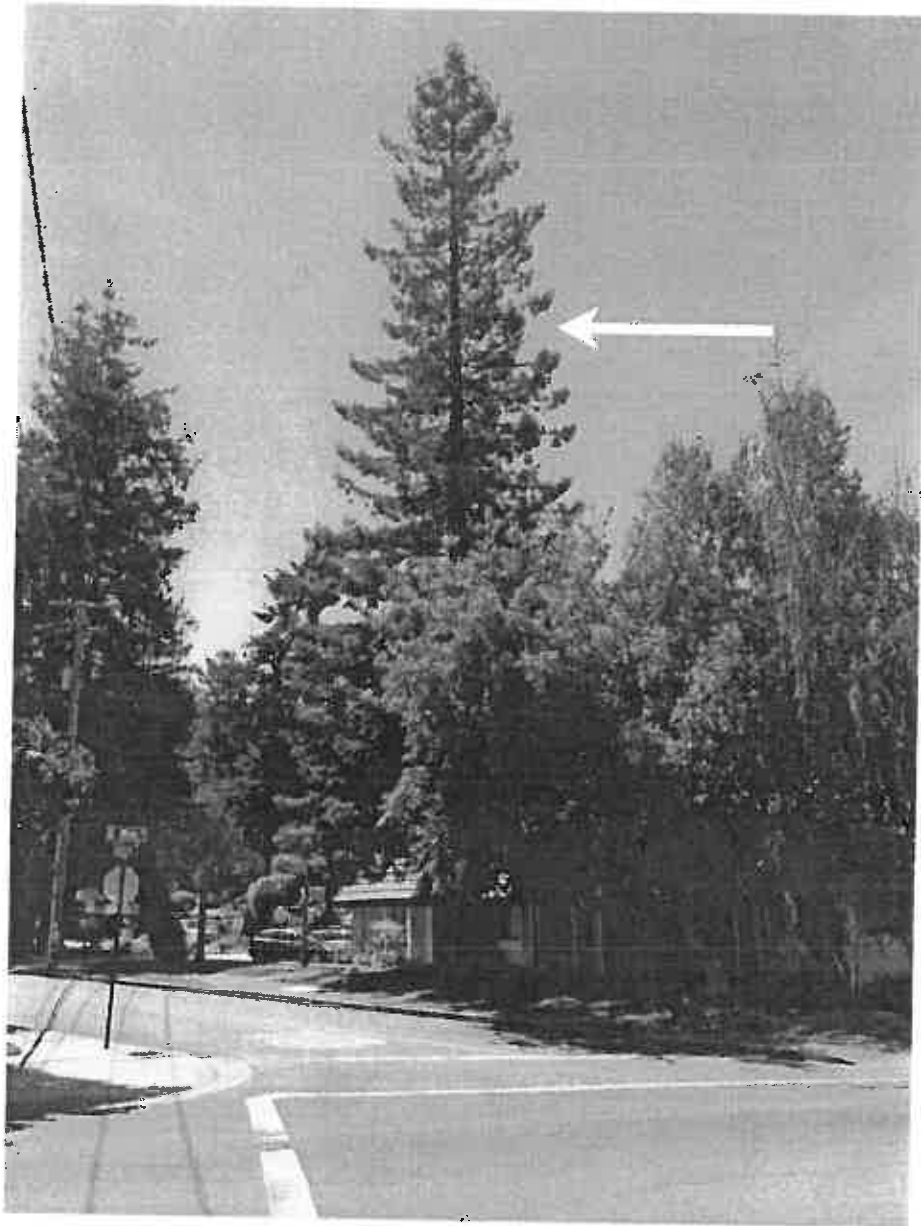
Tree from across Main Street

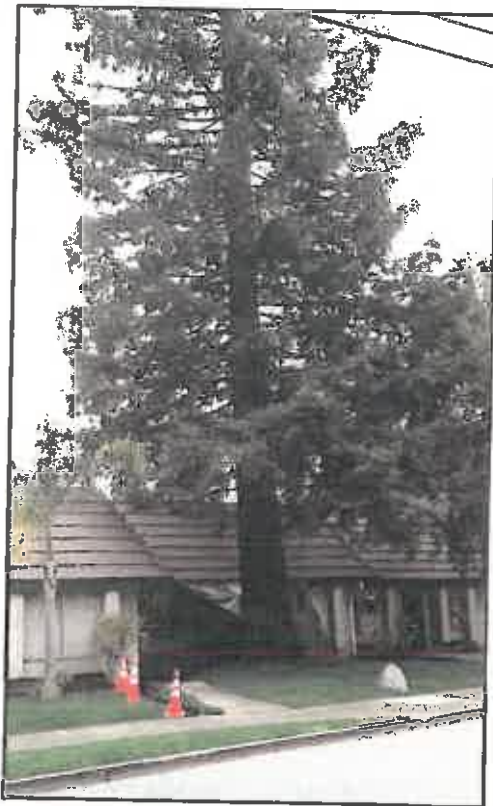
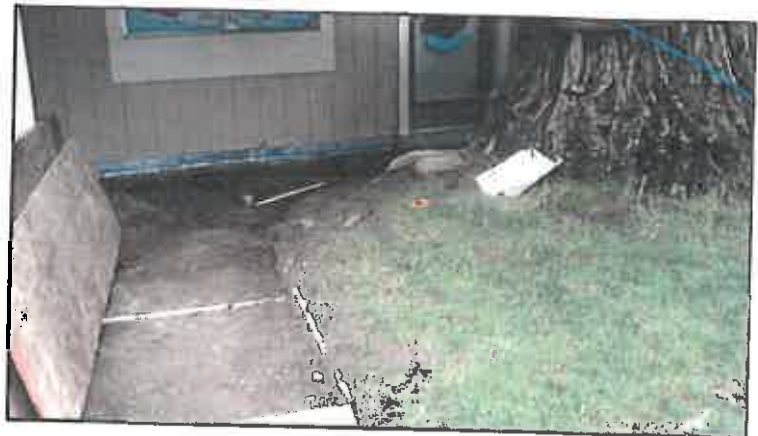
The subject redwood tree was planted too close to the adjacent building. To save or remove the tree is debatable in my opinion; although I lean more toward removal. On one hand a reasonable argument to remove the redwood can be made due to its large size, nearness to the building, past pavement (walkway) damage, certain future pavement (walkway) damage and possible future foundation damage. On the other hand if roots of the tree are confirmed not to be damaging the foundation at this time and a walkway can be built above existing roots, then it may be reasonable to save the tree – at least for the time being.

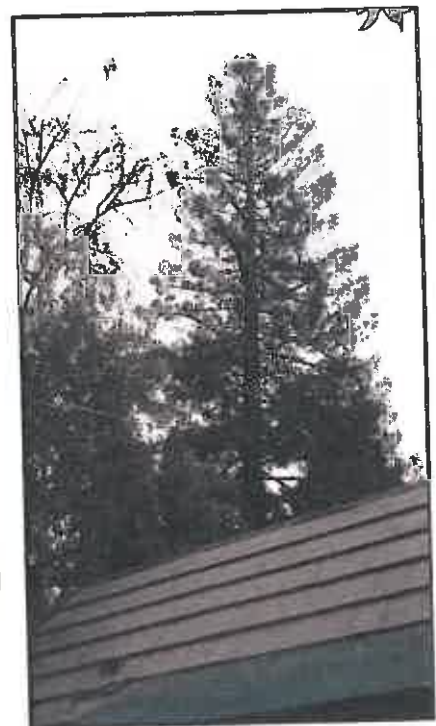
Notes: The vigor of the redwood is not good, nor is it poor; but its canopy density, particularly in the upper half of the tree, is sparser than desirable for the redwood's age and size. Although the tree is not dying, it does appear to be struggling at this point in its lifecycle. The reason for this is probably drought – the redwood is not receiving as much water from natural rainfall as it has in the past, and it is beginning to decline. Redwoods often put on much of their new growth in Spring when soil moisture is plentiful, but they may suffer during the heat of Summer and early Fall as they become larger and irrigation volume is not increased.

The subject redwood tree was planted too close to the adjacent building. Roots of the tree have been causing pavement damage alongside the building and threaten the building foundation. It is unclear whether roots of the tree beneath the soil surface are contacting the foundation. Excavation alongside the building foundation, down to the bottom of the footing could be undertaken to more accurately determine whether or not
