Deborah Ellis, MS

15735 Camino Del Cerro – Peer Review #1 of the arborist report and recommendations for trees in the vicinity of the proposed development

- Arborist Report (*Tree Inventory, Assessment & Protection. Camino Del Cerro Los Gatos*). Monarch Consulting Arborists, August 4, 2015

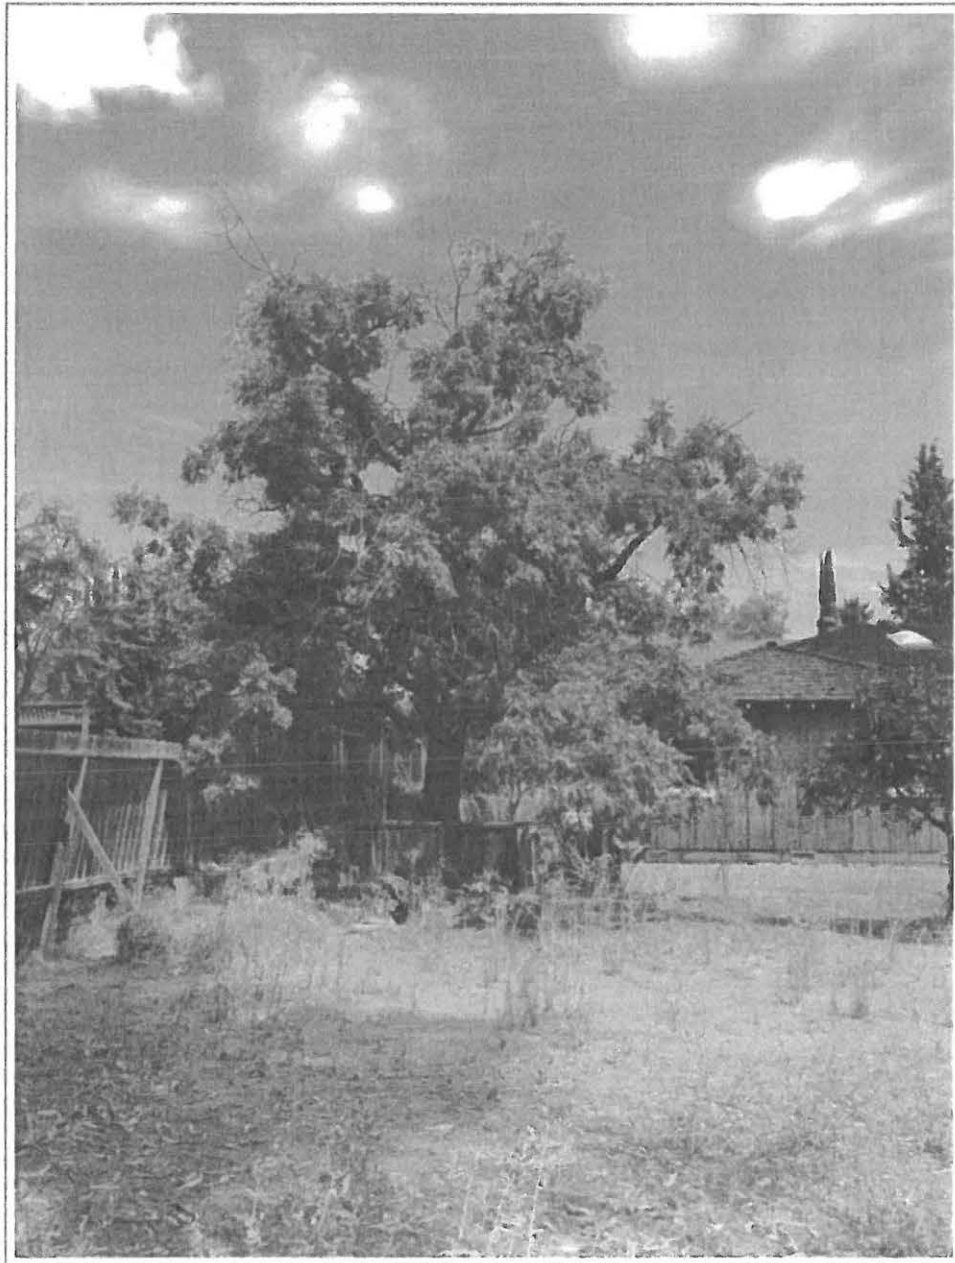
C1: black walnut 889

Eleven trees will be highly affected by the project, four of which are not protected by the ordinance. Eleven more trees will be moderately affected and are located along the driveway. If driveway excavation can be moved away from the trees or biaxial geogric is used the impact can be reduced. The trees highly influenced are all the fruit trees and mock orange along with the three silk, black walnut (889), willow (894), and blue gum eucalyptus (887).

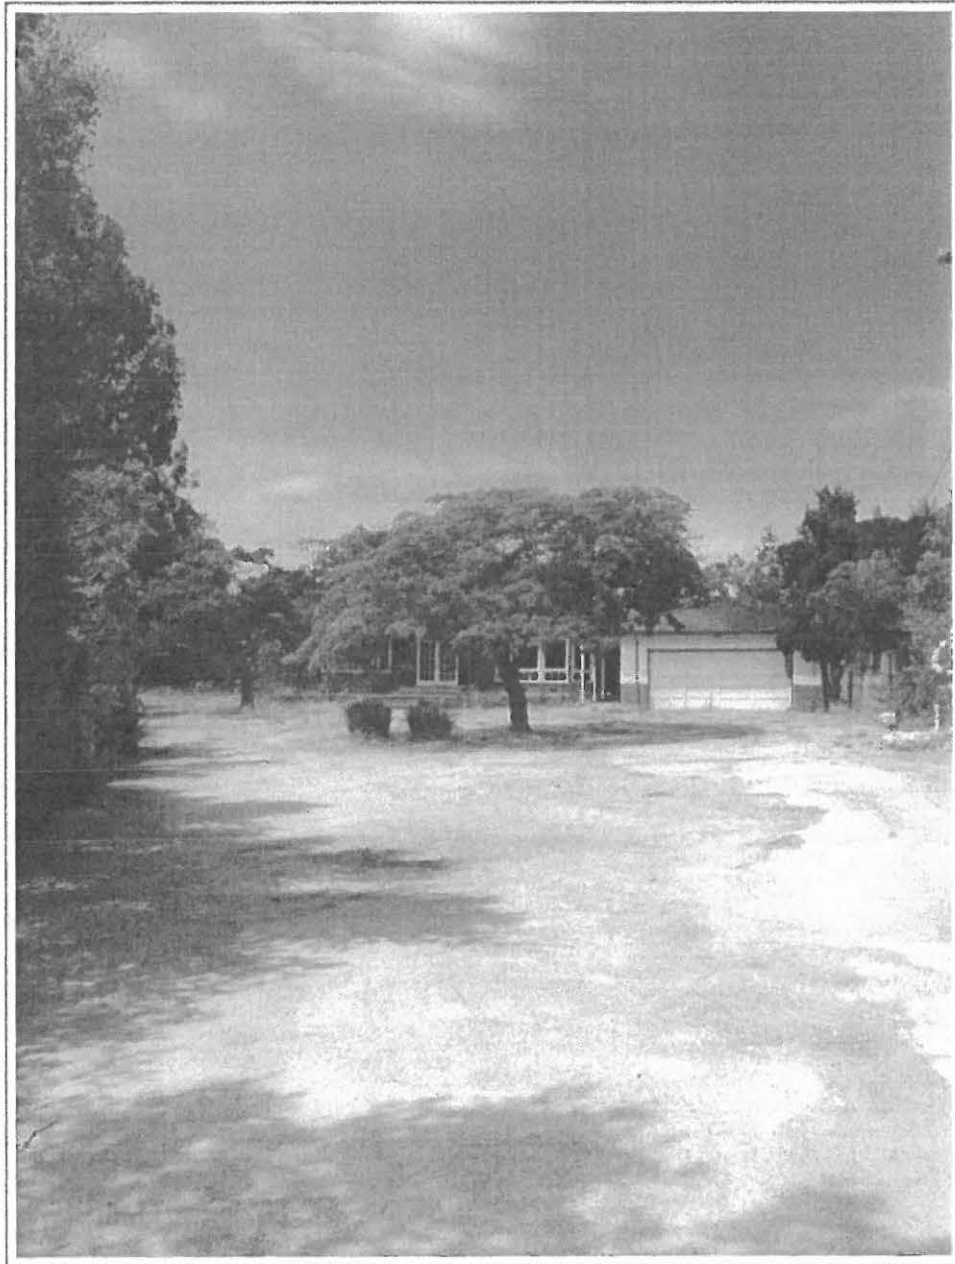
C3: Silk tree 893

The proposed new structure moved the main house east toward the central portion of the lot creating a larger backyard. The new structure footprint is over the two silk trees and orange.

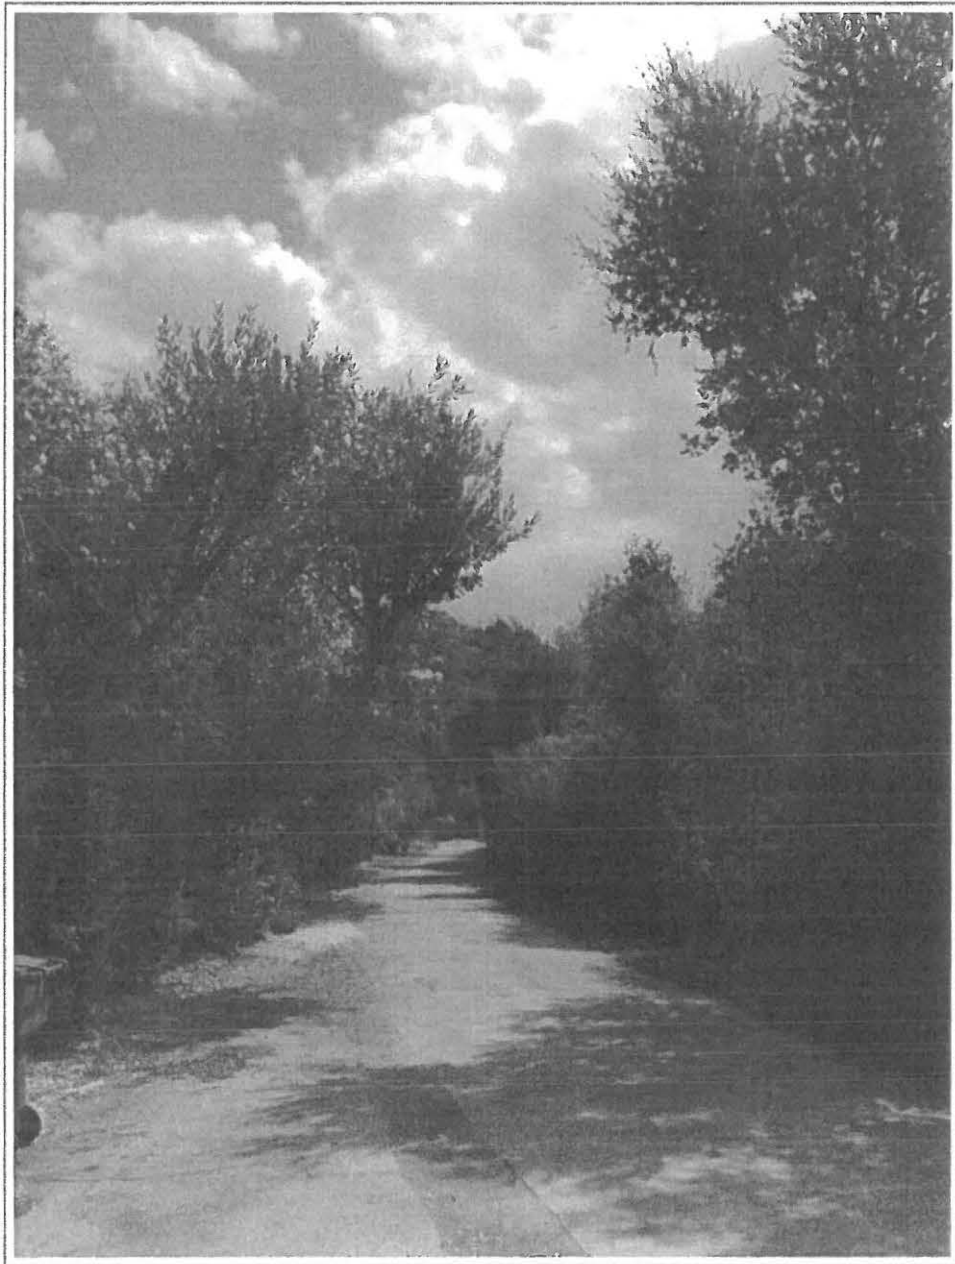
C5: Willow tree 894

Most of the trees are in either fair or good condition, primarily because they are small volunteers that have not developed the same kinds of problems older trees develop. The willow (894) and silk (895) are both in poor shape and located along the north side of the driveway within the oleander hedge.
