Los Gatos Luxury Cars
Development Review Application
620 Blossom Hill Road, Los Gatos CA

ARBORIST REPORT

Los Gatos Luxury Cars
620 Blossom Hill Road
Los Gatos, California

FEBRUARY 20, 2014

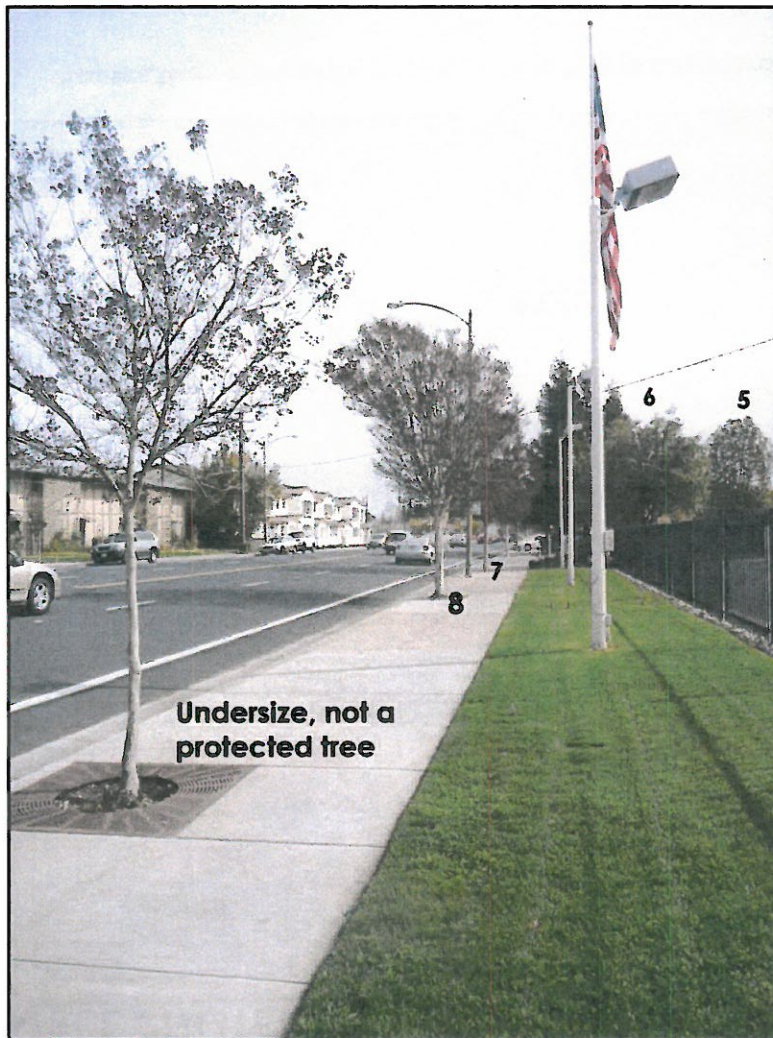
Undersize, not a protected tree

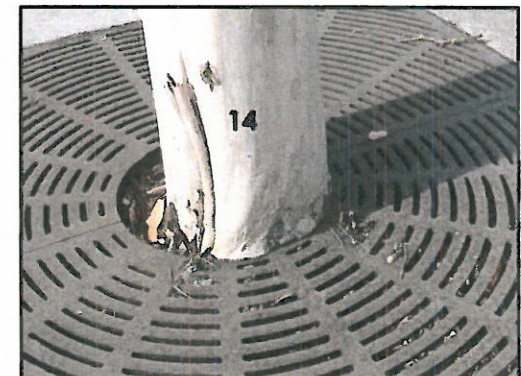
*08	Crape myrtle	8	20*15	80	20	Poor	Low/ Moderate	Remove	Structure	<u>Condition:</u> car hit has cracked trunk all the way through from ground to 4.5 feet above the ground; can see daylight through crack – also much internal decay visible. As a part of new landscaping replace this tree a new tree of same species.	2	3	4
*09	Crape myrtle	8	20*16	80	75	Good	Low/ Moderate	Save		<u>Condition:</u> root collar is close to edge of tree grate. Cut grate to create a gap of several inches between trunk and grate.	2	3	4
*10	Crape myrtle	6	18*10	75	70	Good	Low/ Moderate	Save		<u>Condition:</u> minor car hit wound to lower trunk.	1	2	3

*14	Crape myrtle	9	25*18	90	50	Fair	Low/Moderate	Save		Condition: root collar recently starting to overgrow tree grate. Cut grate to create a gap of several inches between trunk and grate. Large scaffold branch failure wound and cavity on trunk.	2	4	5

Center: close-up of crape myrtle #8 with cracked trunk; this tree should be removed and replaced.

Left: close-up of crape myrtle #14 overgrowing tree grate.

4. **Replace crape myrtle #8** (due to poor condition) with a new crape myrtle tree, as part of new landscaping.
5. **Tree Disposition Plan:** re-label the trees with the tree numbers used in this report. These are the actual numbers on the tree tags that were placed on these trees in the field. Also revise the Legend so that the tree tag numbers are used.

11. **The metal tree grates around crape myrtle City street trees #7, 9-11, 14, 15 and 17 have trunk openings that are too small or will soon be too small due to trunk diameter growth.** The root collars of several of these trees are starting to grow over the grate, which can eventually girdle and kill the tree or cause it to fall over. Cut the grates to make the tree trunk hole larger so that there is a gap of at least 2 inches between the grate and the tree's root collar or trunk.
