V-18-002
U-17-077
S-17-042

RE: 400 - 402 Blossom Hill Road

I reviewed the drawings and evaluated the site context. My comments and recommendations are as follows:

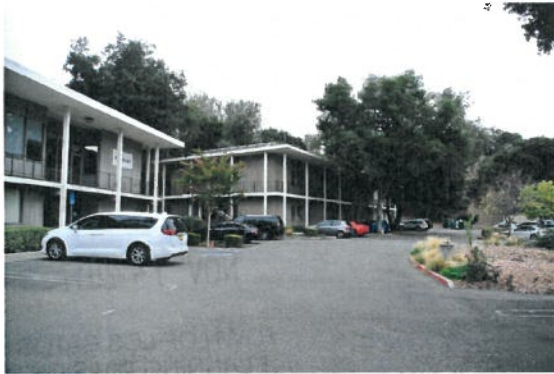
The Site and existing office buildings

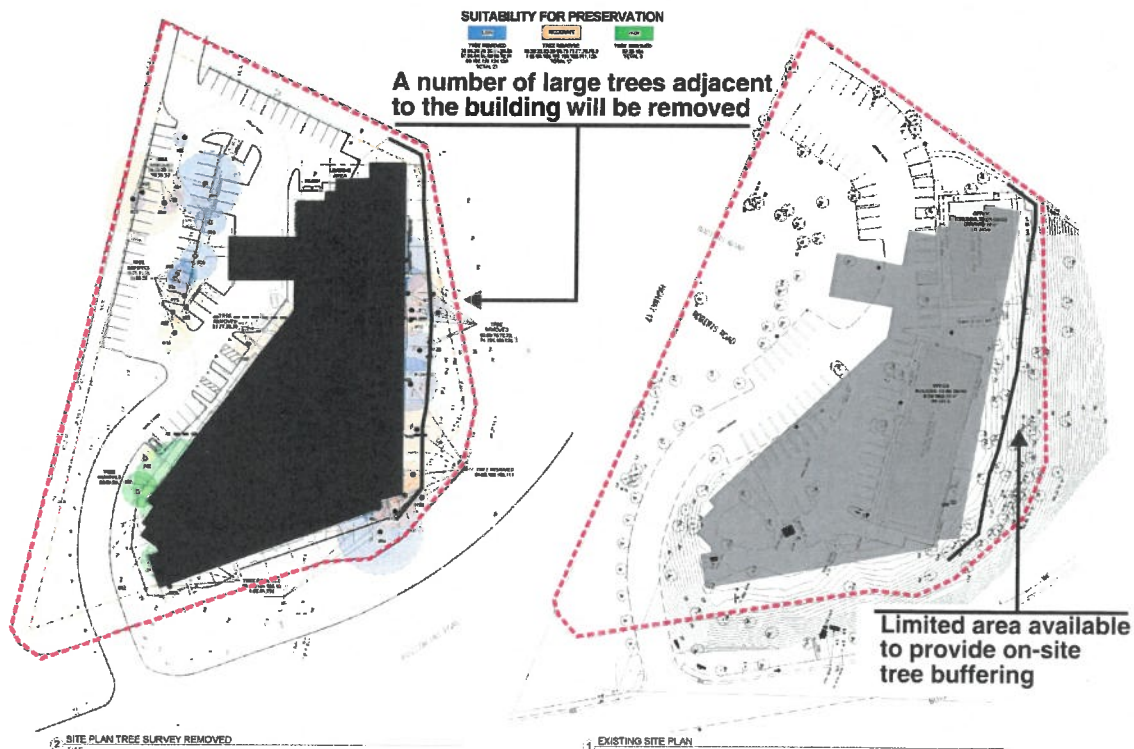
1. The construction of the new building would necessitate the removal of several large trees along the eastern boundary of the site - see illustration below.

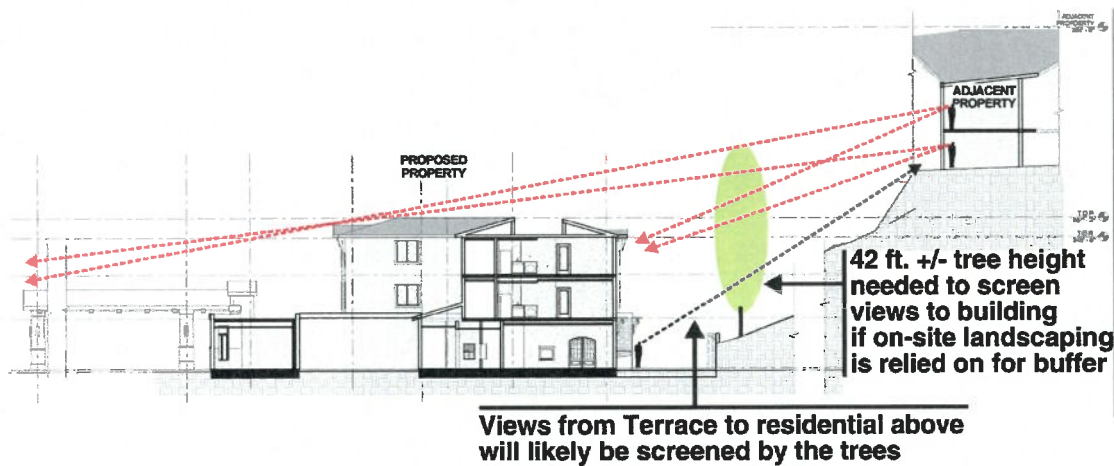
I am unable to evaluate whether the remaining trees on the adjacent slope would be adequate to screen views to the new three-story building from the multifamily homes above. It appears that some limited new planting of California Buckeye trees is proposed along the eastern edge of the property, but it looks like three of the four trees are located outside of the site boundary. California Buckeyes have the potential to grow up to 20-40 feet in height, but I don't know how long that might take and whether the sloped hillside environment would be conducive to reaching their maximum height potential. If the existing trees on the adjacent parcel to the east are insufficient to screen views to the new building, trees on the project site would likely need to be in the 40-foot range to provide screening of the roof and mechanical equipment well of the new structure- see illustration below.

An additional caution would be to explore with the applicant's design team whether the roof-mounted mechanical equipment would have the potential for noise intrusion on the residential units above the site.

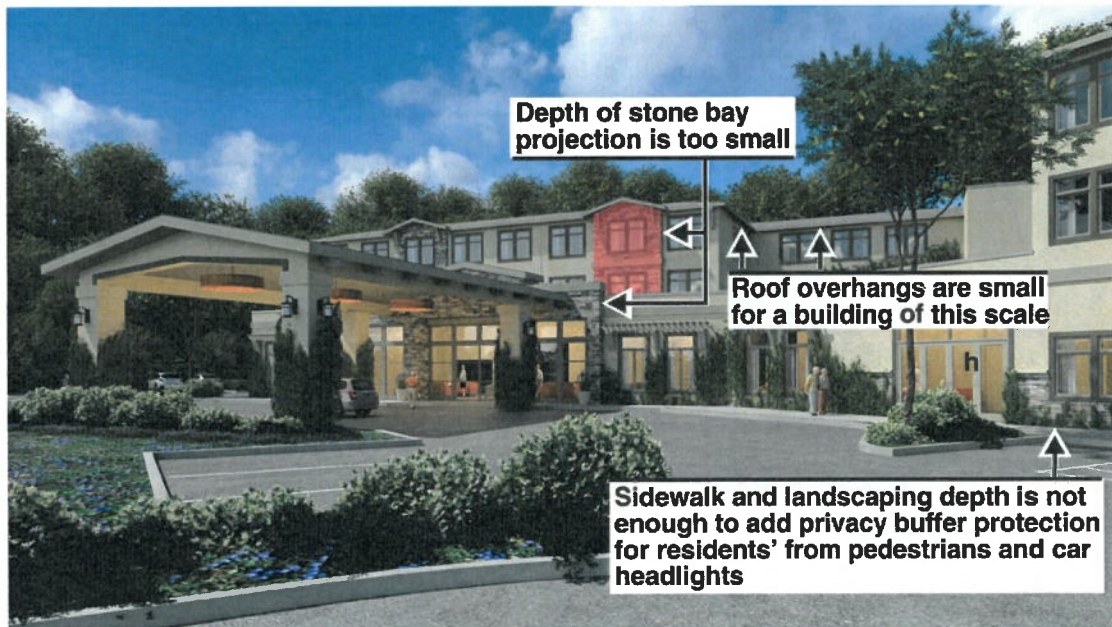
3. The depth of the bay elements faced with stone is quite small for a building of this scale.

Recommendation: Substantially increase the depth of all of the bay pop outs.

Note: The sketch on the previous page shows some minor landscaping below the windows, but the landscape plan does not show any landscaping along the sidewalk/parking lot edge.

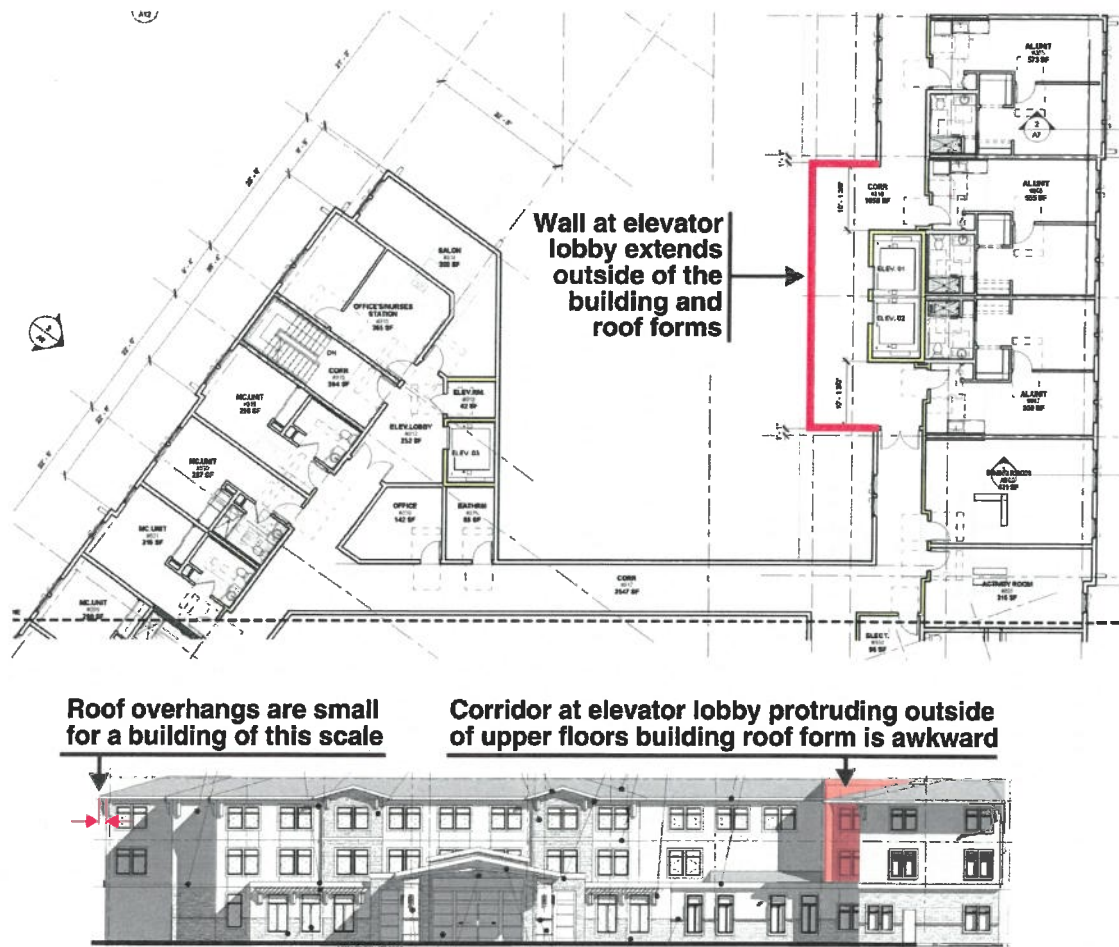
5. The location of the elevators necessitates a jog in the corridor on the upper levels which pushes a stucco box outside the building and roof forms. This condition is not consistent with the overall design of the building. The condition is created by the shallower building depth on upper floors from the east wall to the corridor than is provided on the first floor. Therefore, the corridors are not aligned vertically.

Recommendation: Revise the floor plans to keep the corridor within the overall building and roof forms. Alternatively, explore design alternatives to better integrate the corridor pop out into the character and design of the building.

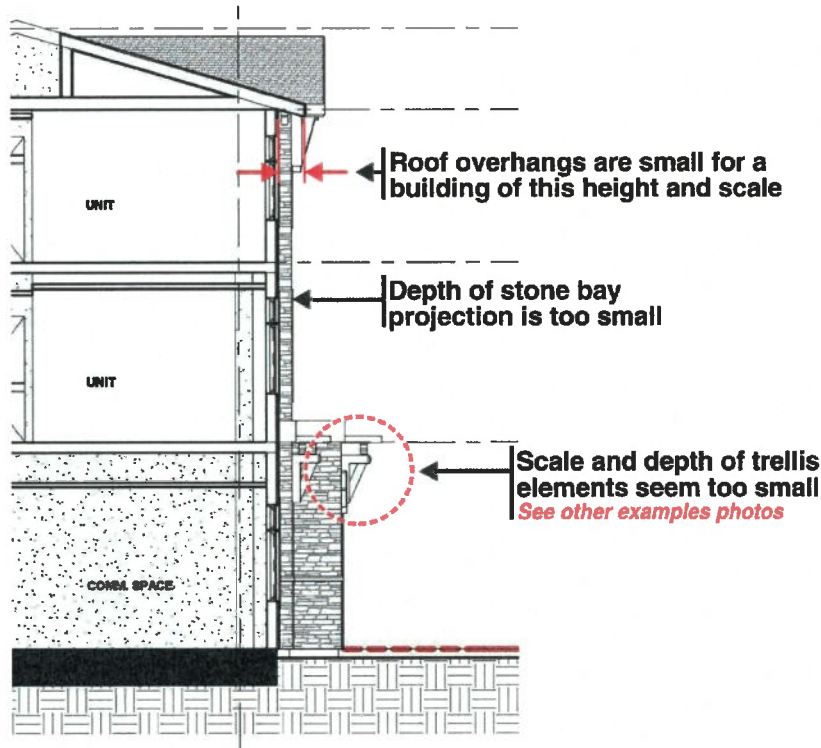
6. The scale and depth of the applied trellis elements seem too small for a building of this scale.

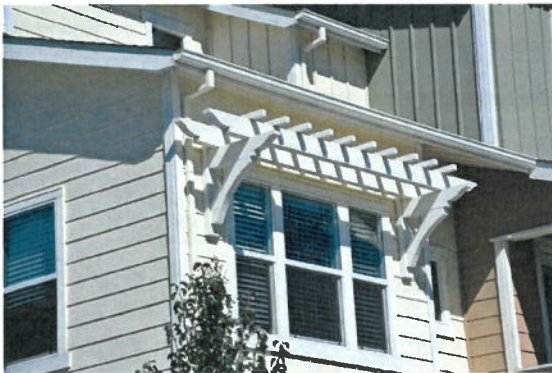
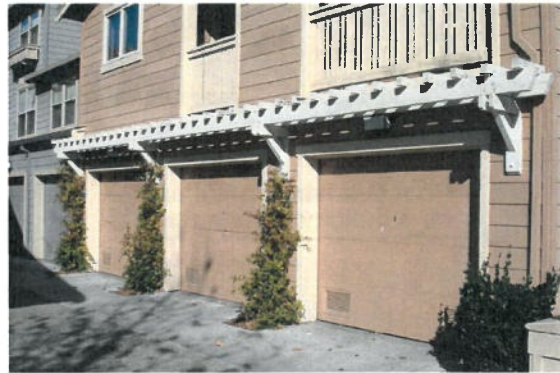
Recommendation: Revise the design of the trellis elements - see two examples below

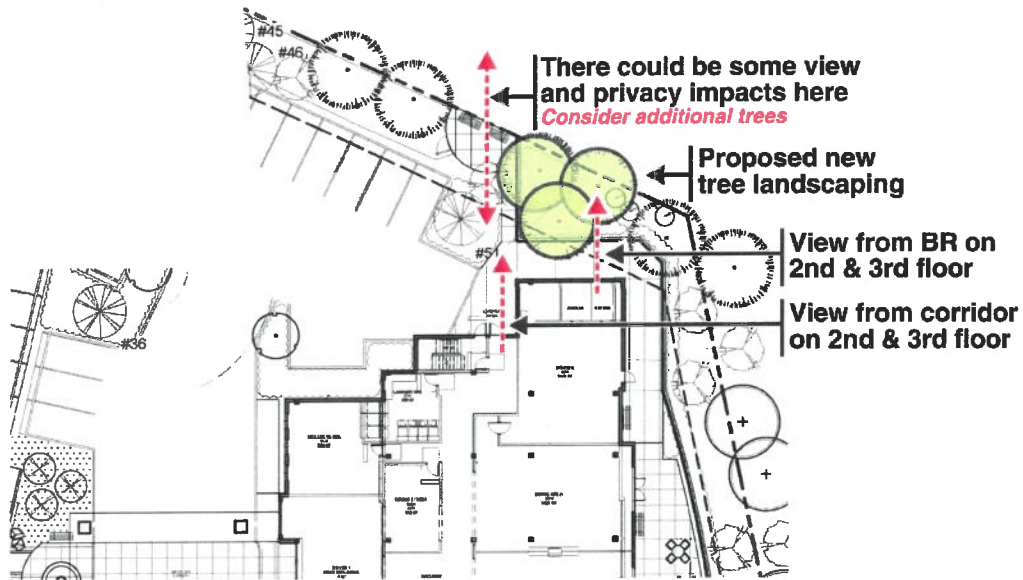
You specifically asked about the relationship of the new building to the two-story building on the adjacent property. The potential issues are views to the new three-story building and privacy intrusion views into the existing multifamily units windows and private open space. There is one set of bedroom windows and one single corridor window on the north facade at the second and third floors of the new building - see diagram on the next page.

The landscape plan shows new trees at the north property line. The drawing key is not altogether clear, but it appears that there will be California Redwoods planted at the north end of the building. That should shield views to and from the new building at the bedroom windows. There appears, however, to be a gap in landscaping in the areas of the new outdoor seating area.

Recommendation: Consider adding additional trees.
